## MEMORANDUM

**RE:** **Zavoral Mining and Reclamation Project – Monitoring and Inspection Report 2 – December 3, 2013**

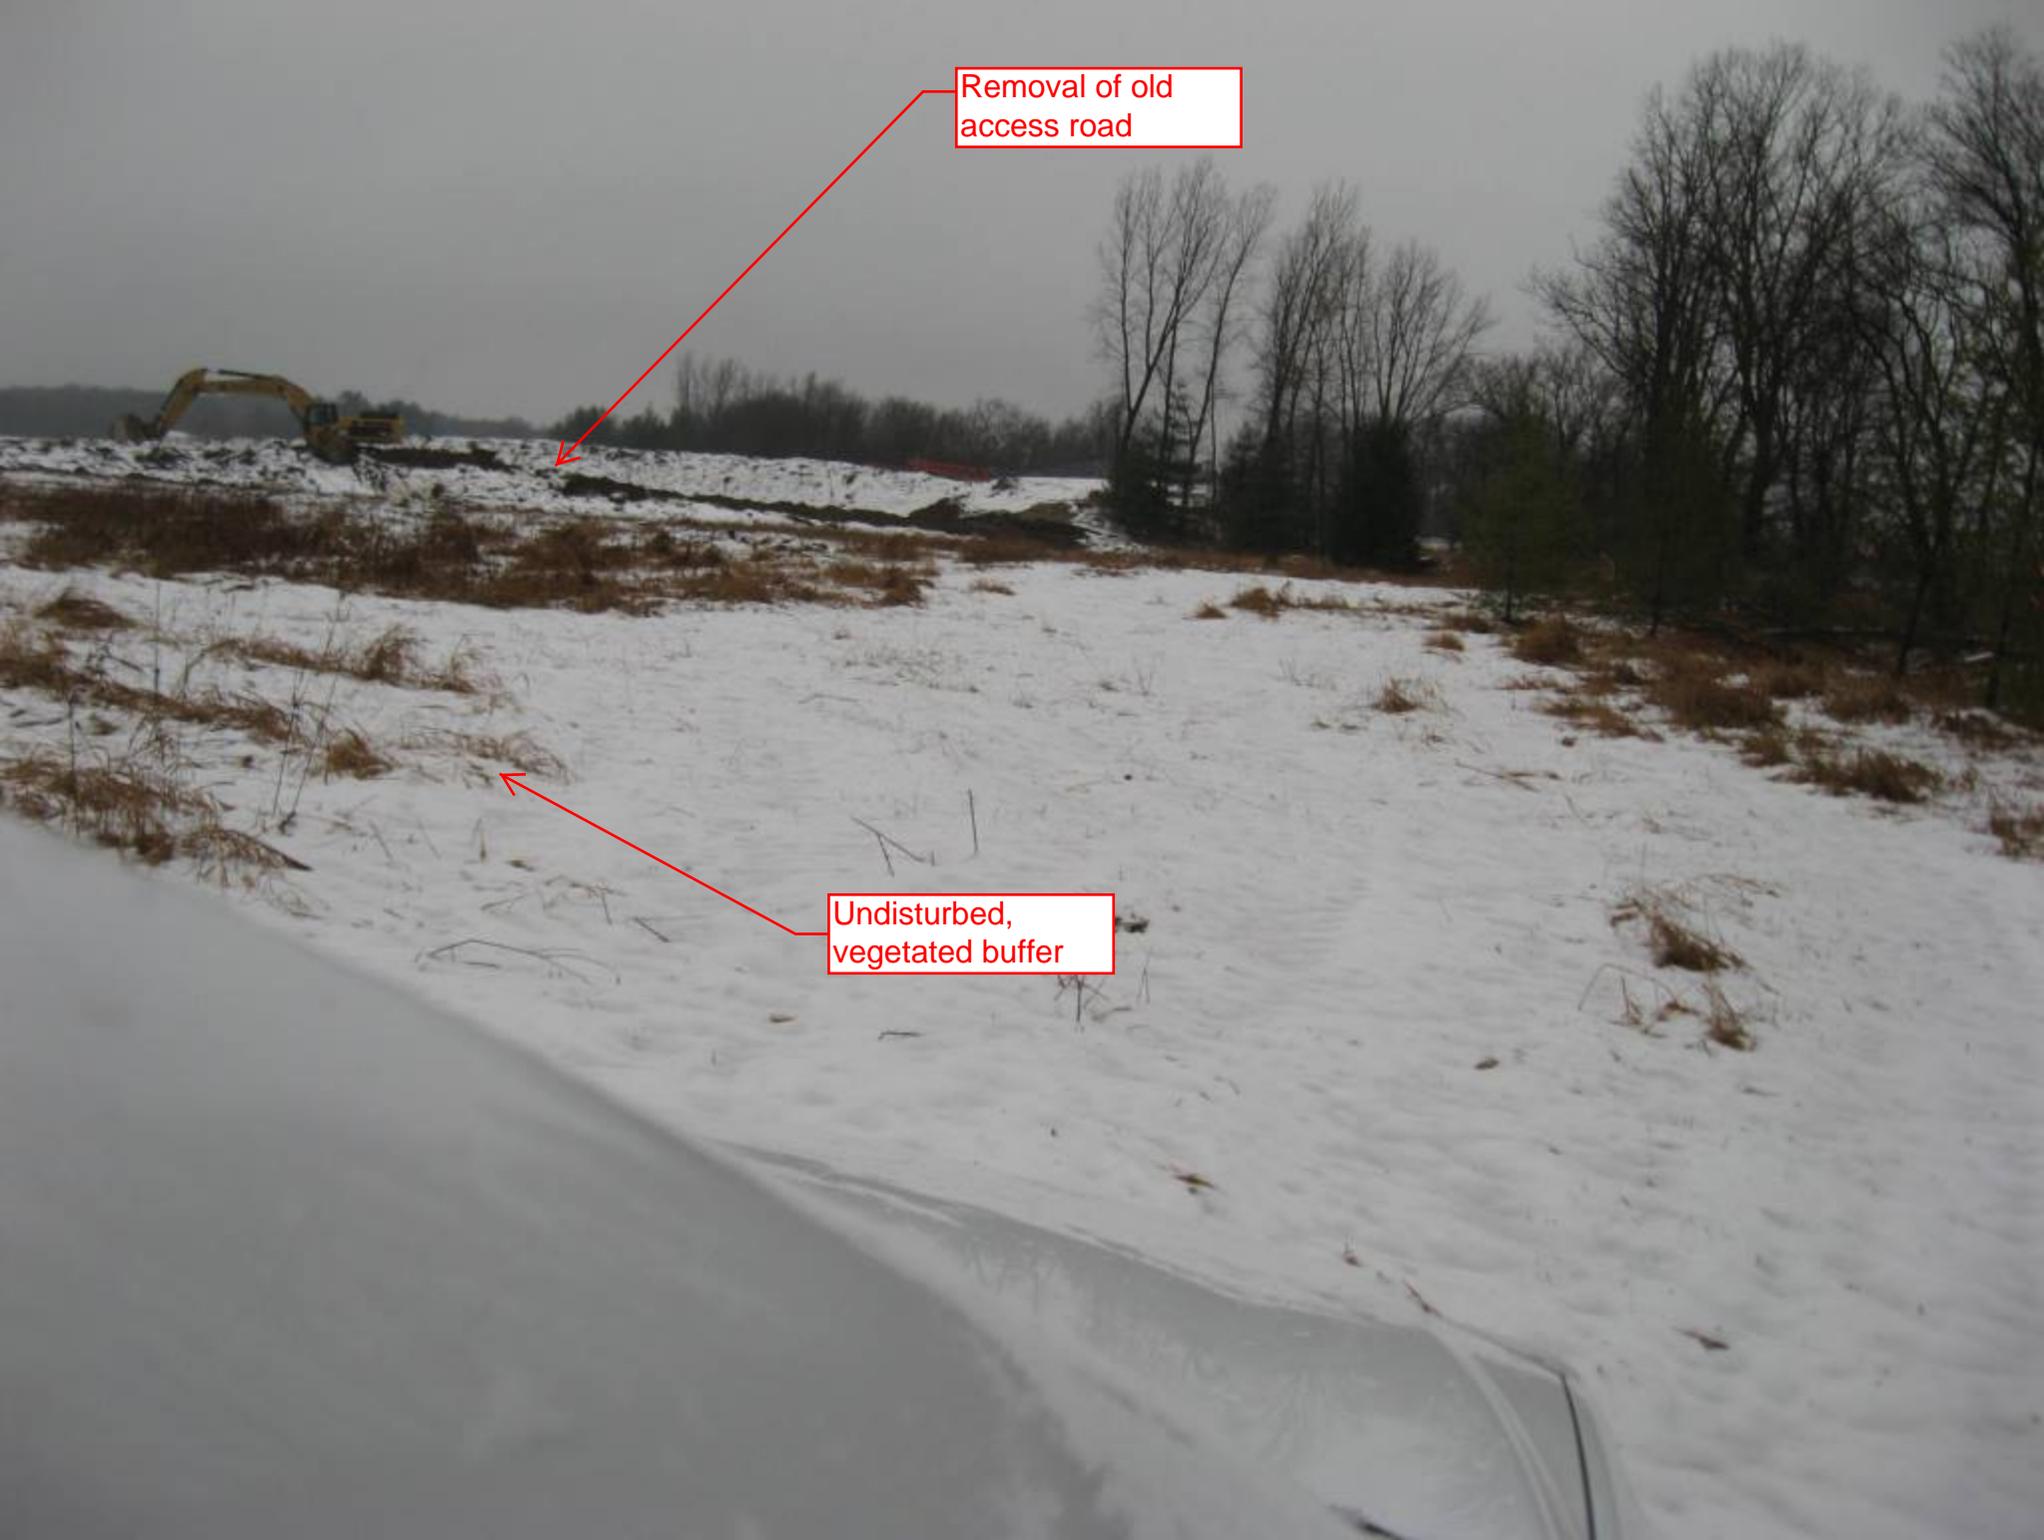
- ii. The construction of the new access road had been completed.
    - iii. In the northern portion of the project area, just north of the old access road, no land disturbing activities had occurred and therefore, silt fence was not installed. Additional detail was provided in the October inspection report. The old access road was actively being removed. Since the removal of the old road will not take much time, the ground is freezing, and there is a very large vegetated buffer between that activity and the project boundary, the installation of silt fence was deemed unnecessary (see attached photo). I asked Christina to keep me informed as to when the old road is removed and the grading in that area is complete. At that time, the drainage of disturbed areas will be internal to the mining area and not offsite to the north and northeast.

Removal of old  
access road

Undisturbed,  
vegetated buffer

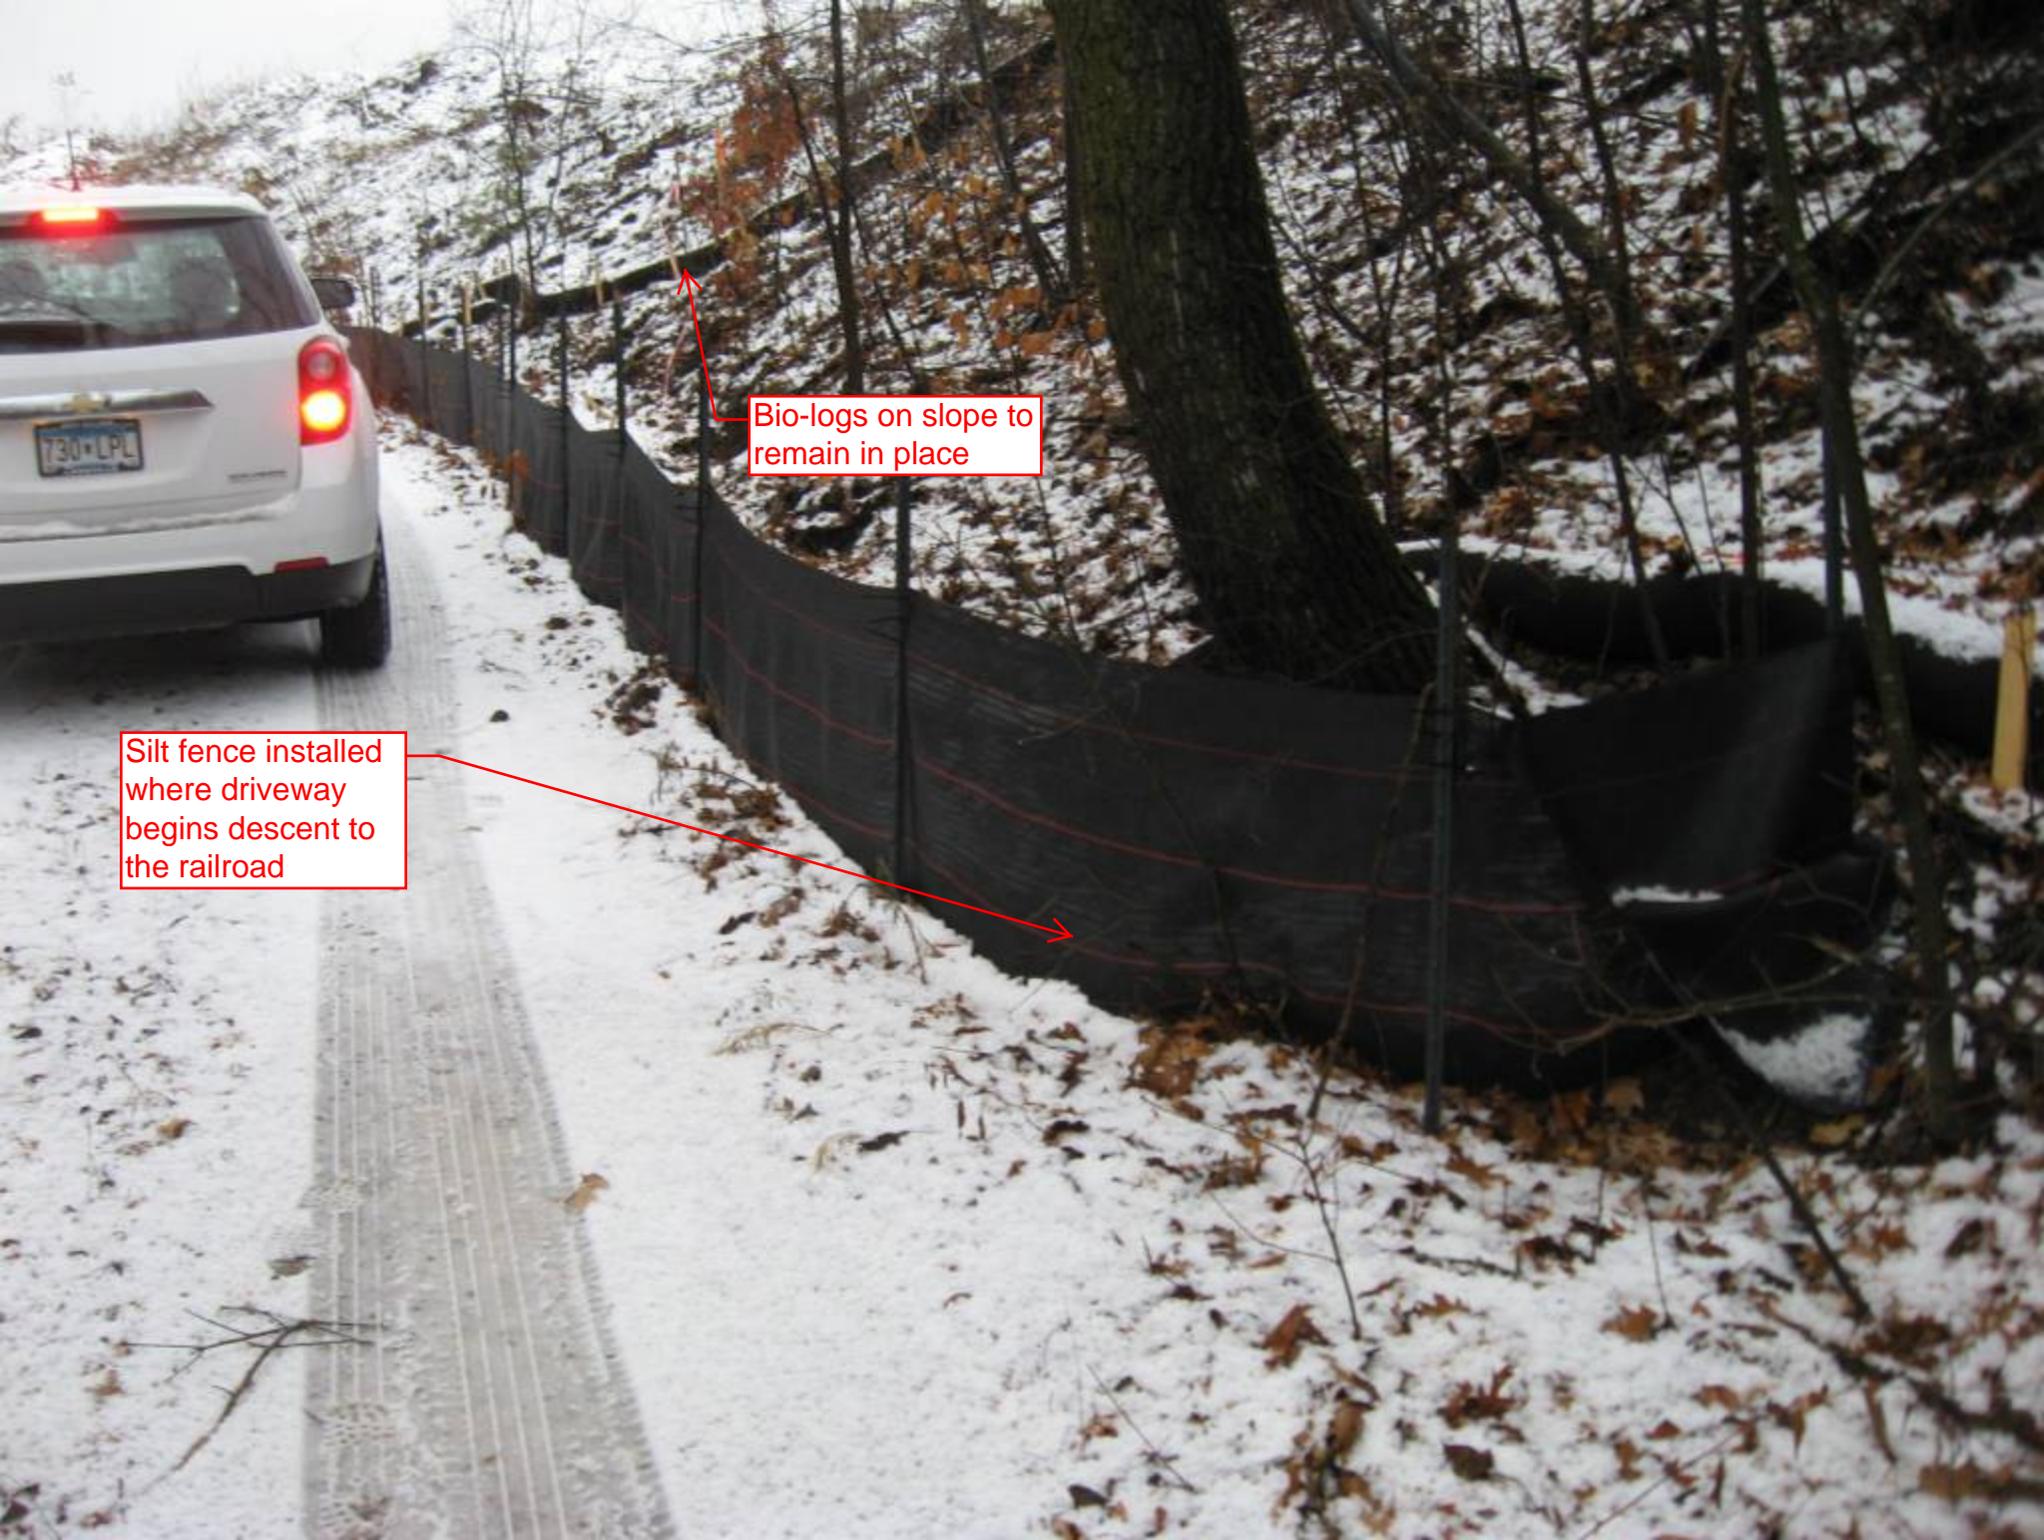
- iv. In the active area near where Mr. Zavoral's driveway begins its descent down the bluff to the railroad tracks, the previous inspection noted the need for perimeter control. Tiller had quickly installed bio-rolls in this area and since then has installed the silt fence (see attached photo).

Bio-logs on slope to remain in place

Silt fence installed where driveway begins descent to the railroad

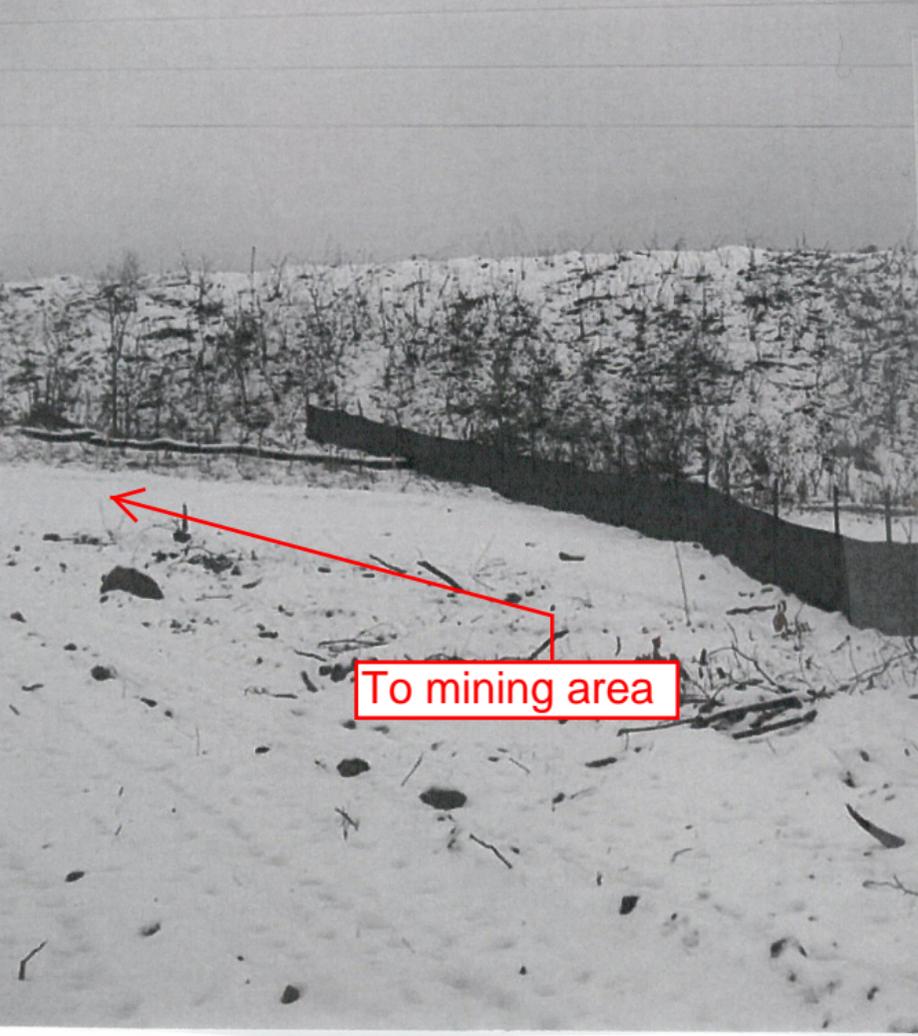
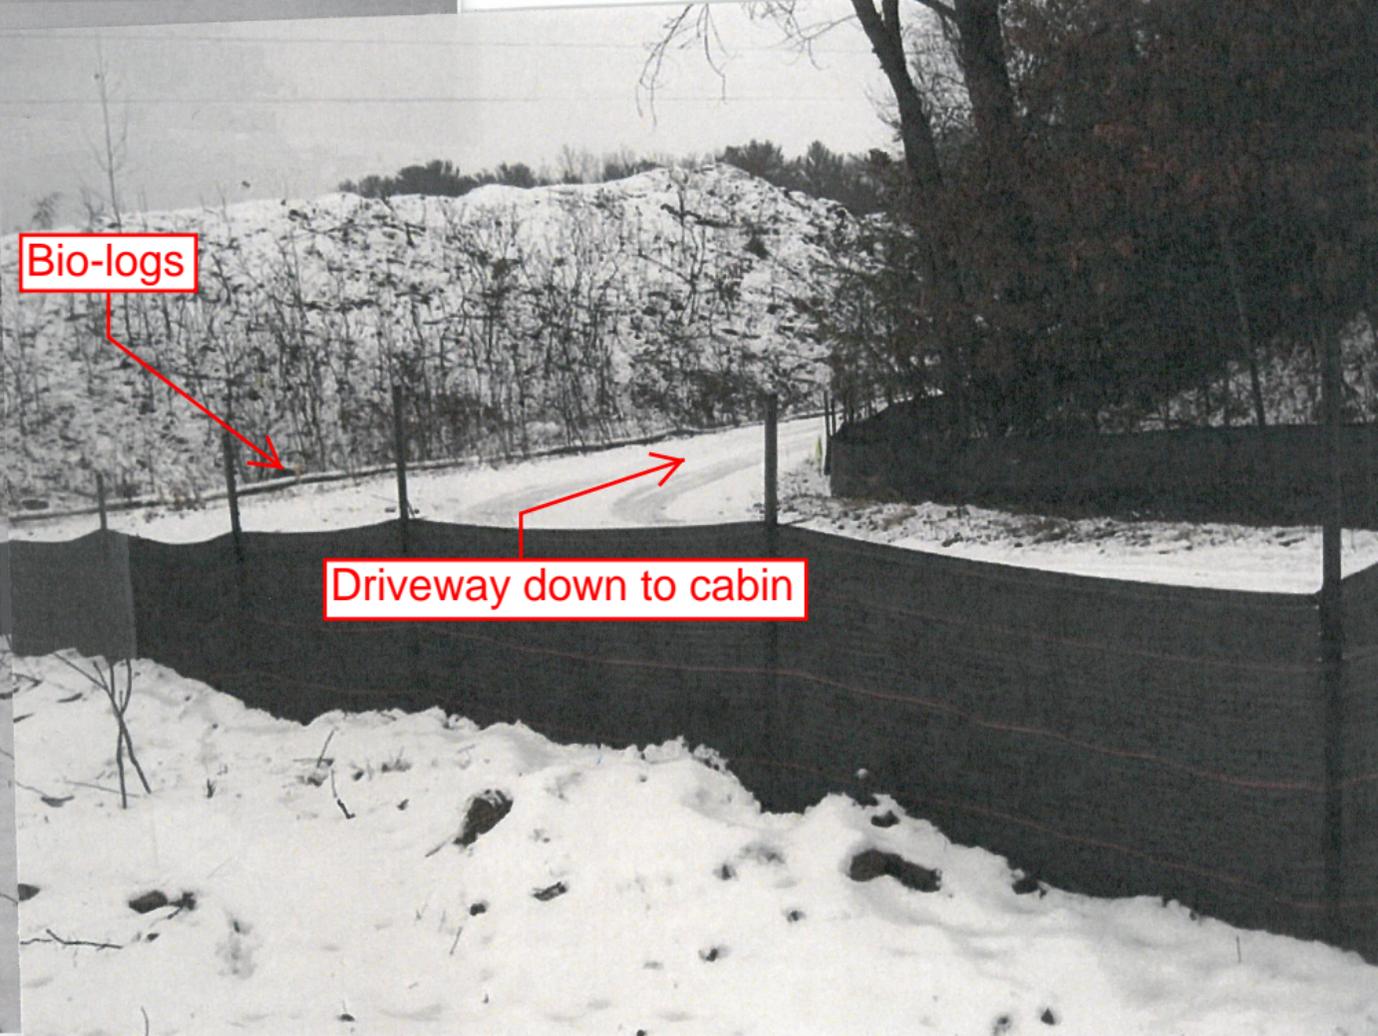
- v. A new silt fence has been installed where an internal mine road meets Mr. Zavoral's driveway. This silt fence is placed to ensure sediment doesn't enter the driveway and flow downhill (see attached photo).

To mining area

Bio-logs

Driveway down to cabin

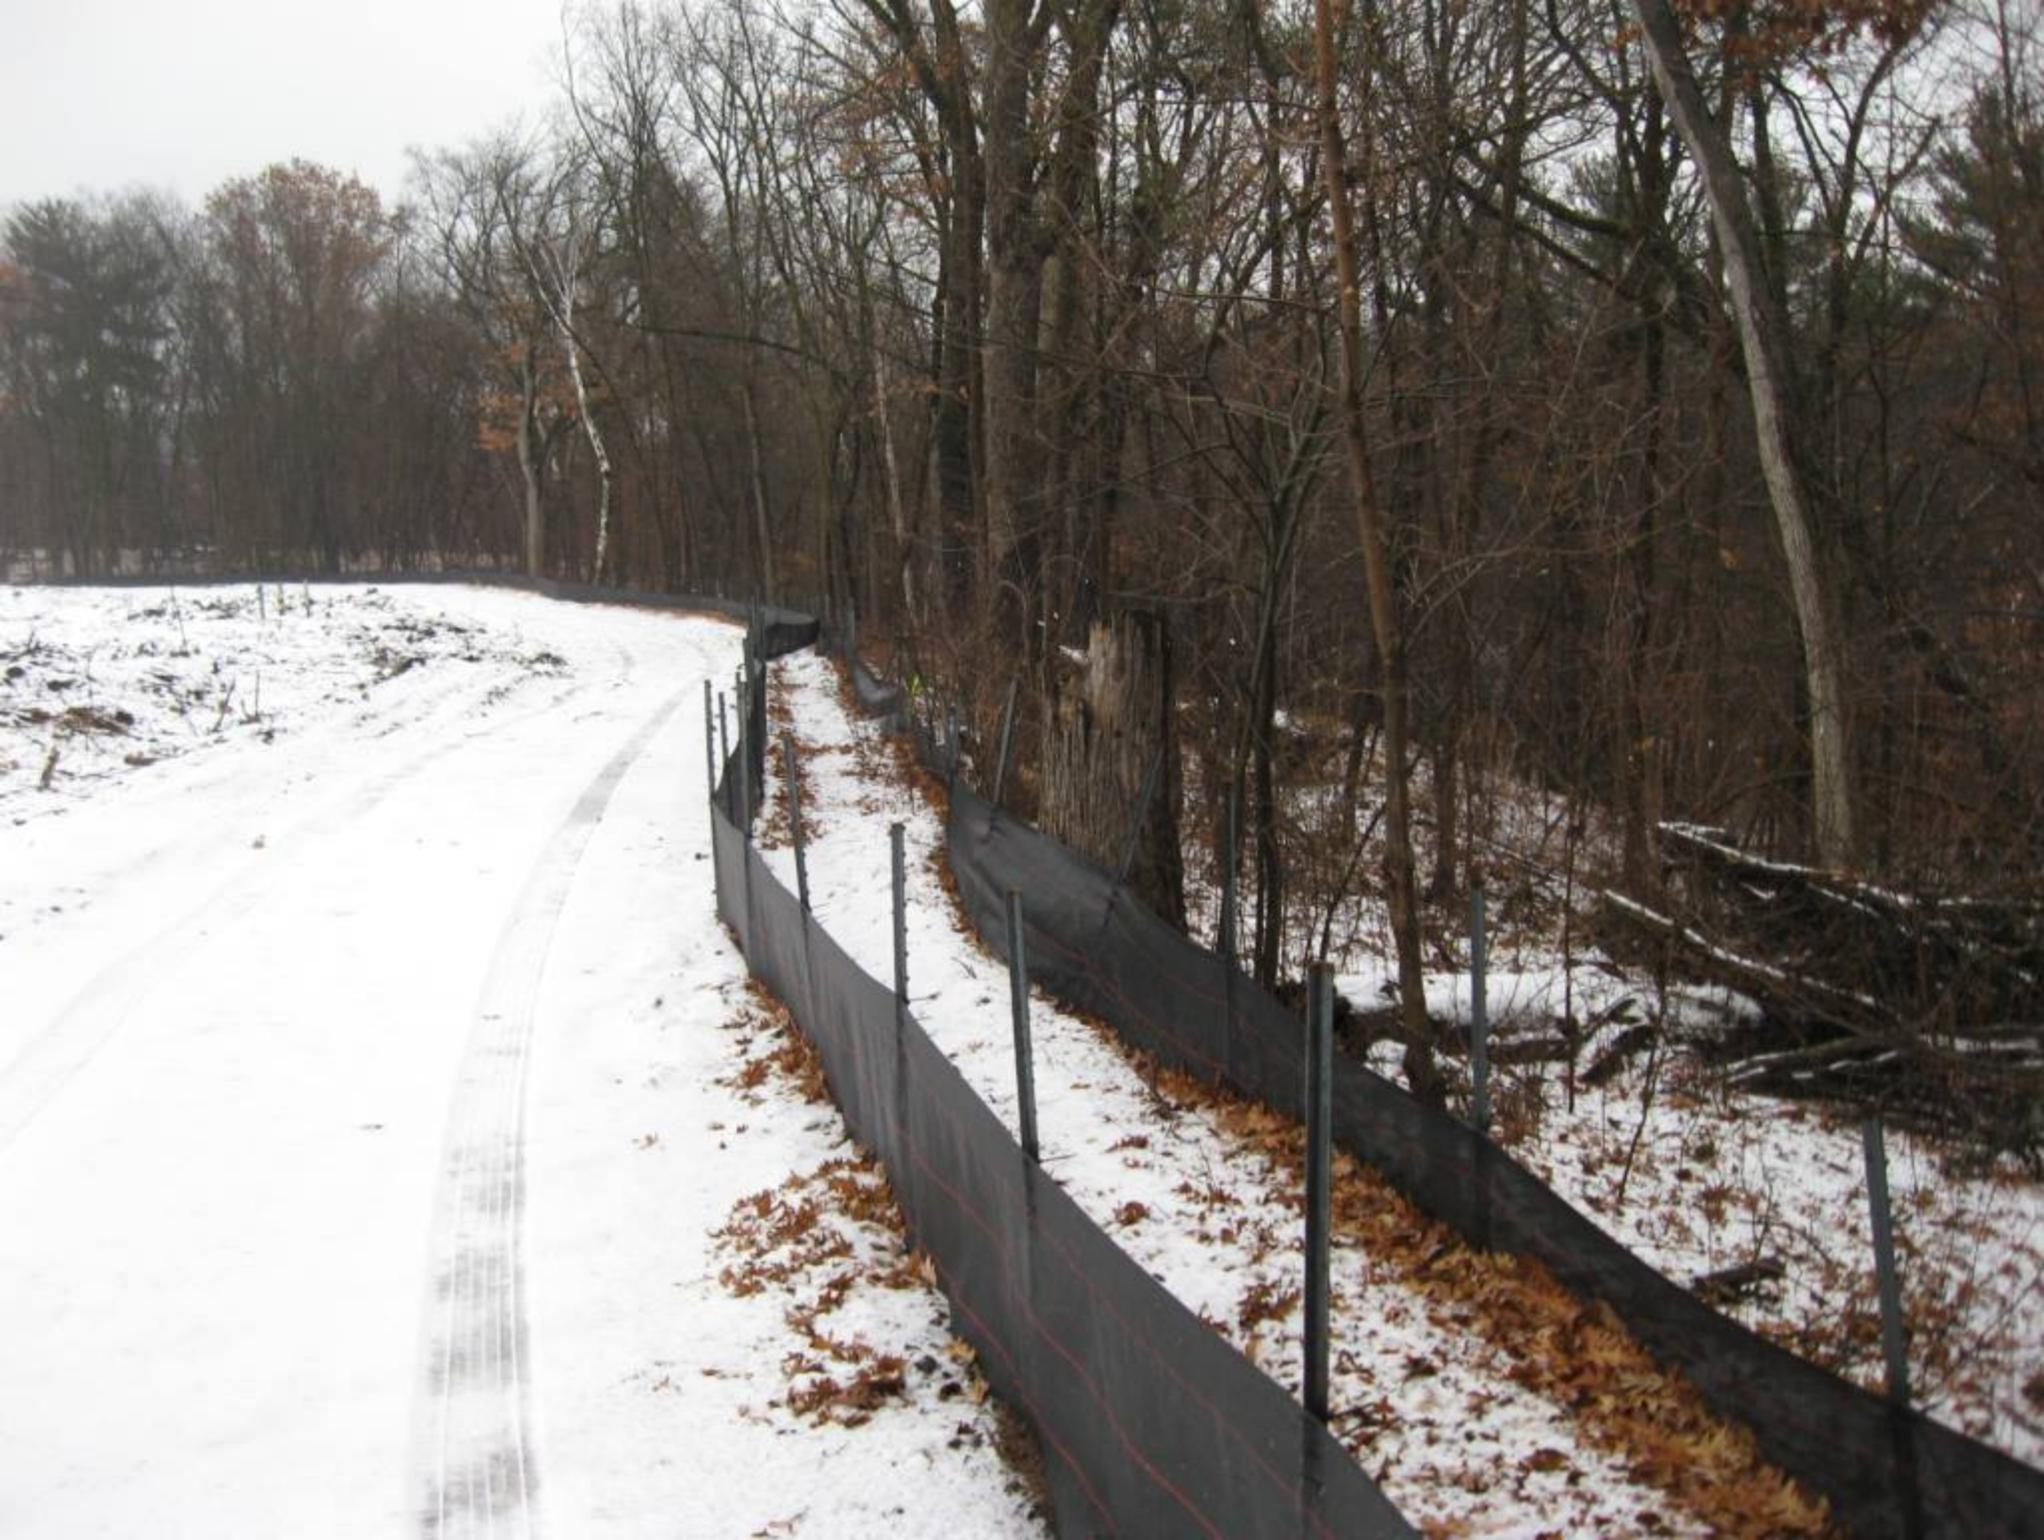
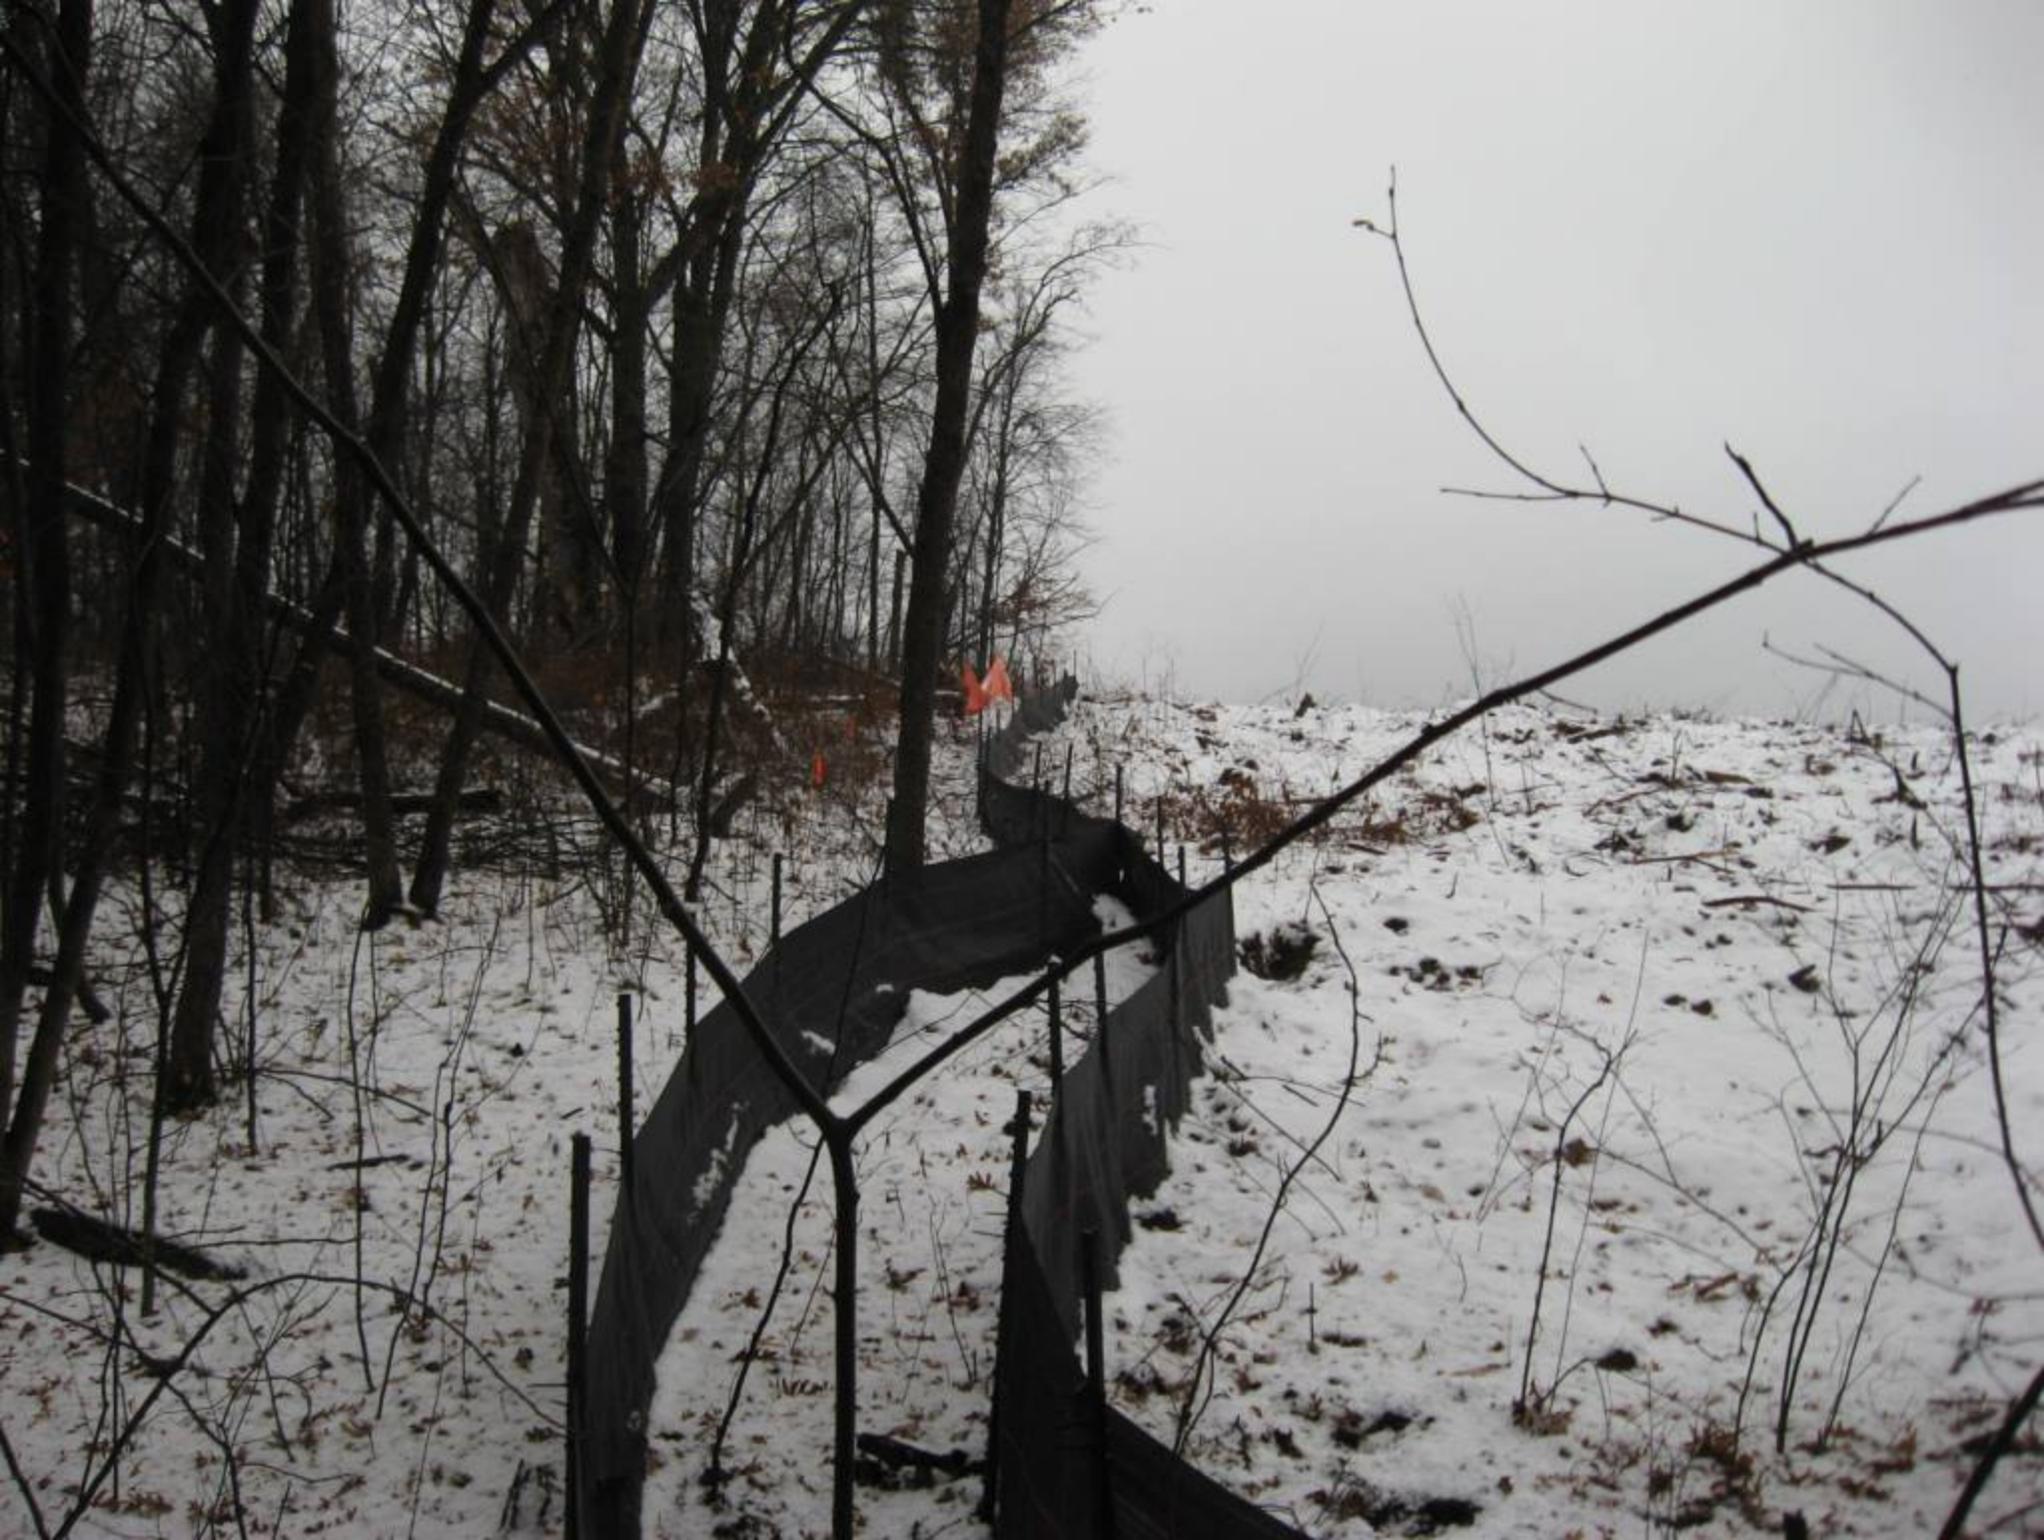
- vi. In areas along the southern project limits (along Mr. Zavoral's driveway), Tiller has installed additional rows of silt fencing (see attached pictures).

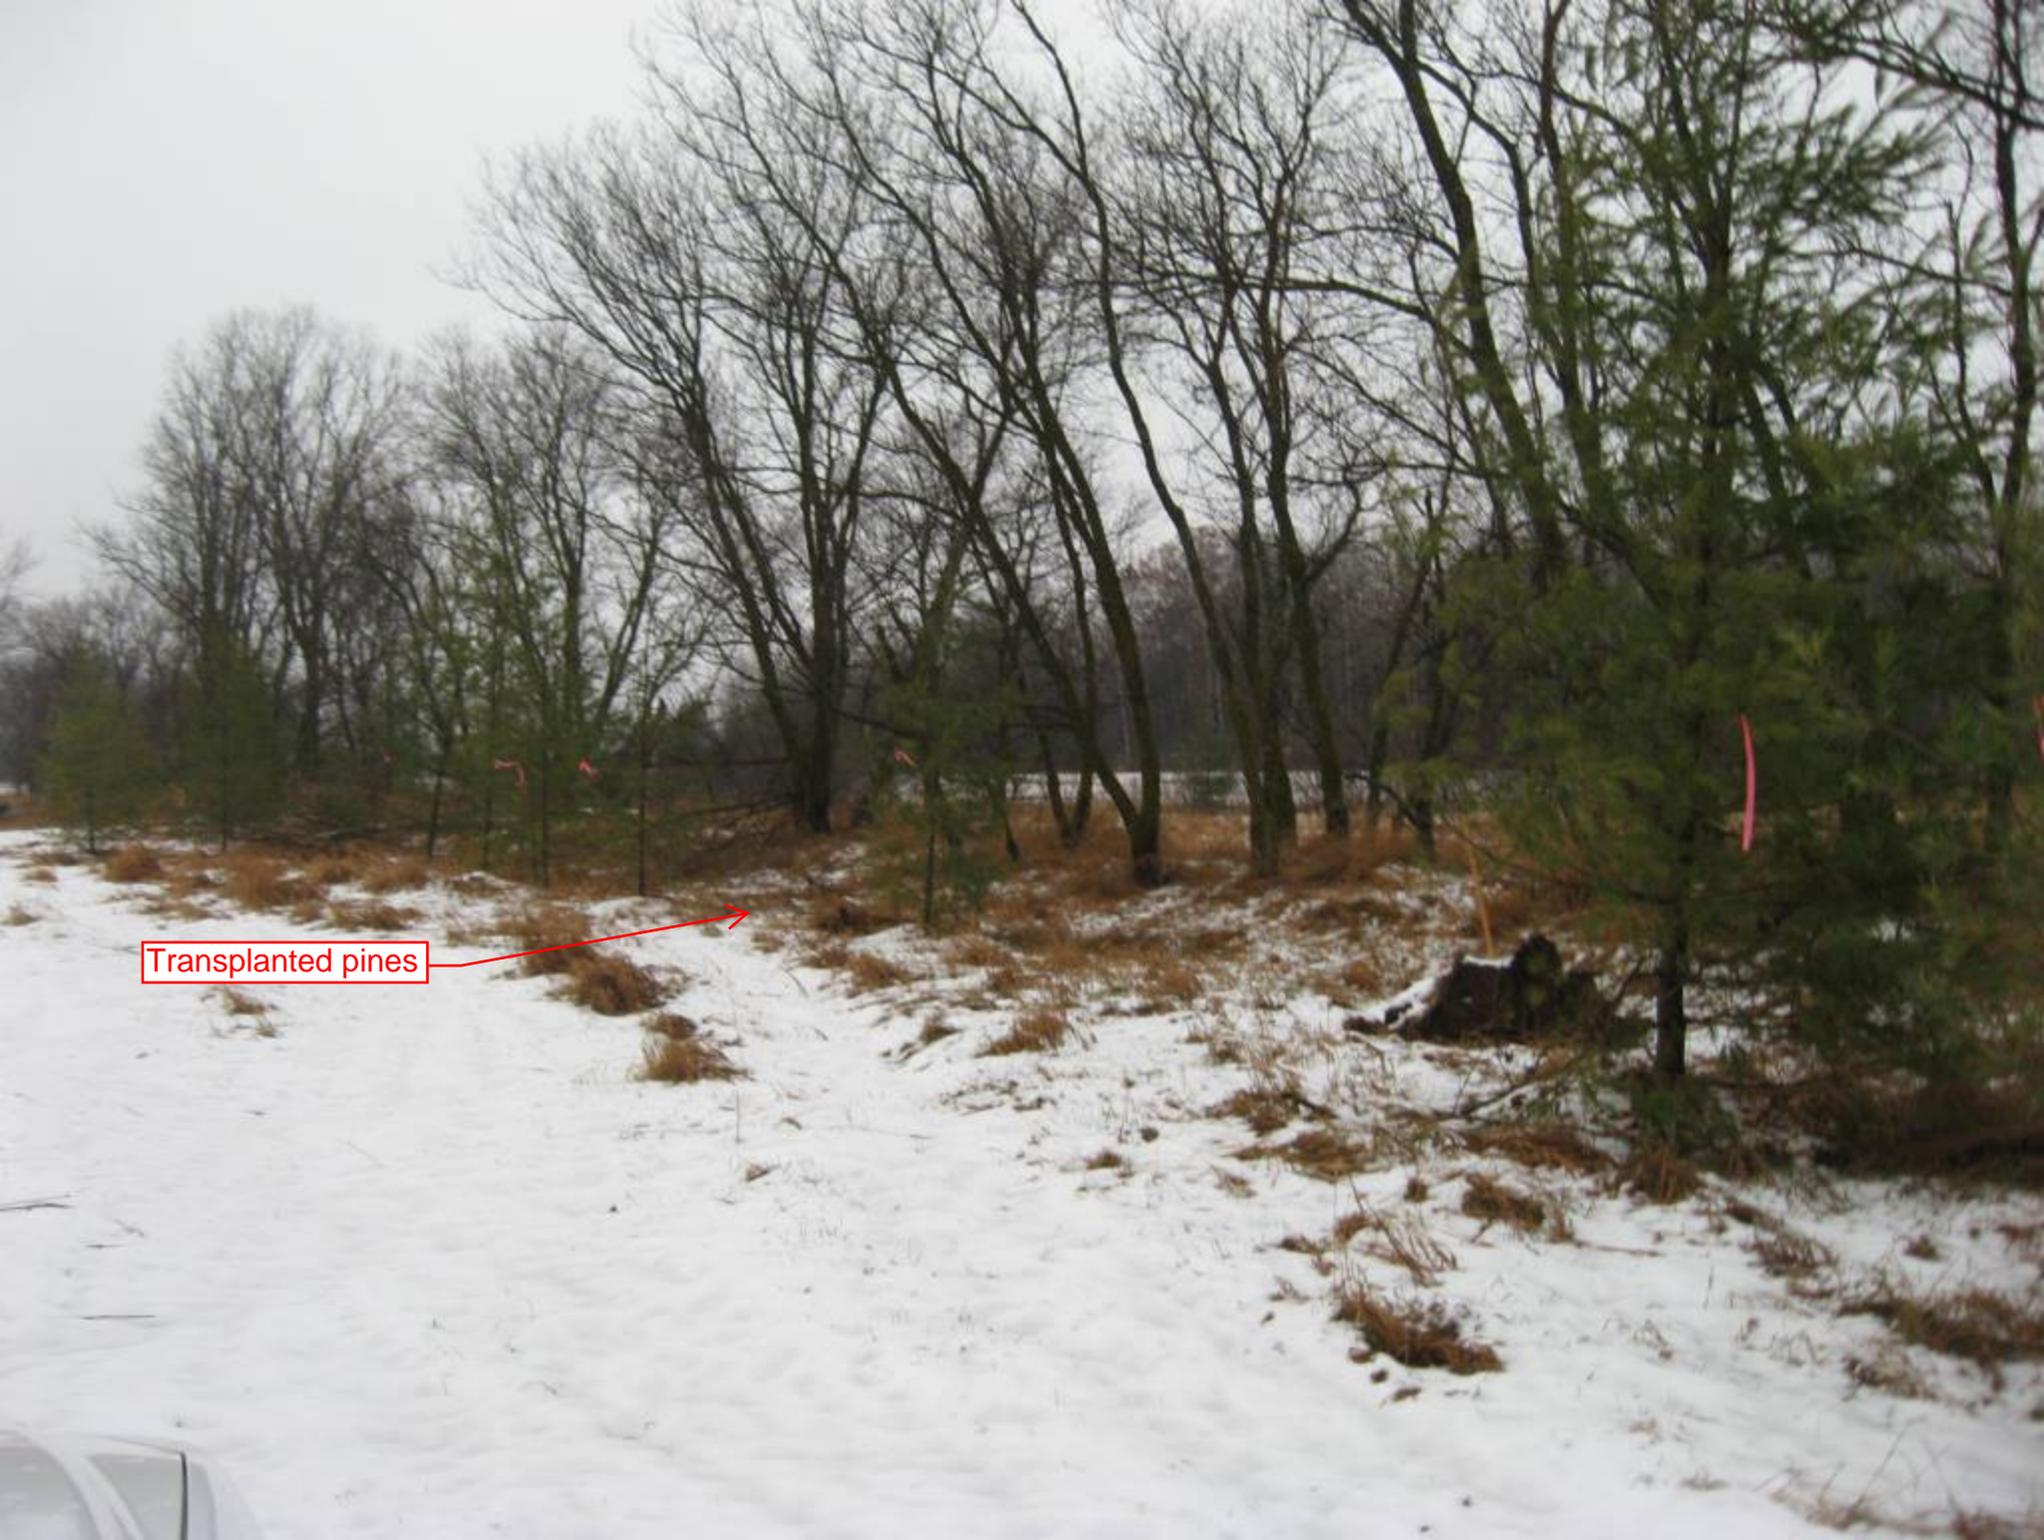
3. Technical Service 5: Reclamation Plan Review and Inspection
  - a. Task 2 – Conduct Site Inspections to Verify Implementation of the Restoration Plan  
Phase 1 of the reclamation was underway during the December 3rd site visit.
    - i. It appeared that most of the grading for Reclamation Phase 1 had been completed.
    - ii. The prairie seed installation was scheduled for the day of the site inspection, but may have been delayed due to the weather conditions.
    - iii. As previously stated in the October report, Tiller’s representative noted that the tree transplantation efforts have been challenging due to the poor soil conditions on the site. Most of the transplanted trees have been placed along the northern boundary of the project area (see attached photo). WCD asked Tiller to summarize the final numbers of transplanted trees in their annual report.

Transplanted pines
