TO: Kristina Handt, Administrator, City of Scandia

FROM: Jed Chesnut, Wetland/Natural Resource Specialist

RE: **Zavoral Mining and Reclamation Project – Monitoring and Inspection Report
2014 Inspection #1 – April 2, 2014**

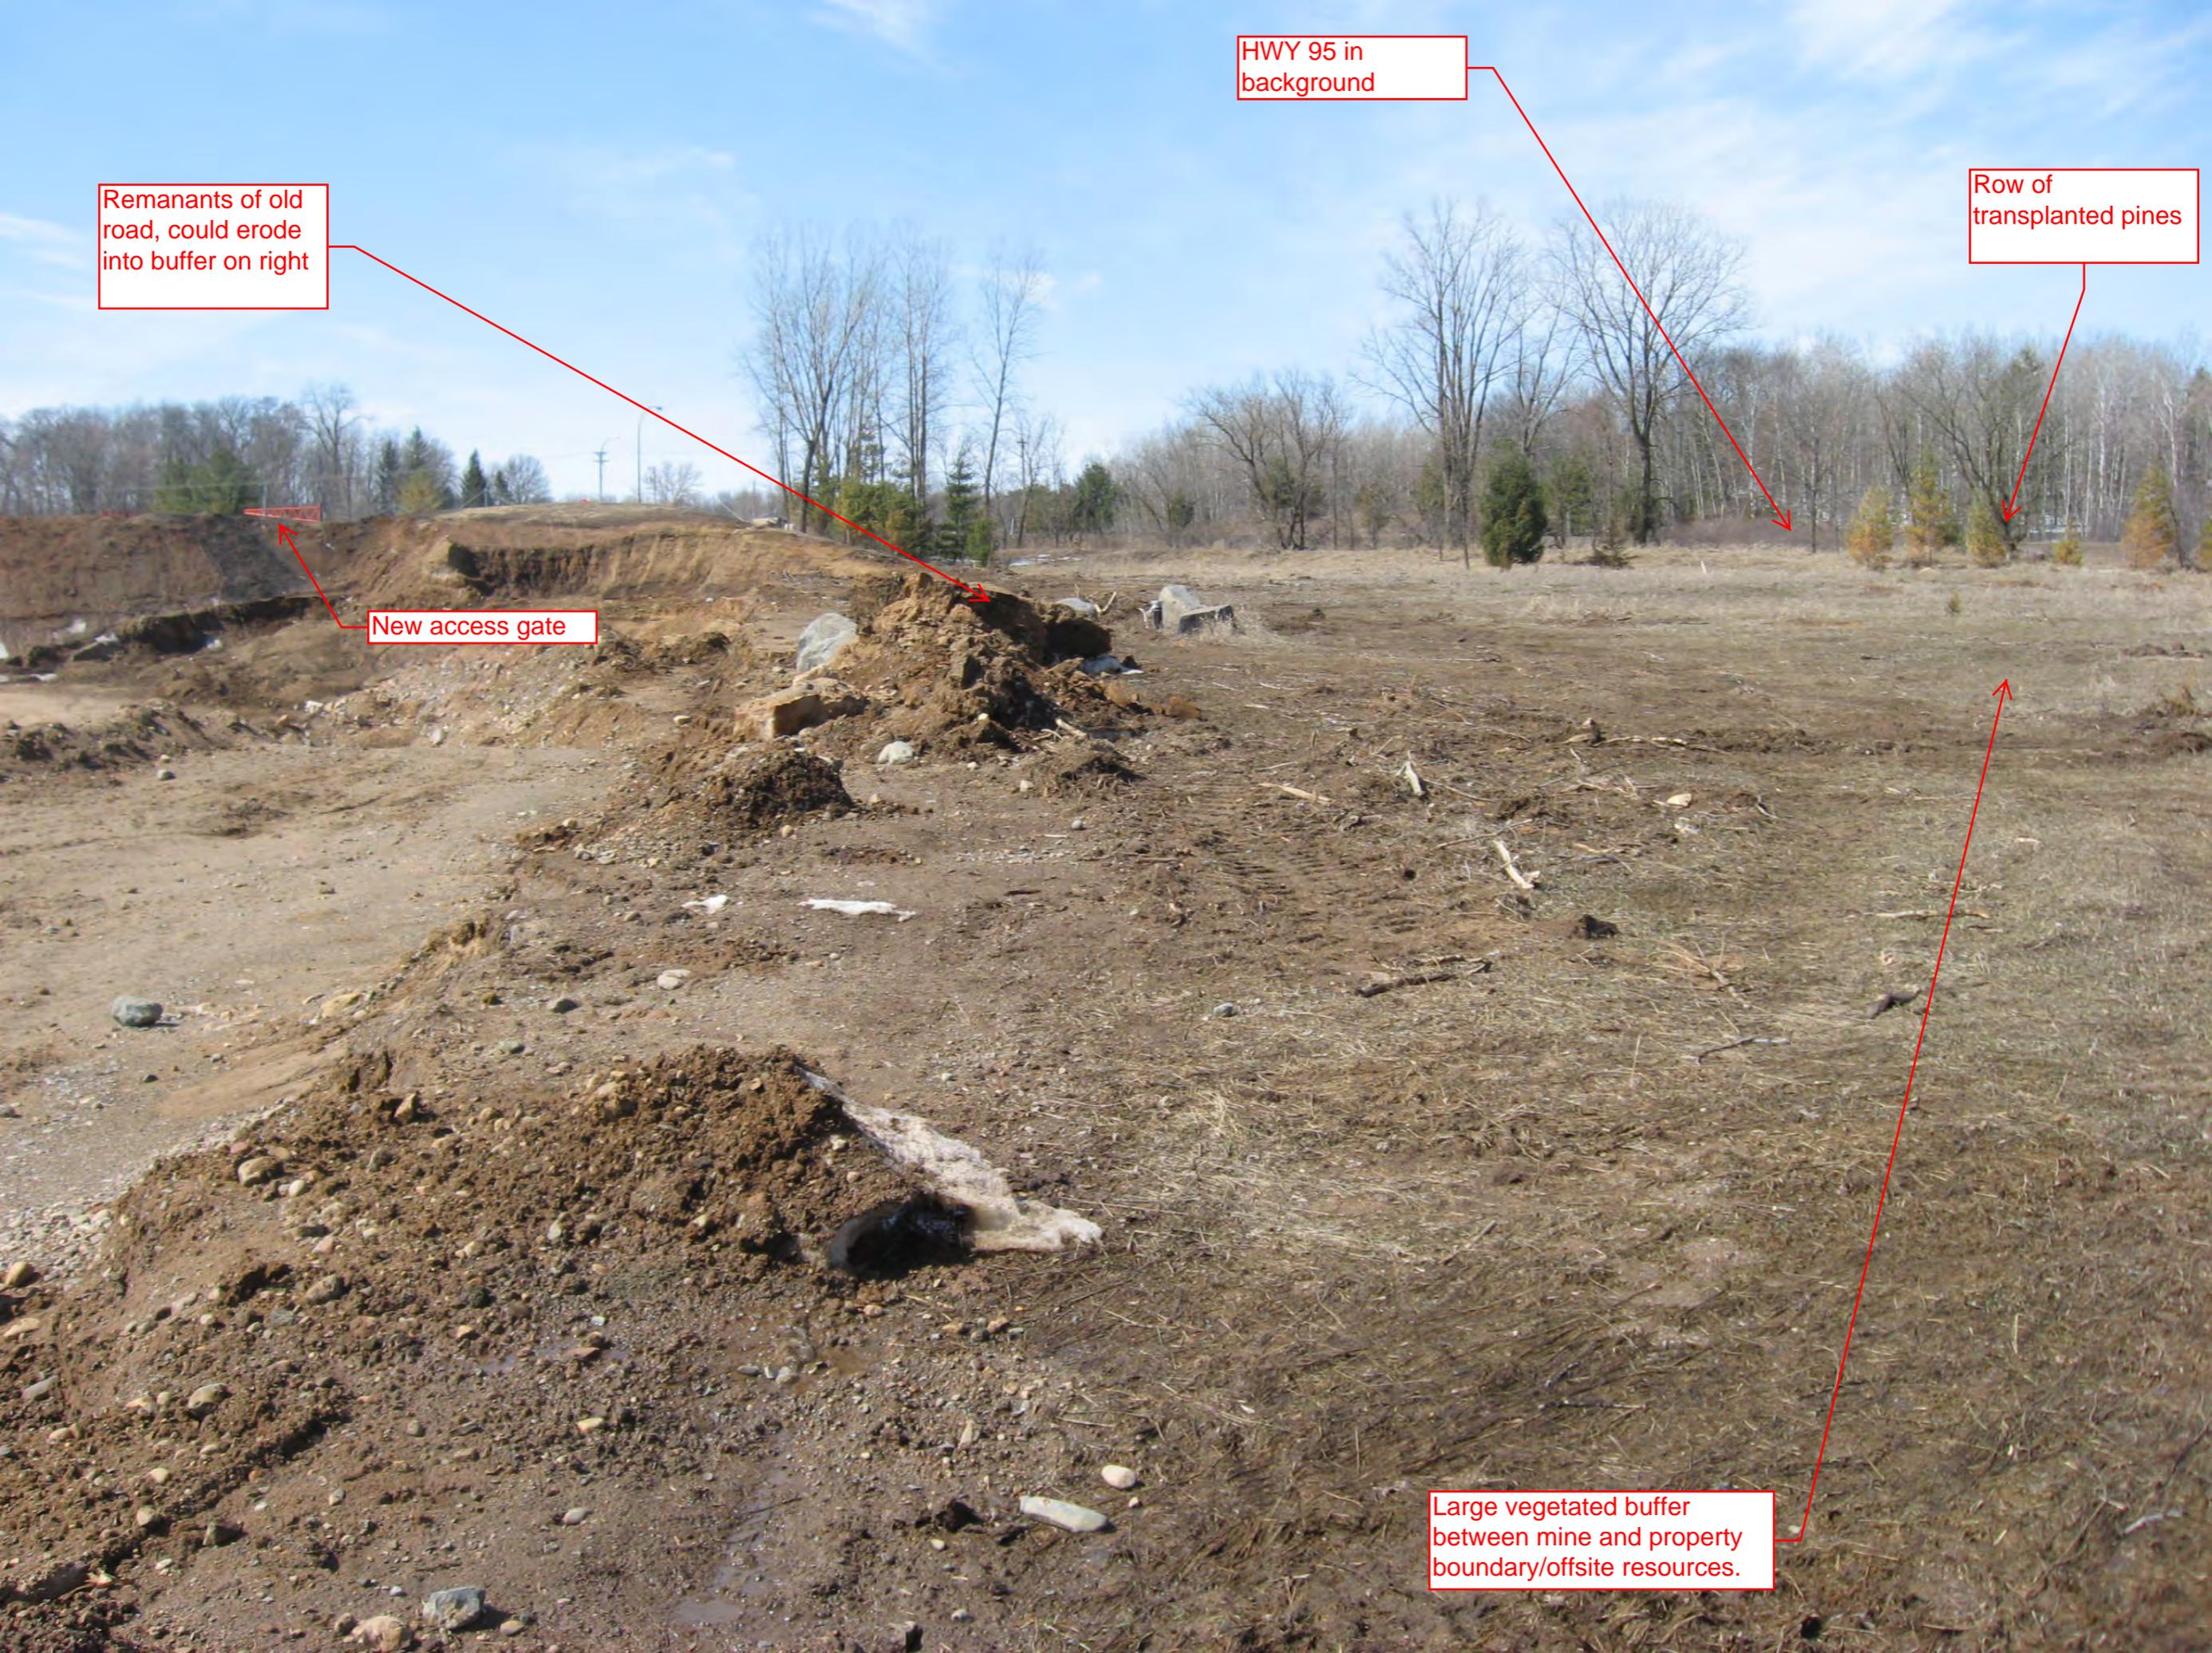
- iii. There was still no major land disturbing activities in the northern portion of the project area, just north of where the old access road was.
 - iv. The old access road was mostly removed; however there was still a small area of disturbed land that sloped toward the buffered area. But, since there was still a very large vegetated buffer between the land disturbing activity and the project boundary, the installation of silt fence was still deemed unnecessary (see attached photo).

Remnants of old road, could erode into buffer on right

HWY 95 in background

Row of transplanted pines

New access gate

Large vegetated buffer between mine and property boundary/offsite resources.

- v. WCD recommended seeding the slopes of the old road bed remnants with oats, if the area was going to be left alone for more than a couple weeks. This would help stabilize the slopes until Tiller is ready to finalize the grades in that area.

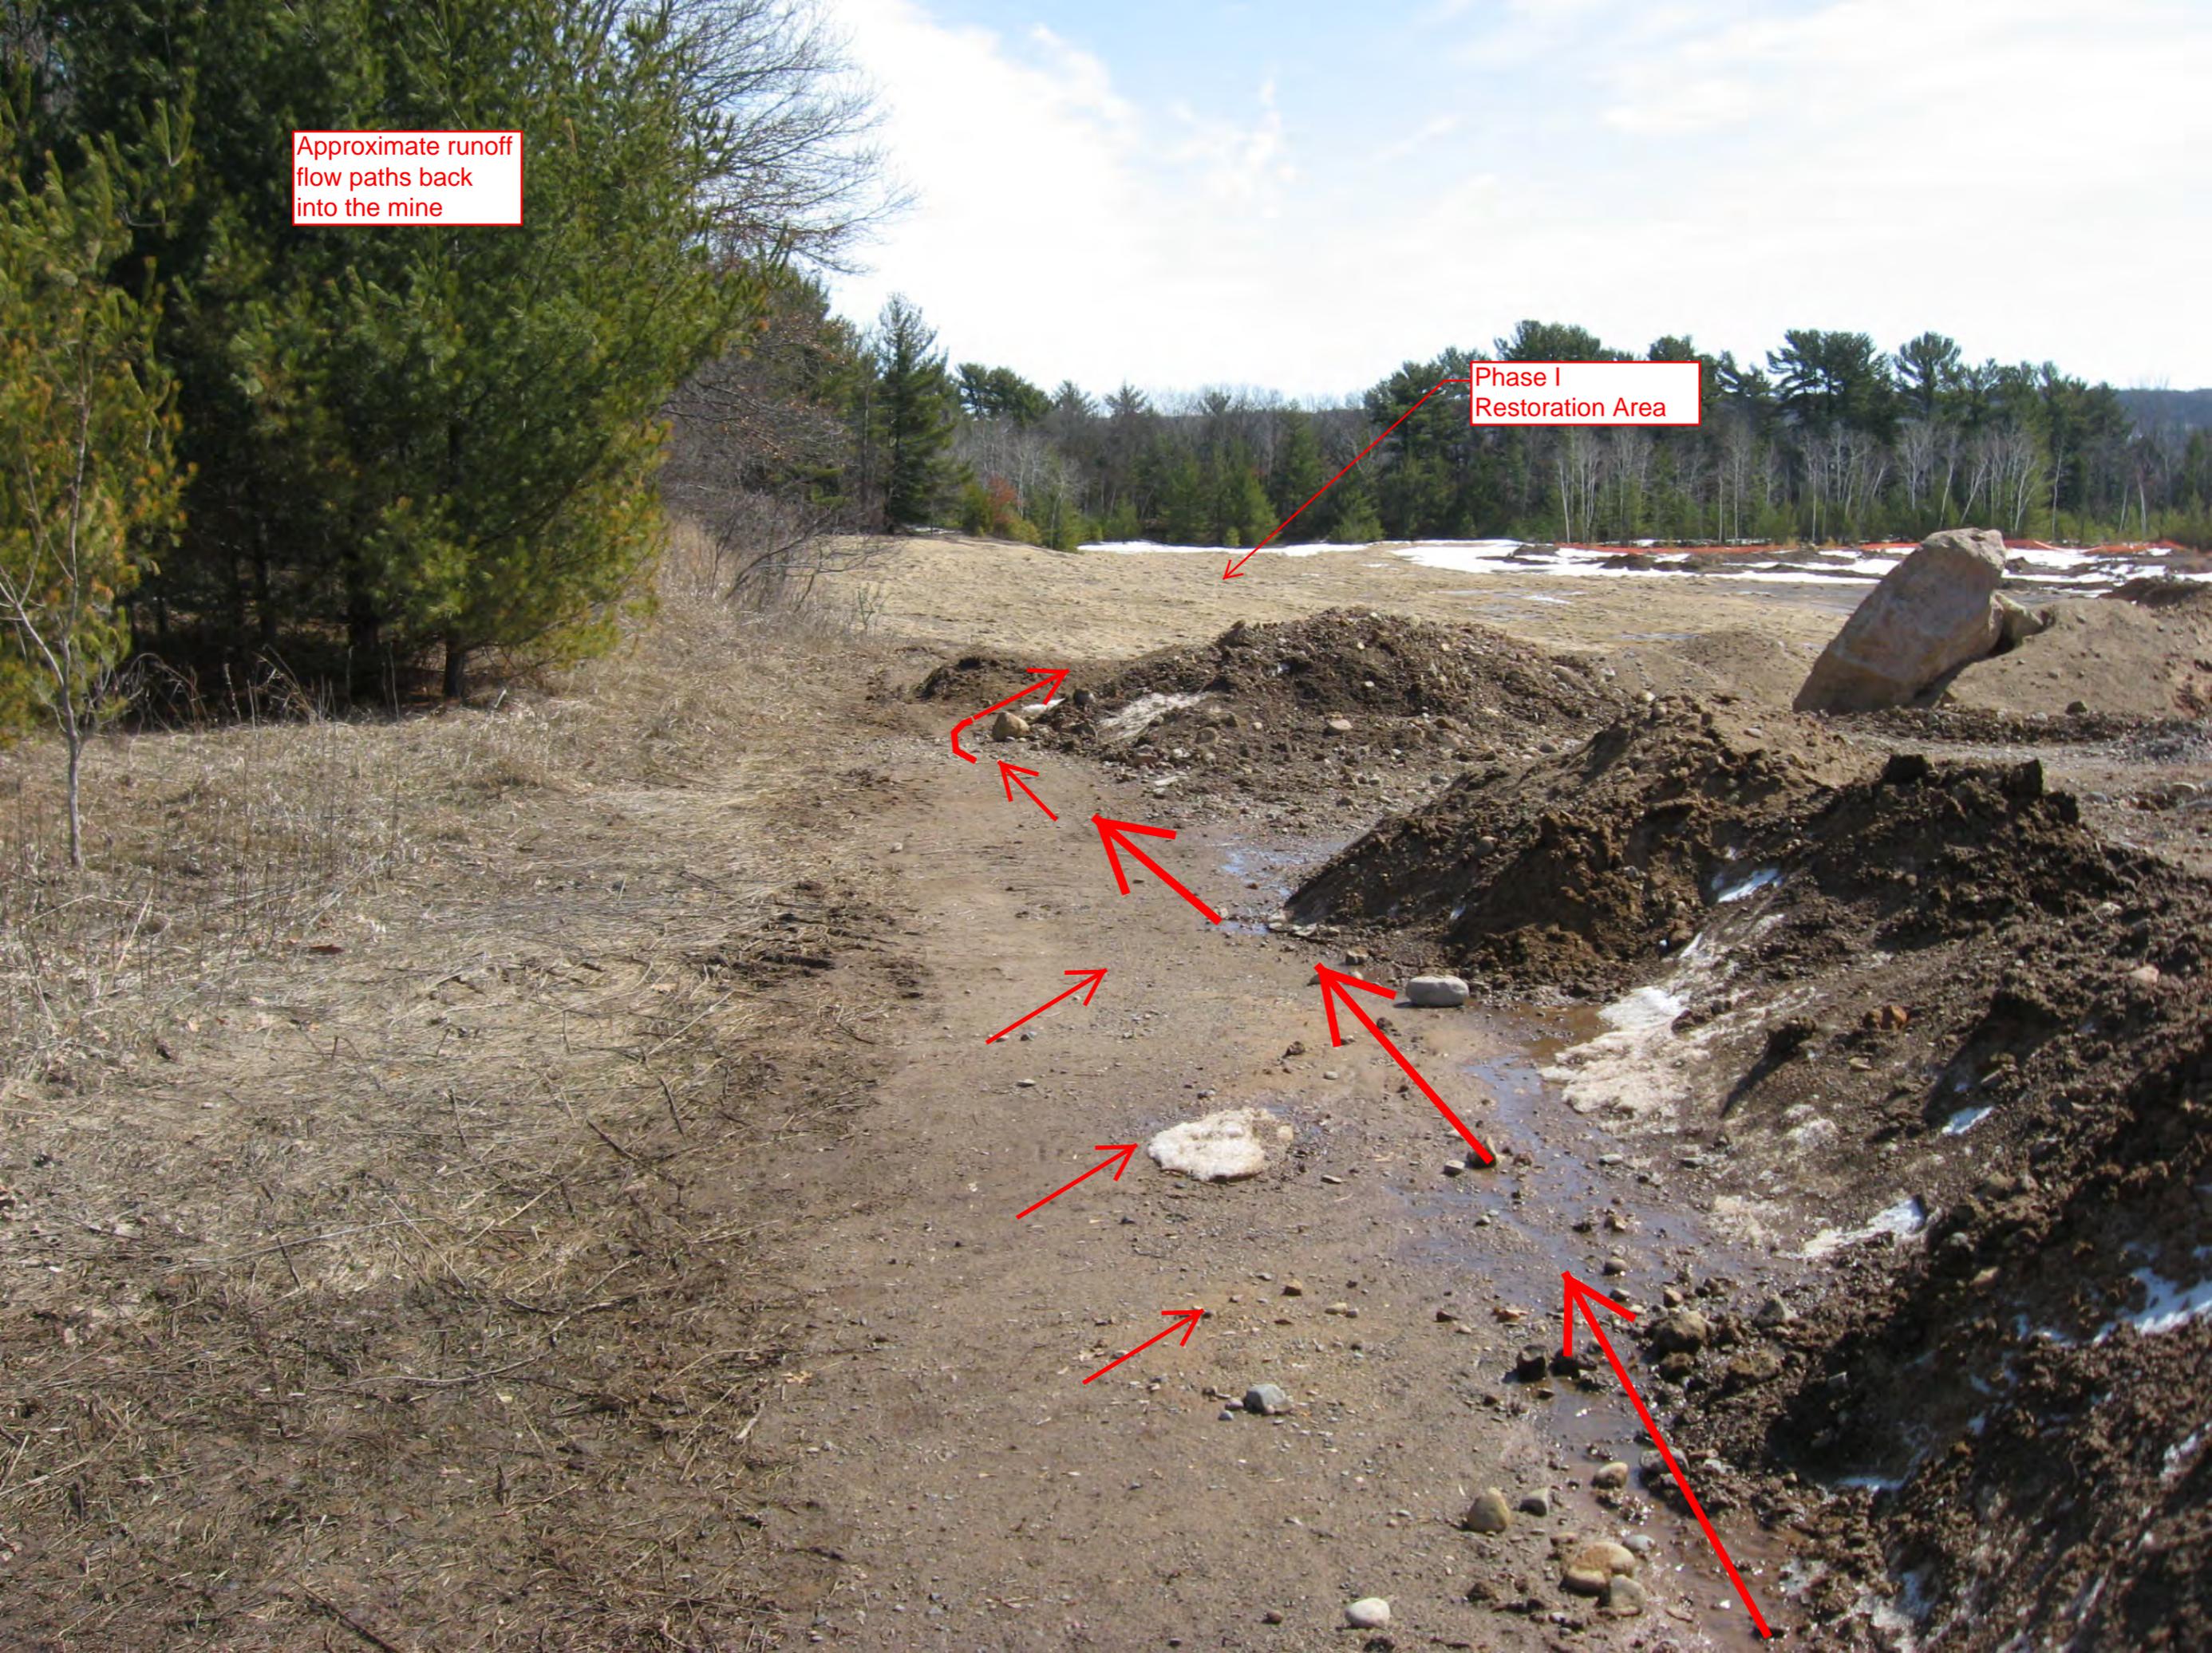
- vi. Tiller noted that the disturbed land, as described above, drained along the edge of the mining area and back into the mine area. Christina Morrison observed flowing water along this course during a site visit in late March. See attached photo for more information.

Approximate runoff
flow paths back
into the mine

Phase I
Restoration Area

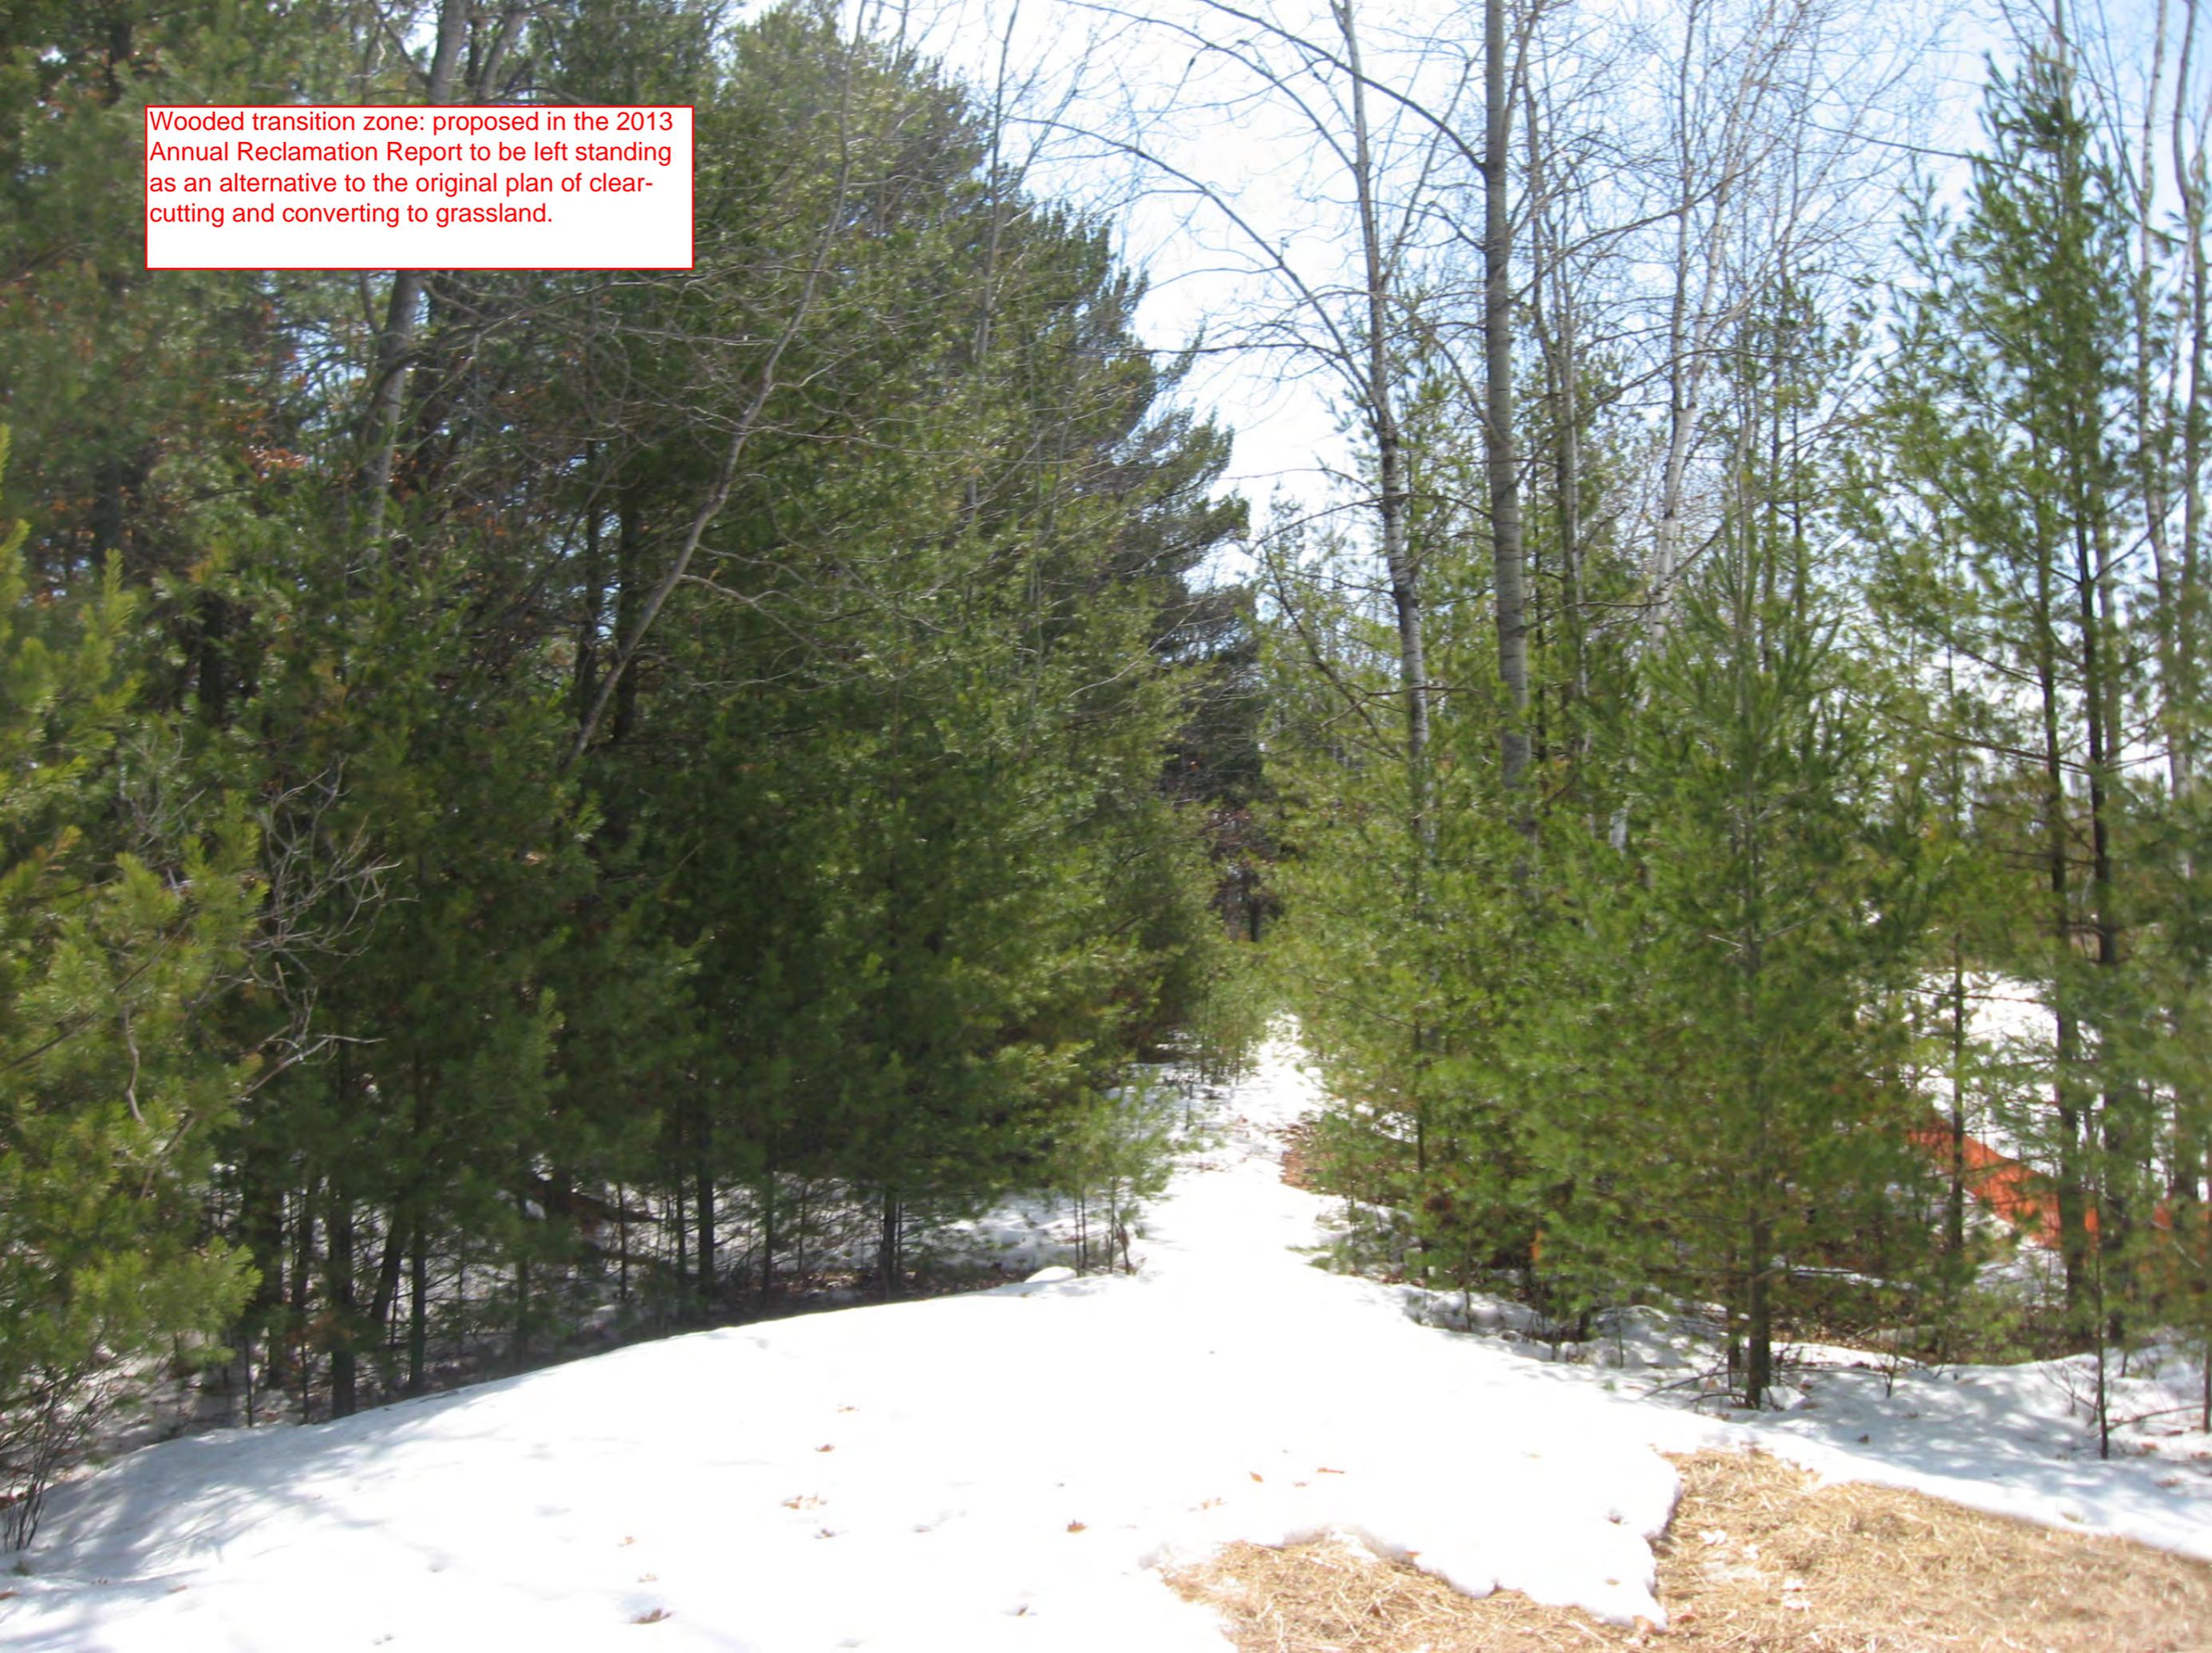
- ii. The area noted in Tiller’s annual reclamation report for 2013 as the proposed wooded transition zone (left uncut and planned to be managed) between the mine and the forest, was reviewed. Since the City will most likely be viewing this area on a separate site visit as part of the Annual Operating Permit, no specific detail is provided here. A photo of the area is attached for information.

Phase I Reclamation Area

Engineered topsoil

Wooded transition zone: proposed in the 2013 Annual Reclamation Report to be left standing as an alternative to the original plan of clear-cutting and converting to grassland.
