MEMORANDUM

FROM: Jed Chesnut, Wetland/Natural Resource Specialist

DATE: March 17, 2015

RE: **Zavoral Mining and Reclamation Project – Monitoring and Inspection Report
2015 Inspection #1 – March 12, 2015**

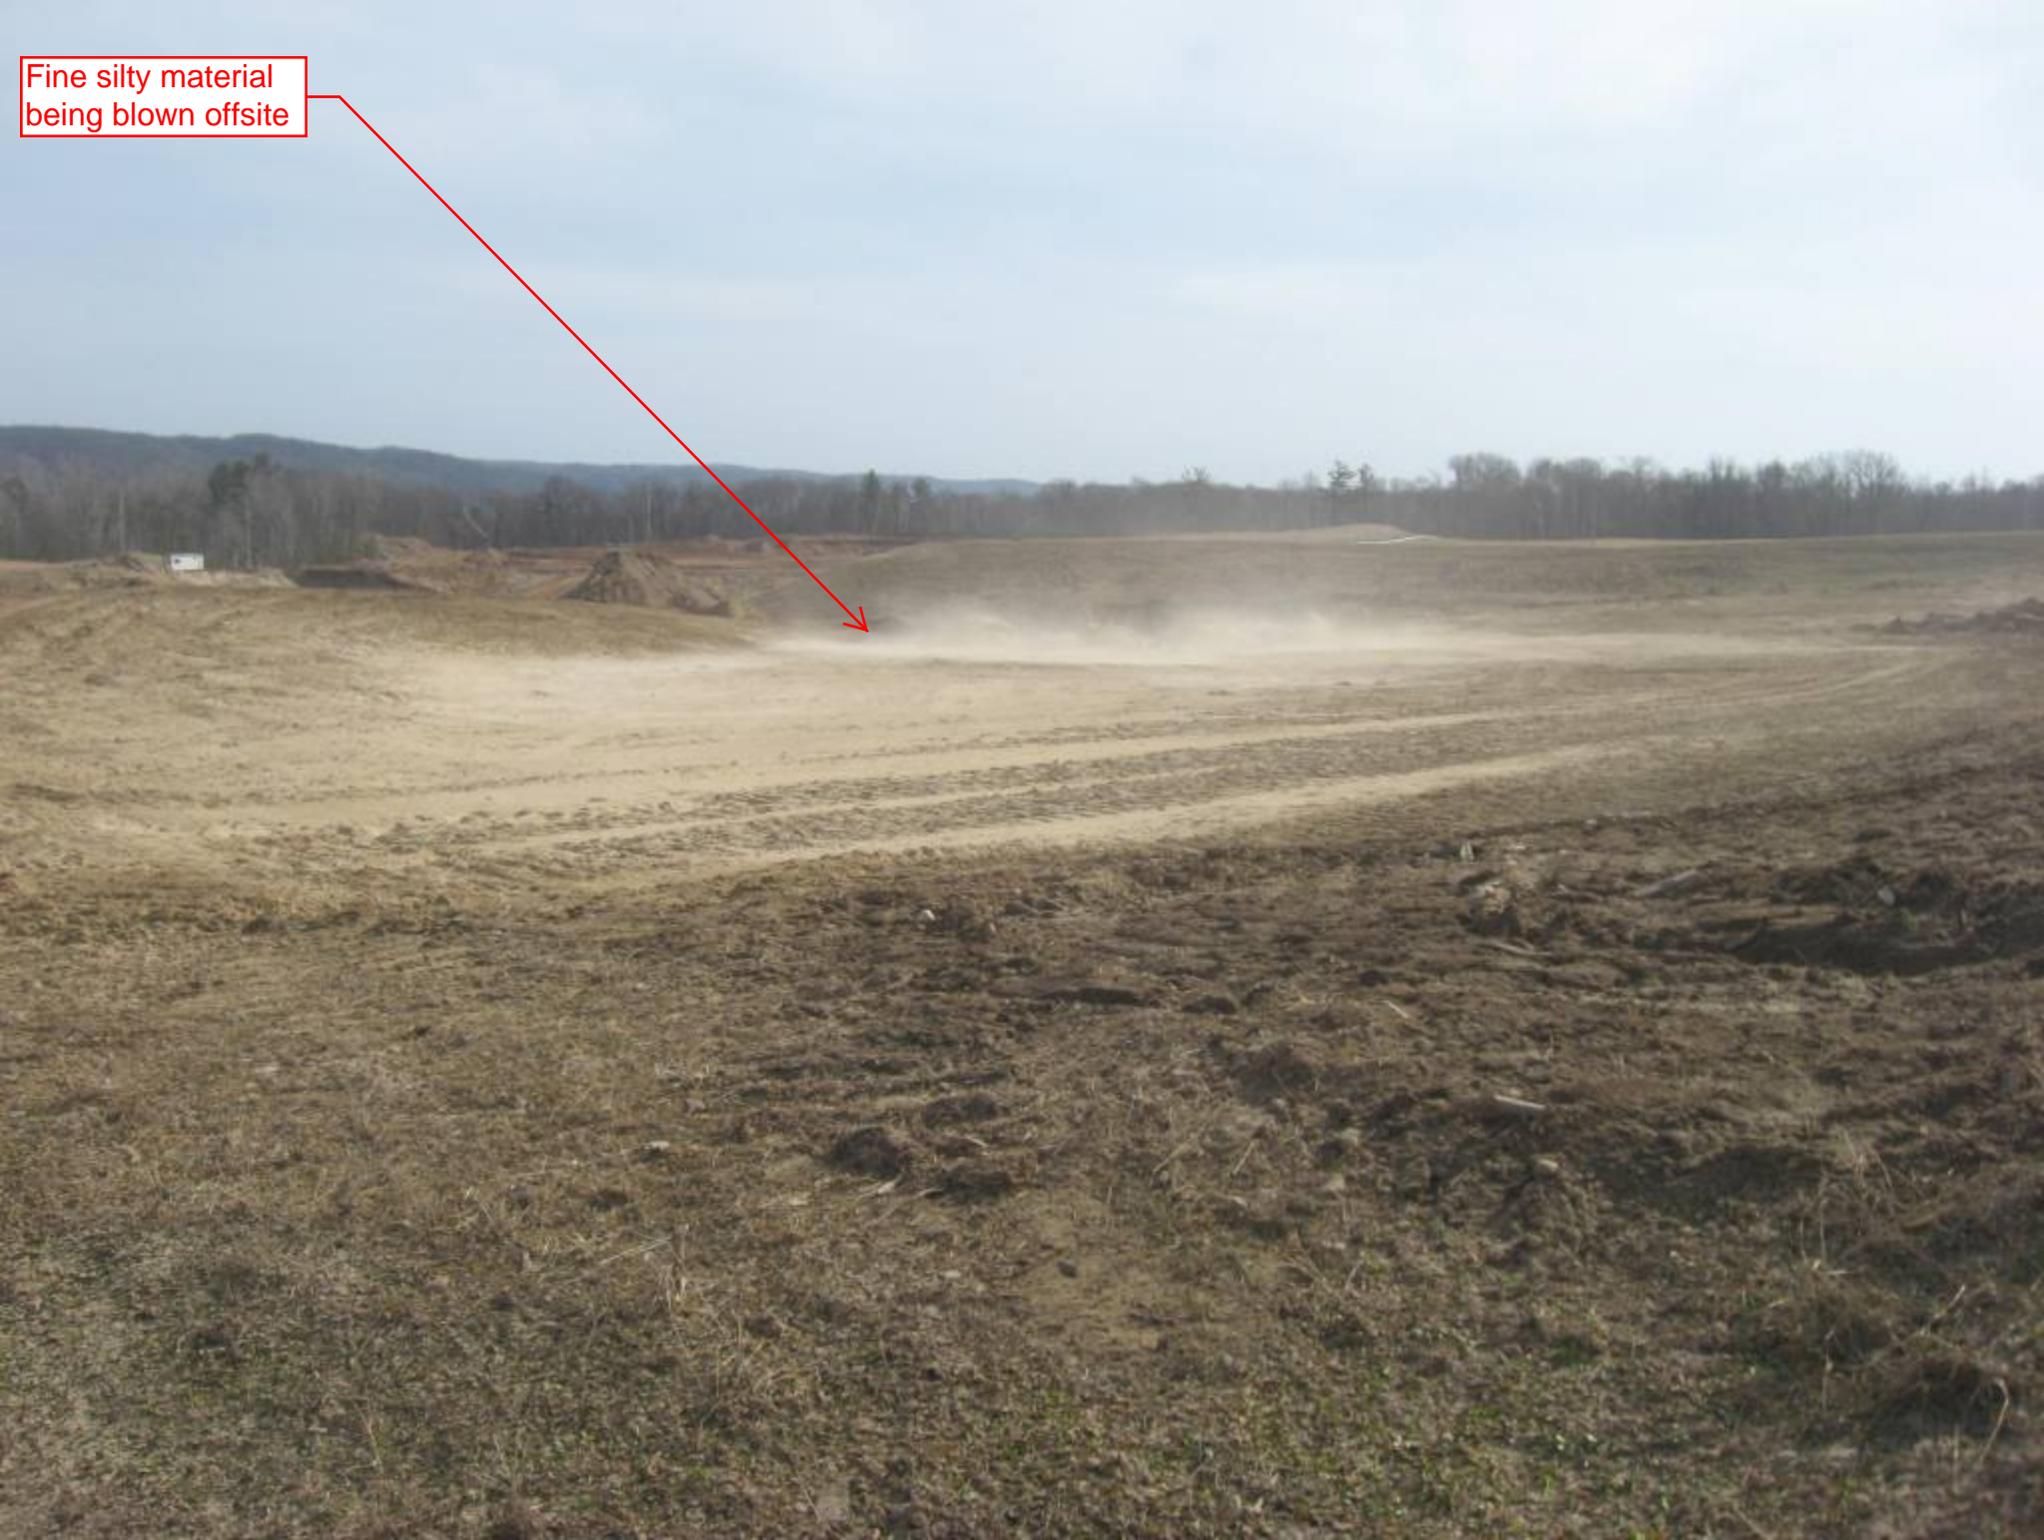
- iii. There were some stockpiles of very fine silt material that was being blown off-site due to the windy conditions. See attached pictures. Corrective action may be needed.

Fine silty material
being blown offsite

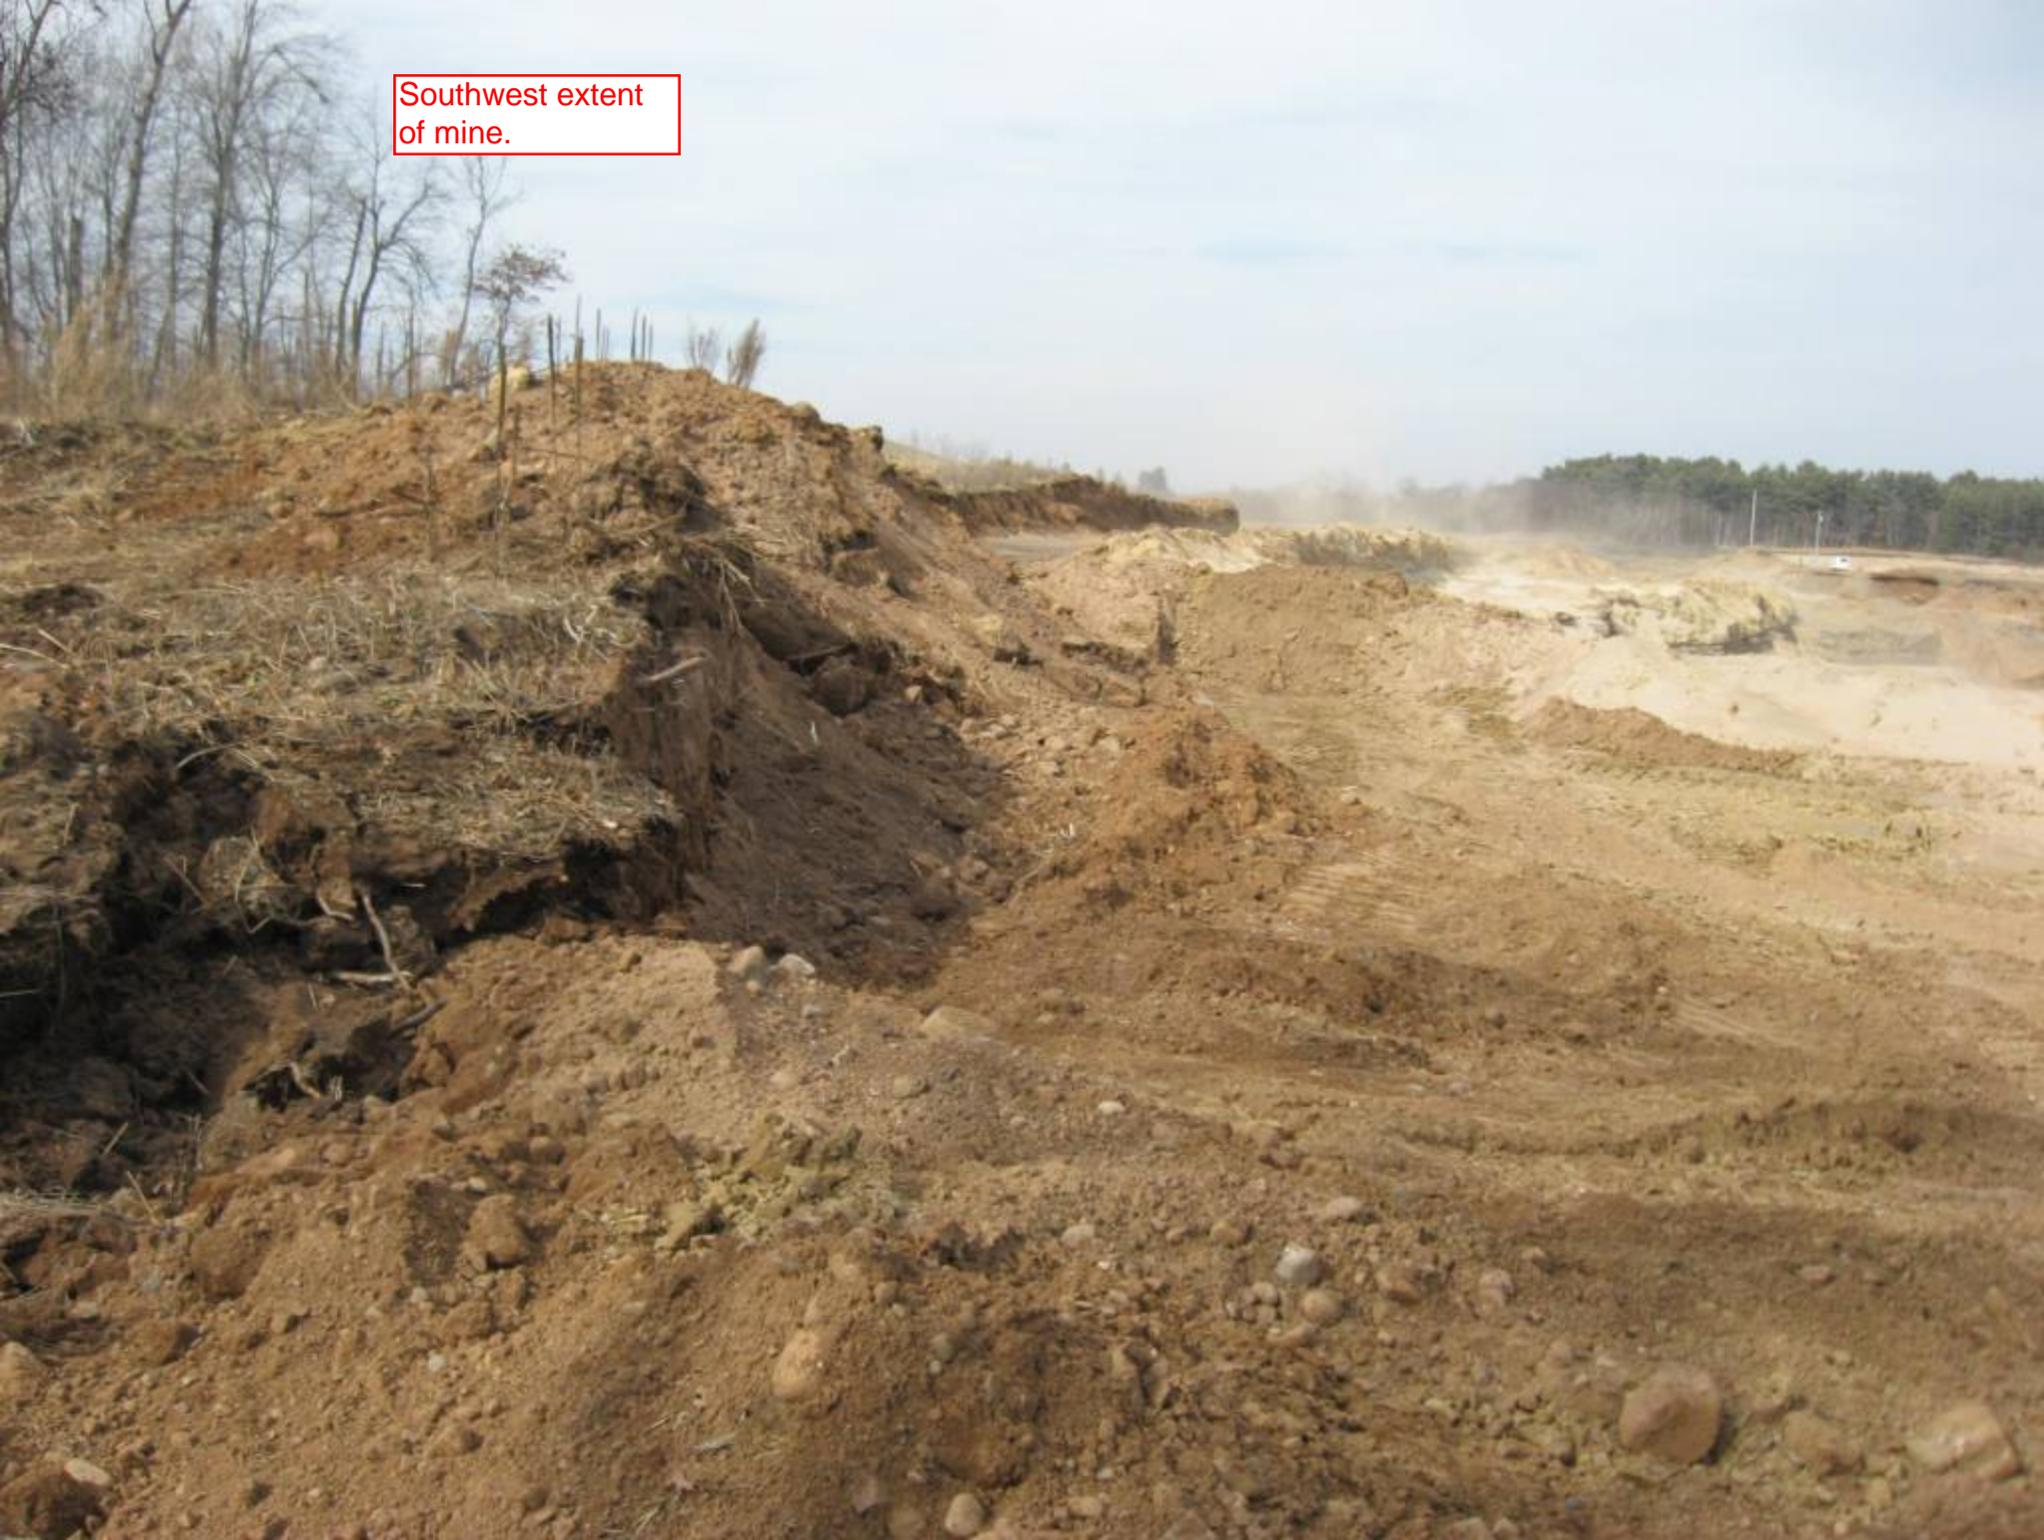
- iv. The entire site had changed significantly since the December inspection. Phase II mining was well underway and much material had been removed. Excavation extended near to the silt fence along the southern boundary (see attached pictures). Red arrows on the attached pictures signify flow direction of surface water runoff.

Southwest extent
of mine.

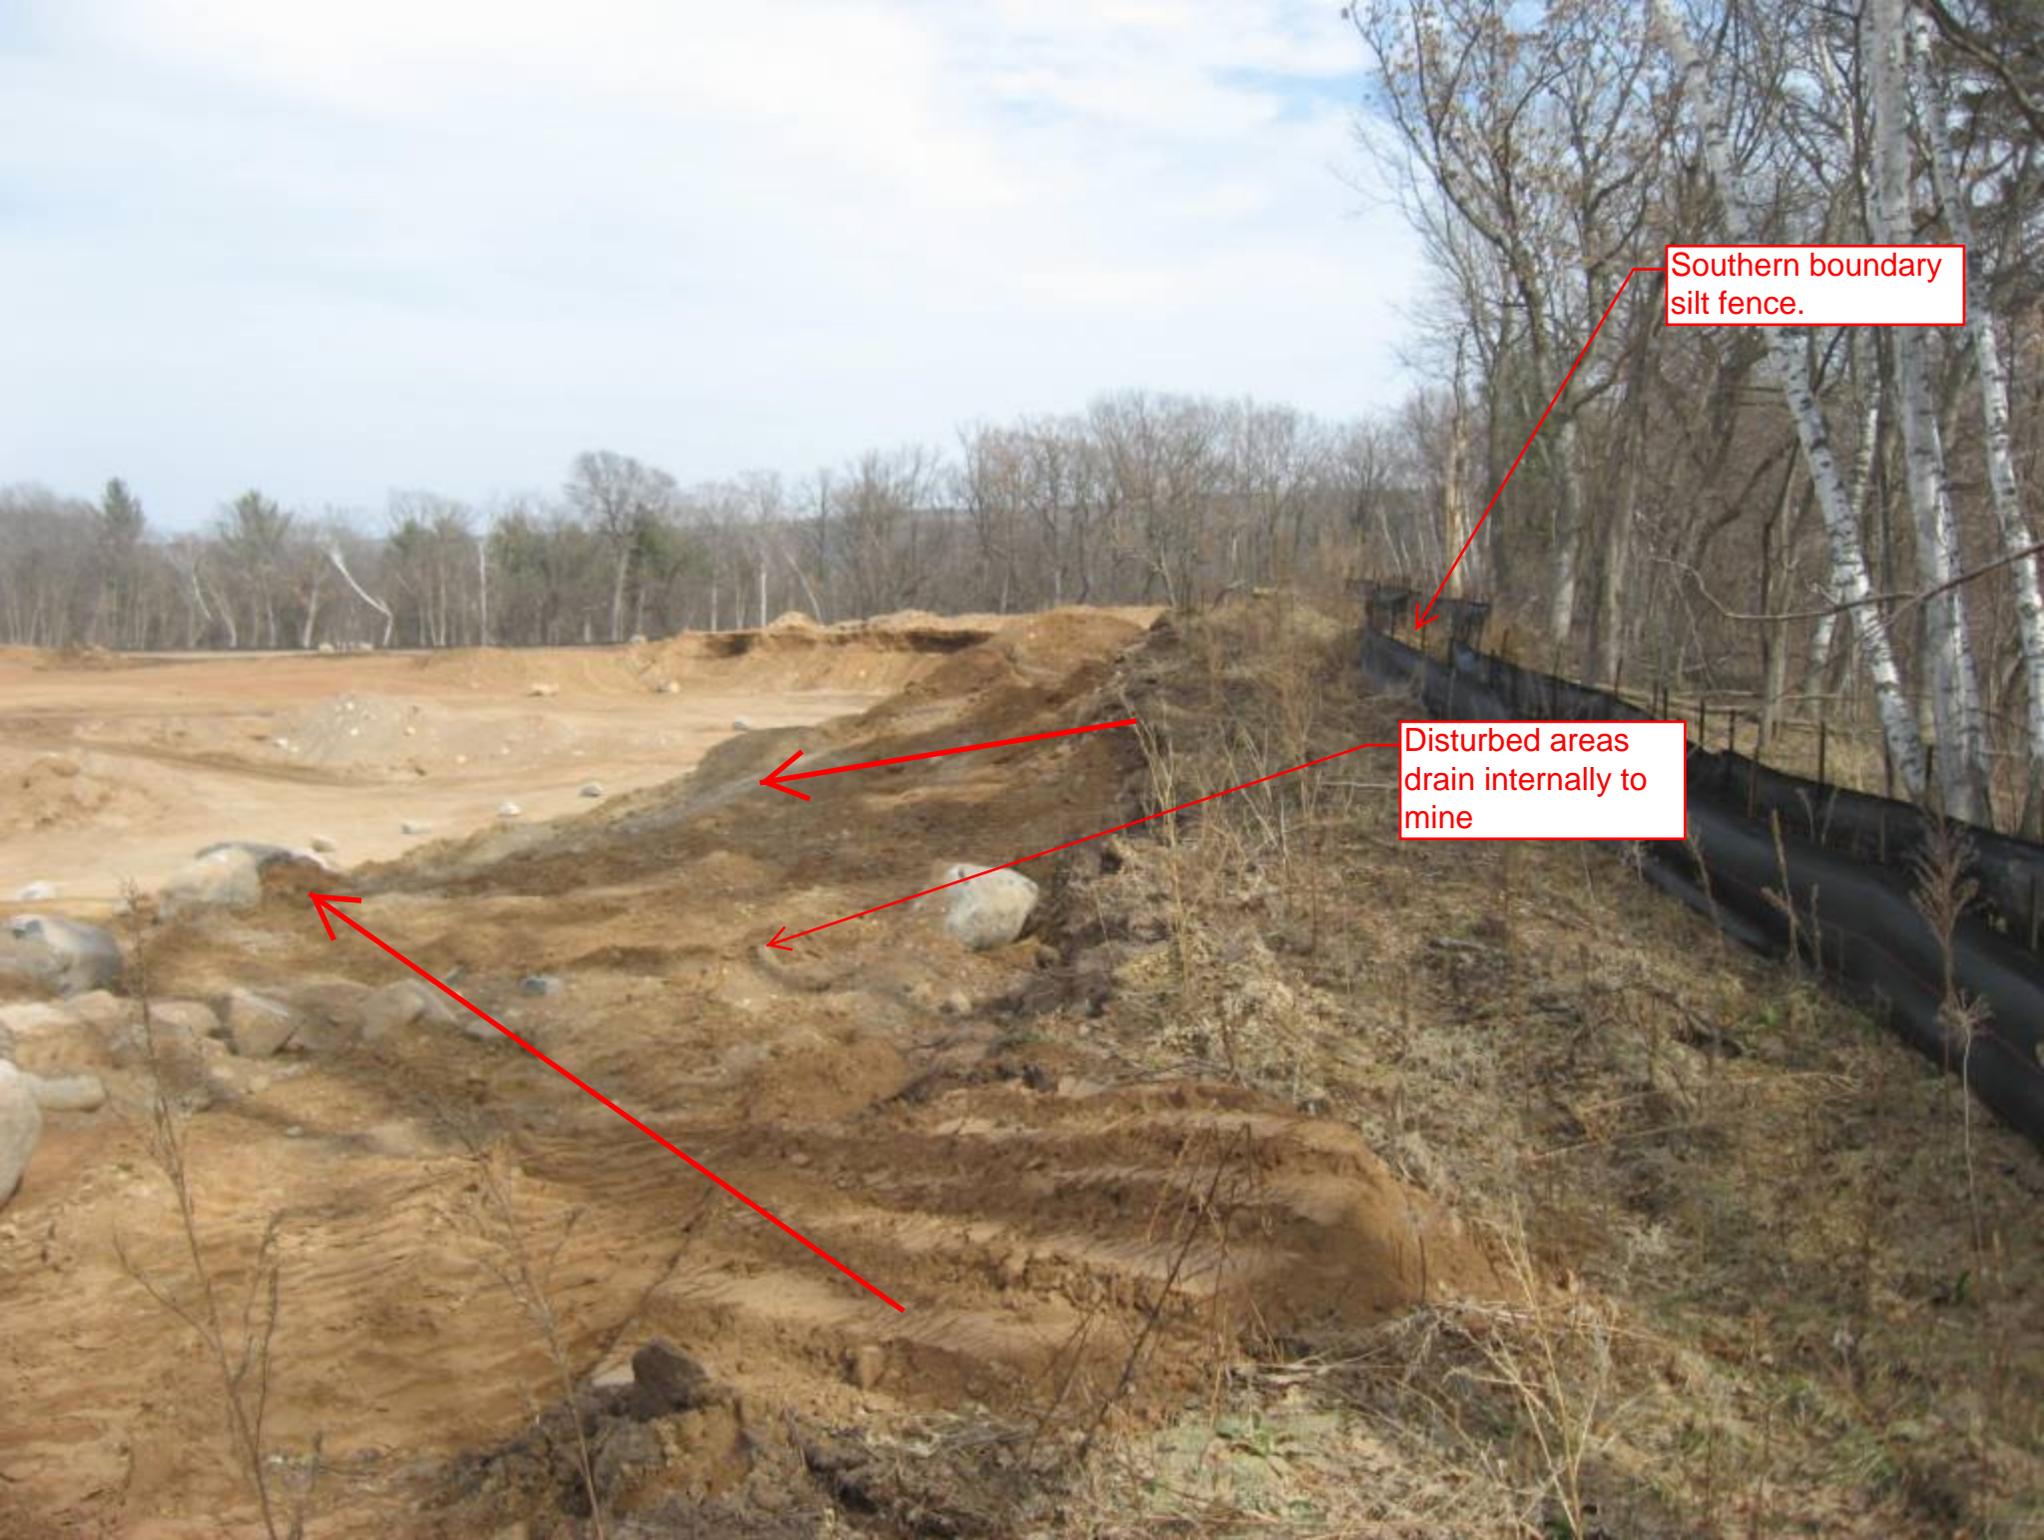
Southern boundary
silt fence.

Disturbed areas
drain internally to
mine

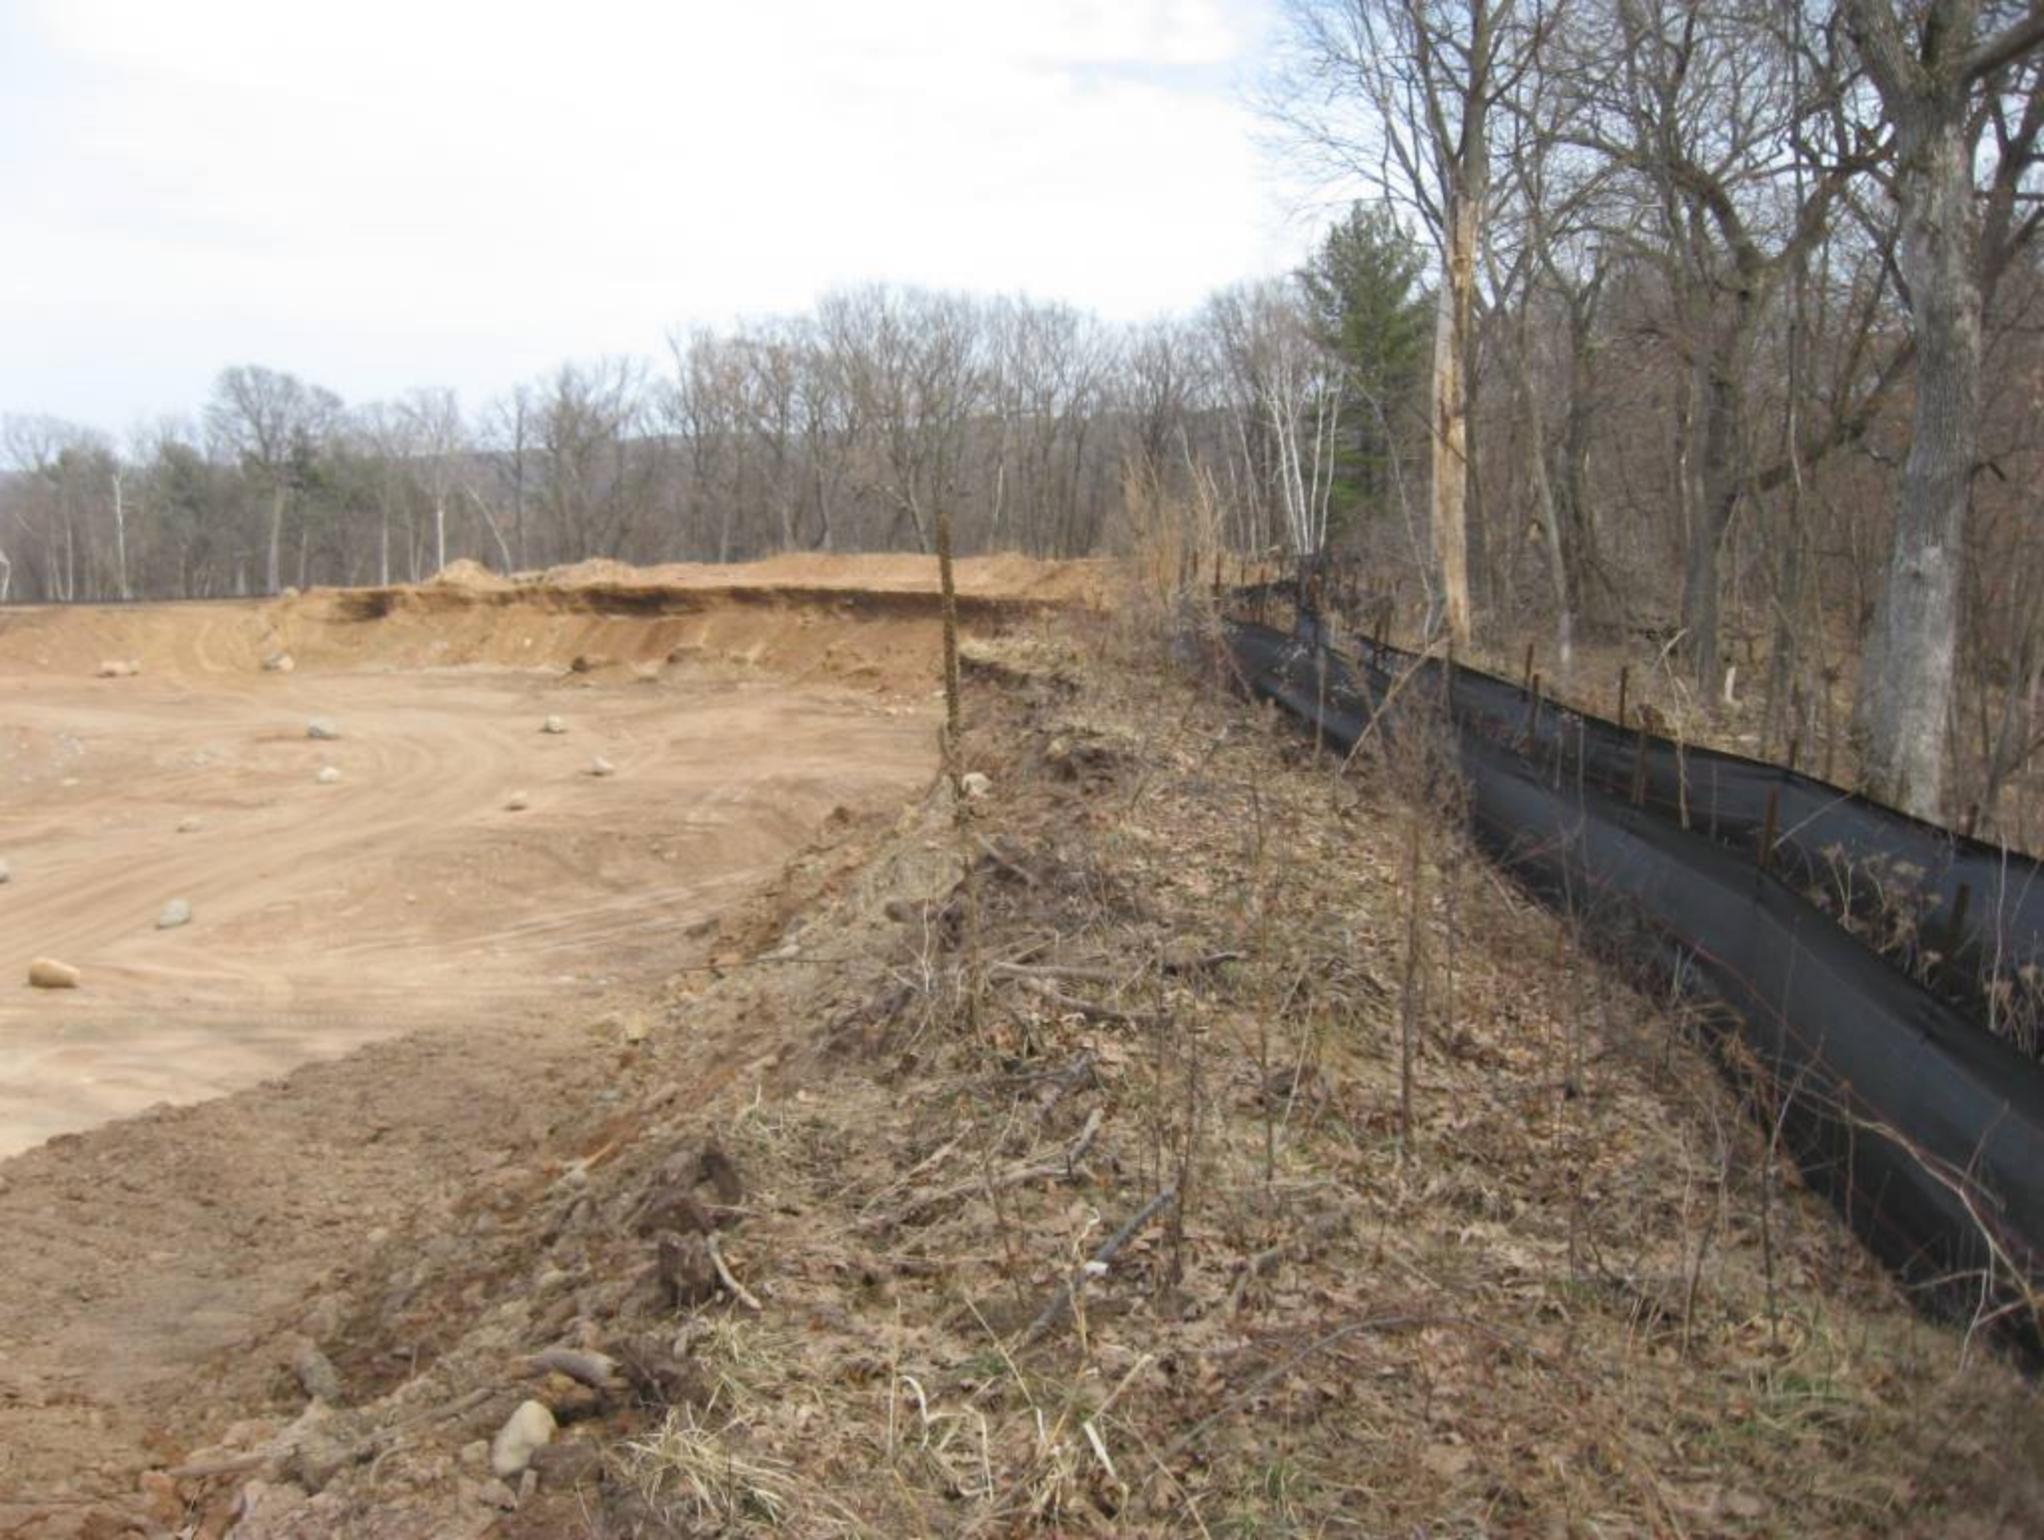
Western edge of mining. Areas drain internally.

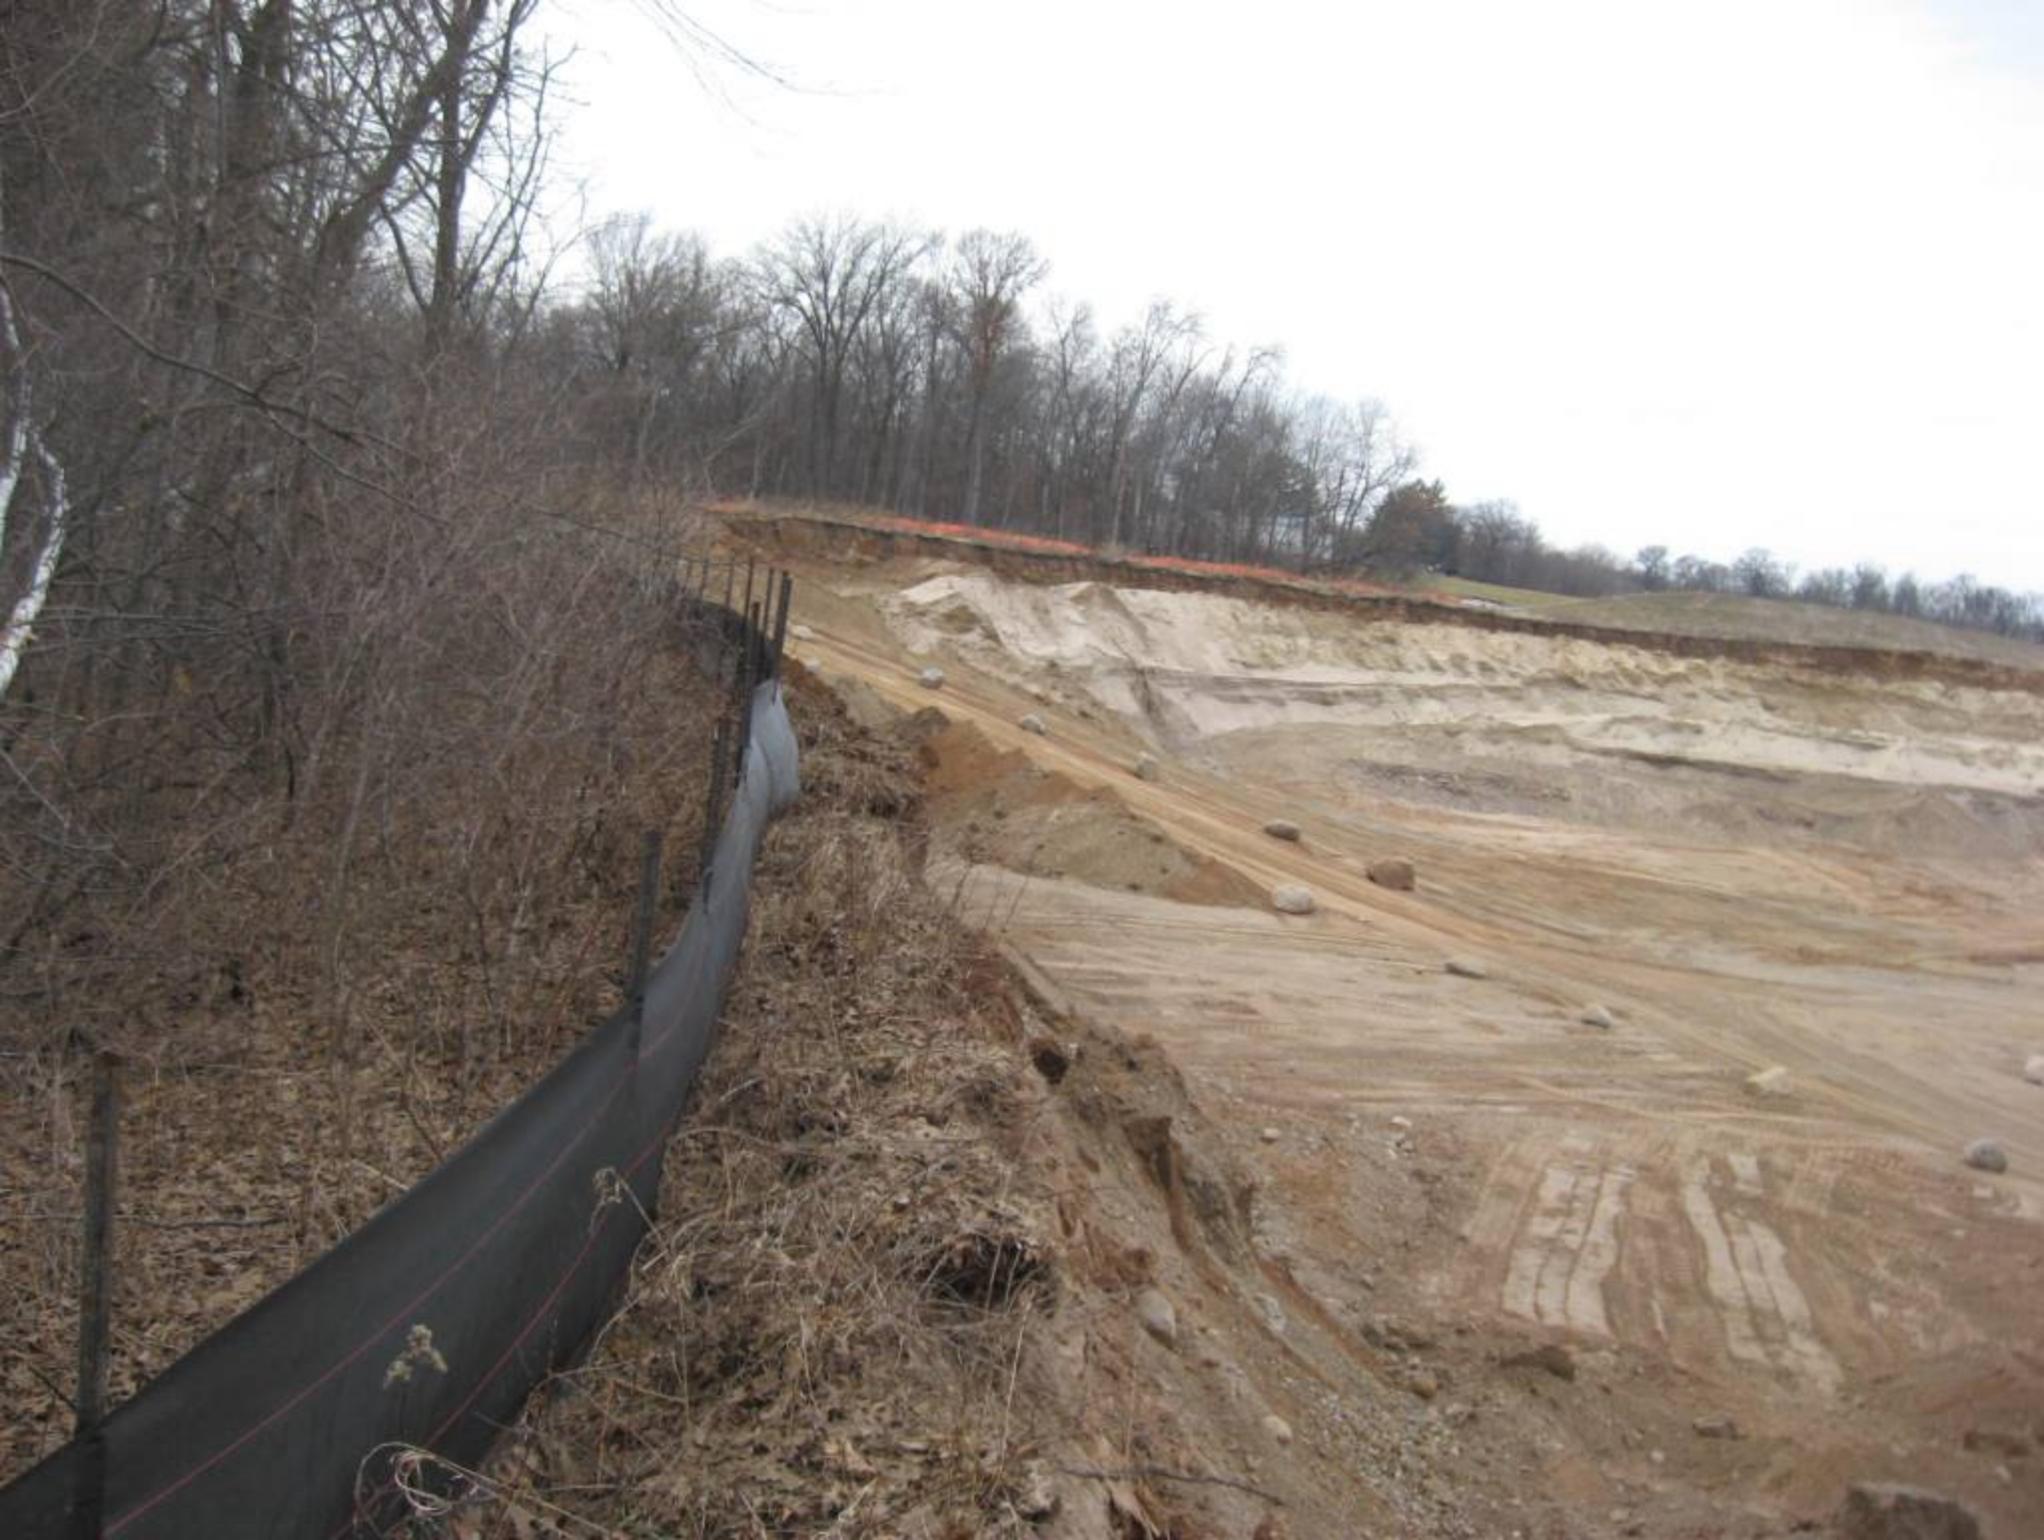
- ii. Silt fence that had been installed in 2013 as per the stormwater pollution and prevention plan (SWPPP) was in good shape. The silt fence throughout the project area was still effective for perimeter control.

Silt fence is in excellent condition

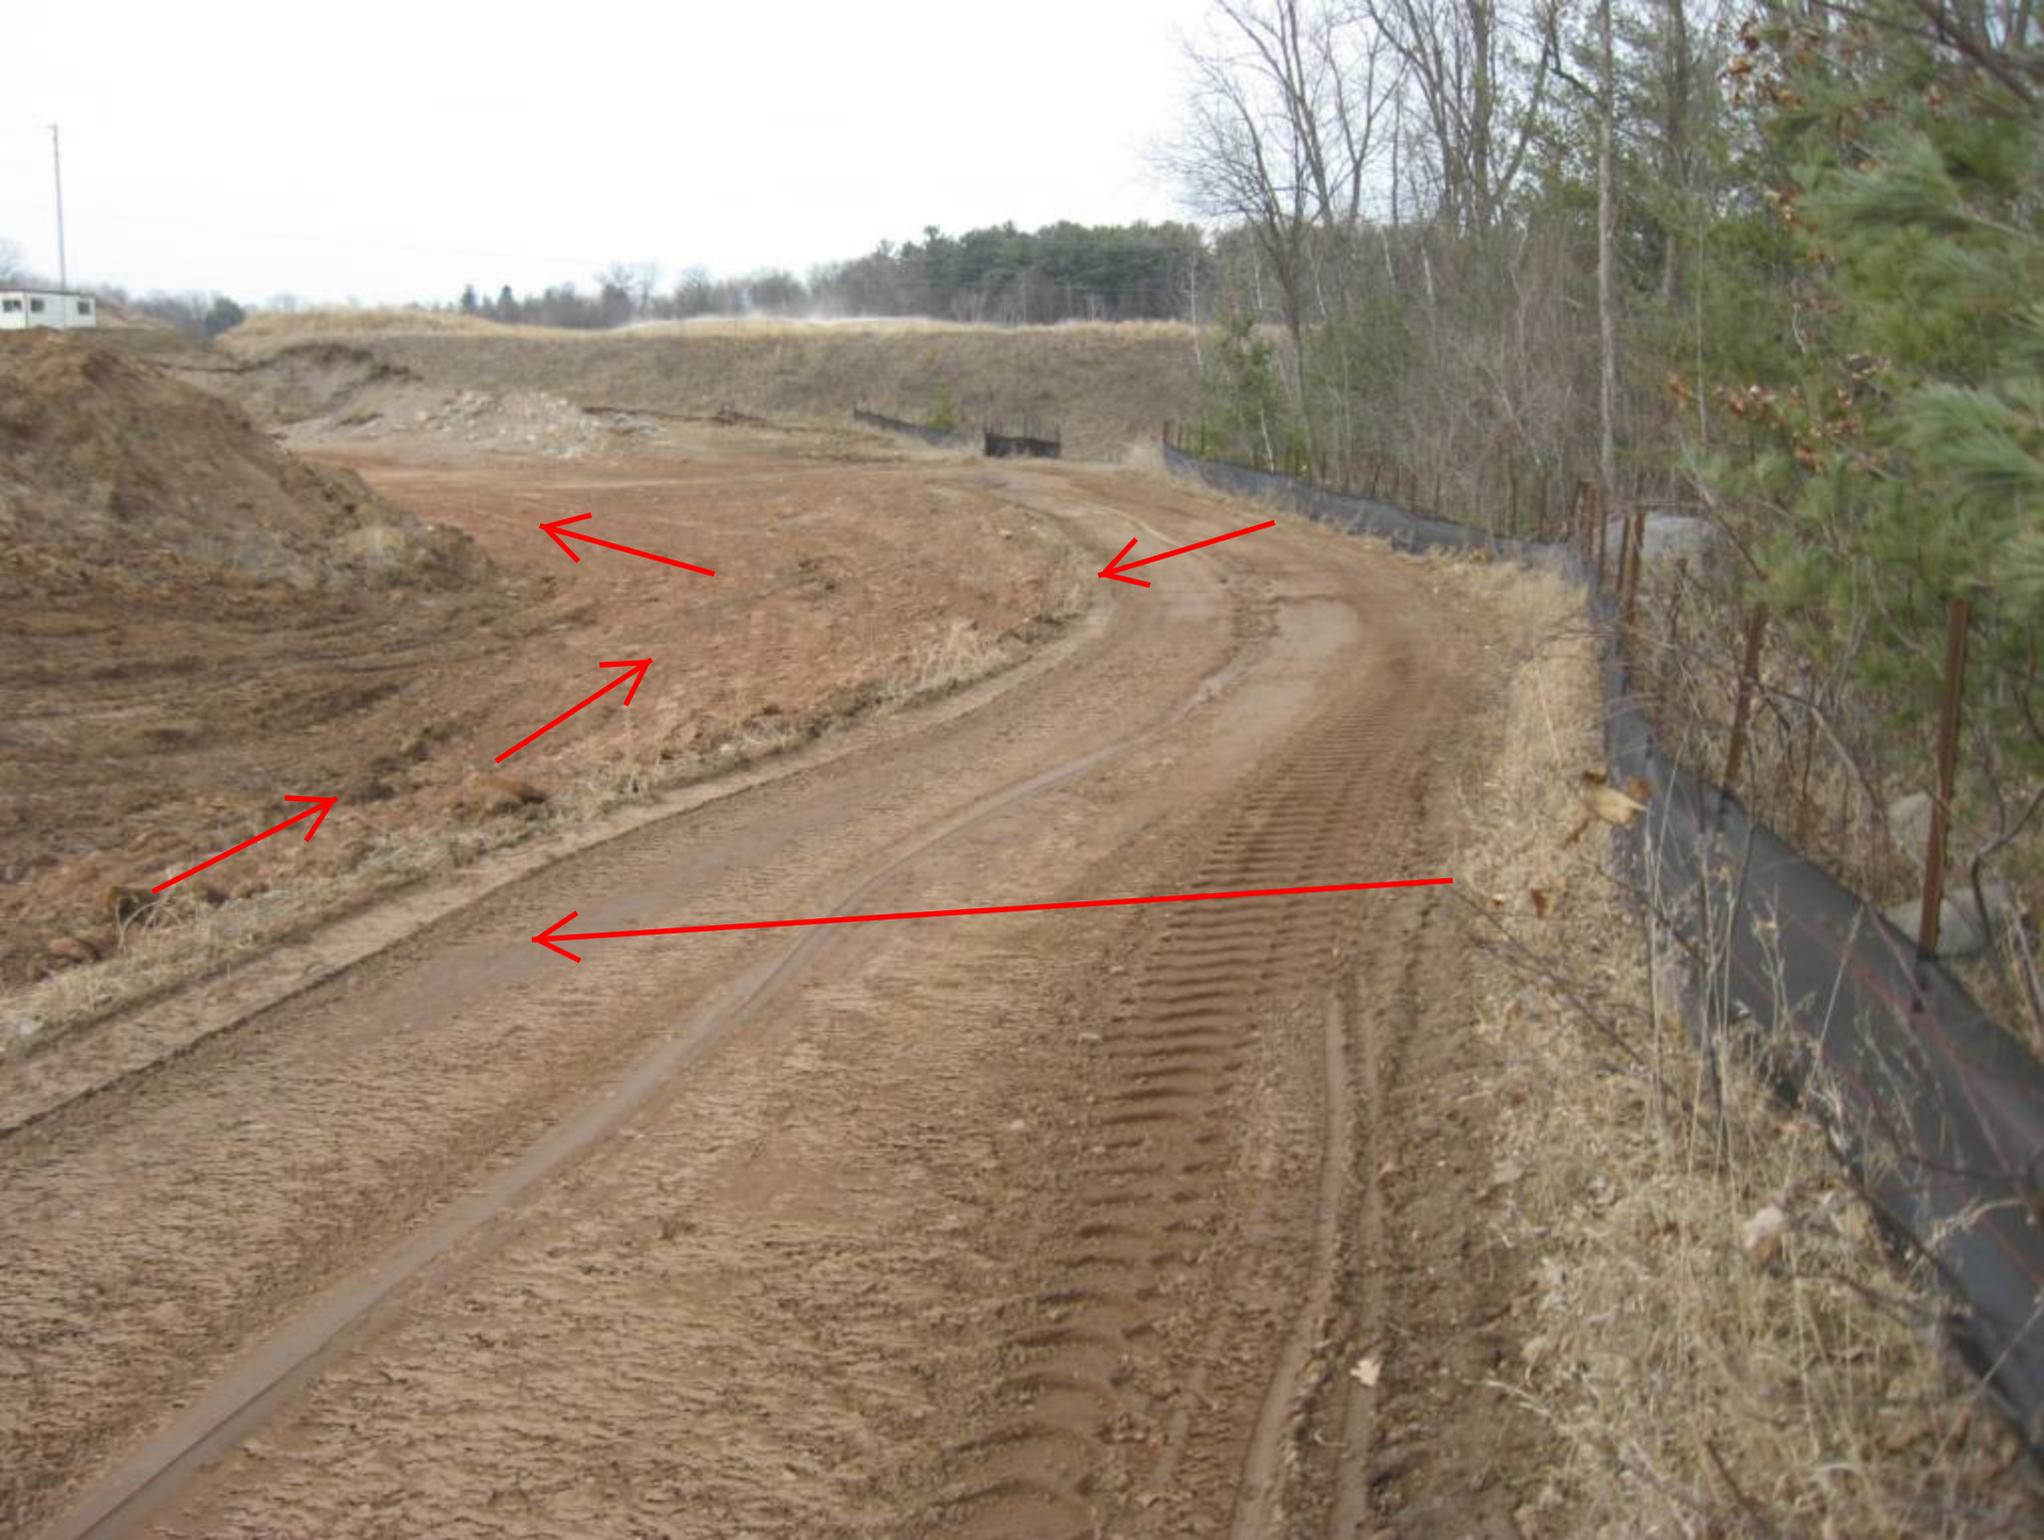
- vii. In 2014, Tiller regraded the internal driveway road that runs along the south and east project limits so that it sloped inward to the mine and therefore runoff would be directed internally. Most of the driveway along the south was no longer present since the area was mined. The driveway is now within the mined area. The diversion drainageways along the east project limit were still present and appeared to be functioning by directing stormwater runoff internally to a ponding area (see attached picture).

Ponding area

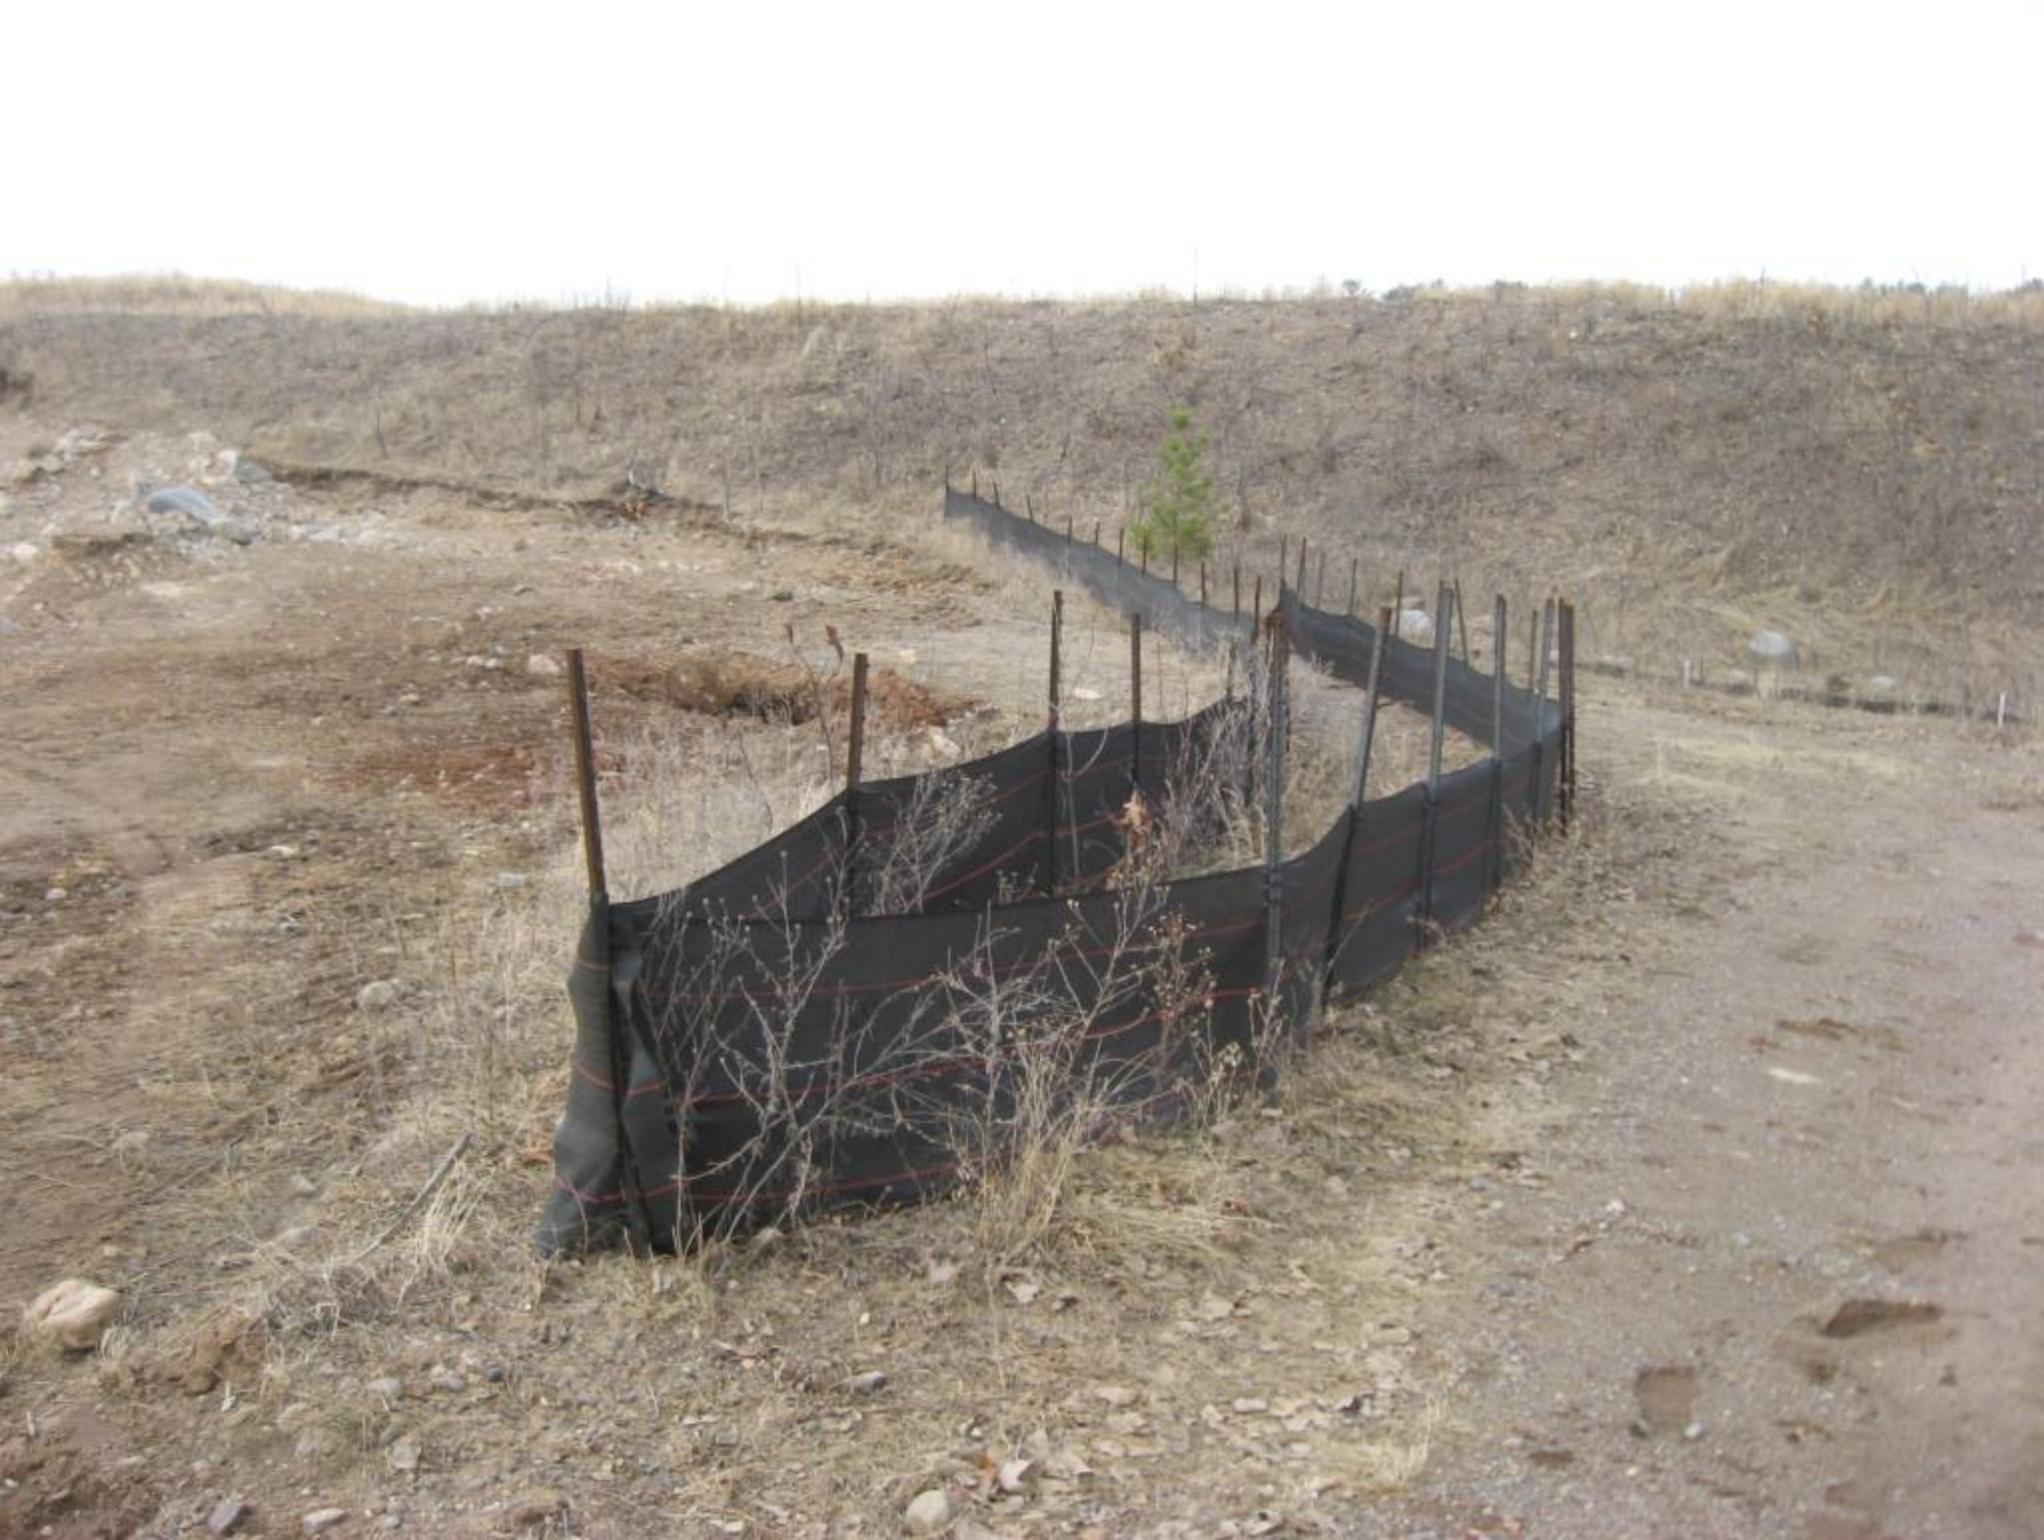
- v. Nearly the entire mine site now drains internally, with one exception where the landowner's driveway exits the mine area and begins its descent towards the river. This area had sufficient perimeter control for erosion and sediment control (see pictures).

Driveway down to
landowner's cabin.
Silt fence is
functional.
