MEMORANDUM

FROM: Jed Chesnut, Wetland/Natural Resource Specialist

RE: **Zavoral Mining and Reclamation Project – Monitoring and Inspection Report
2014 Inspection #5 – October 16, 2014**

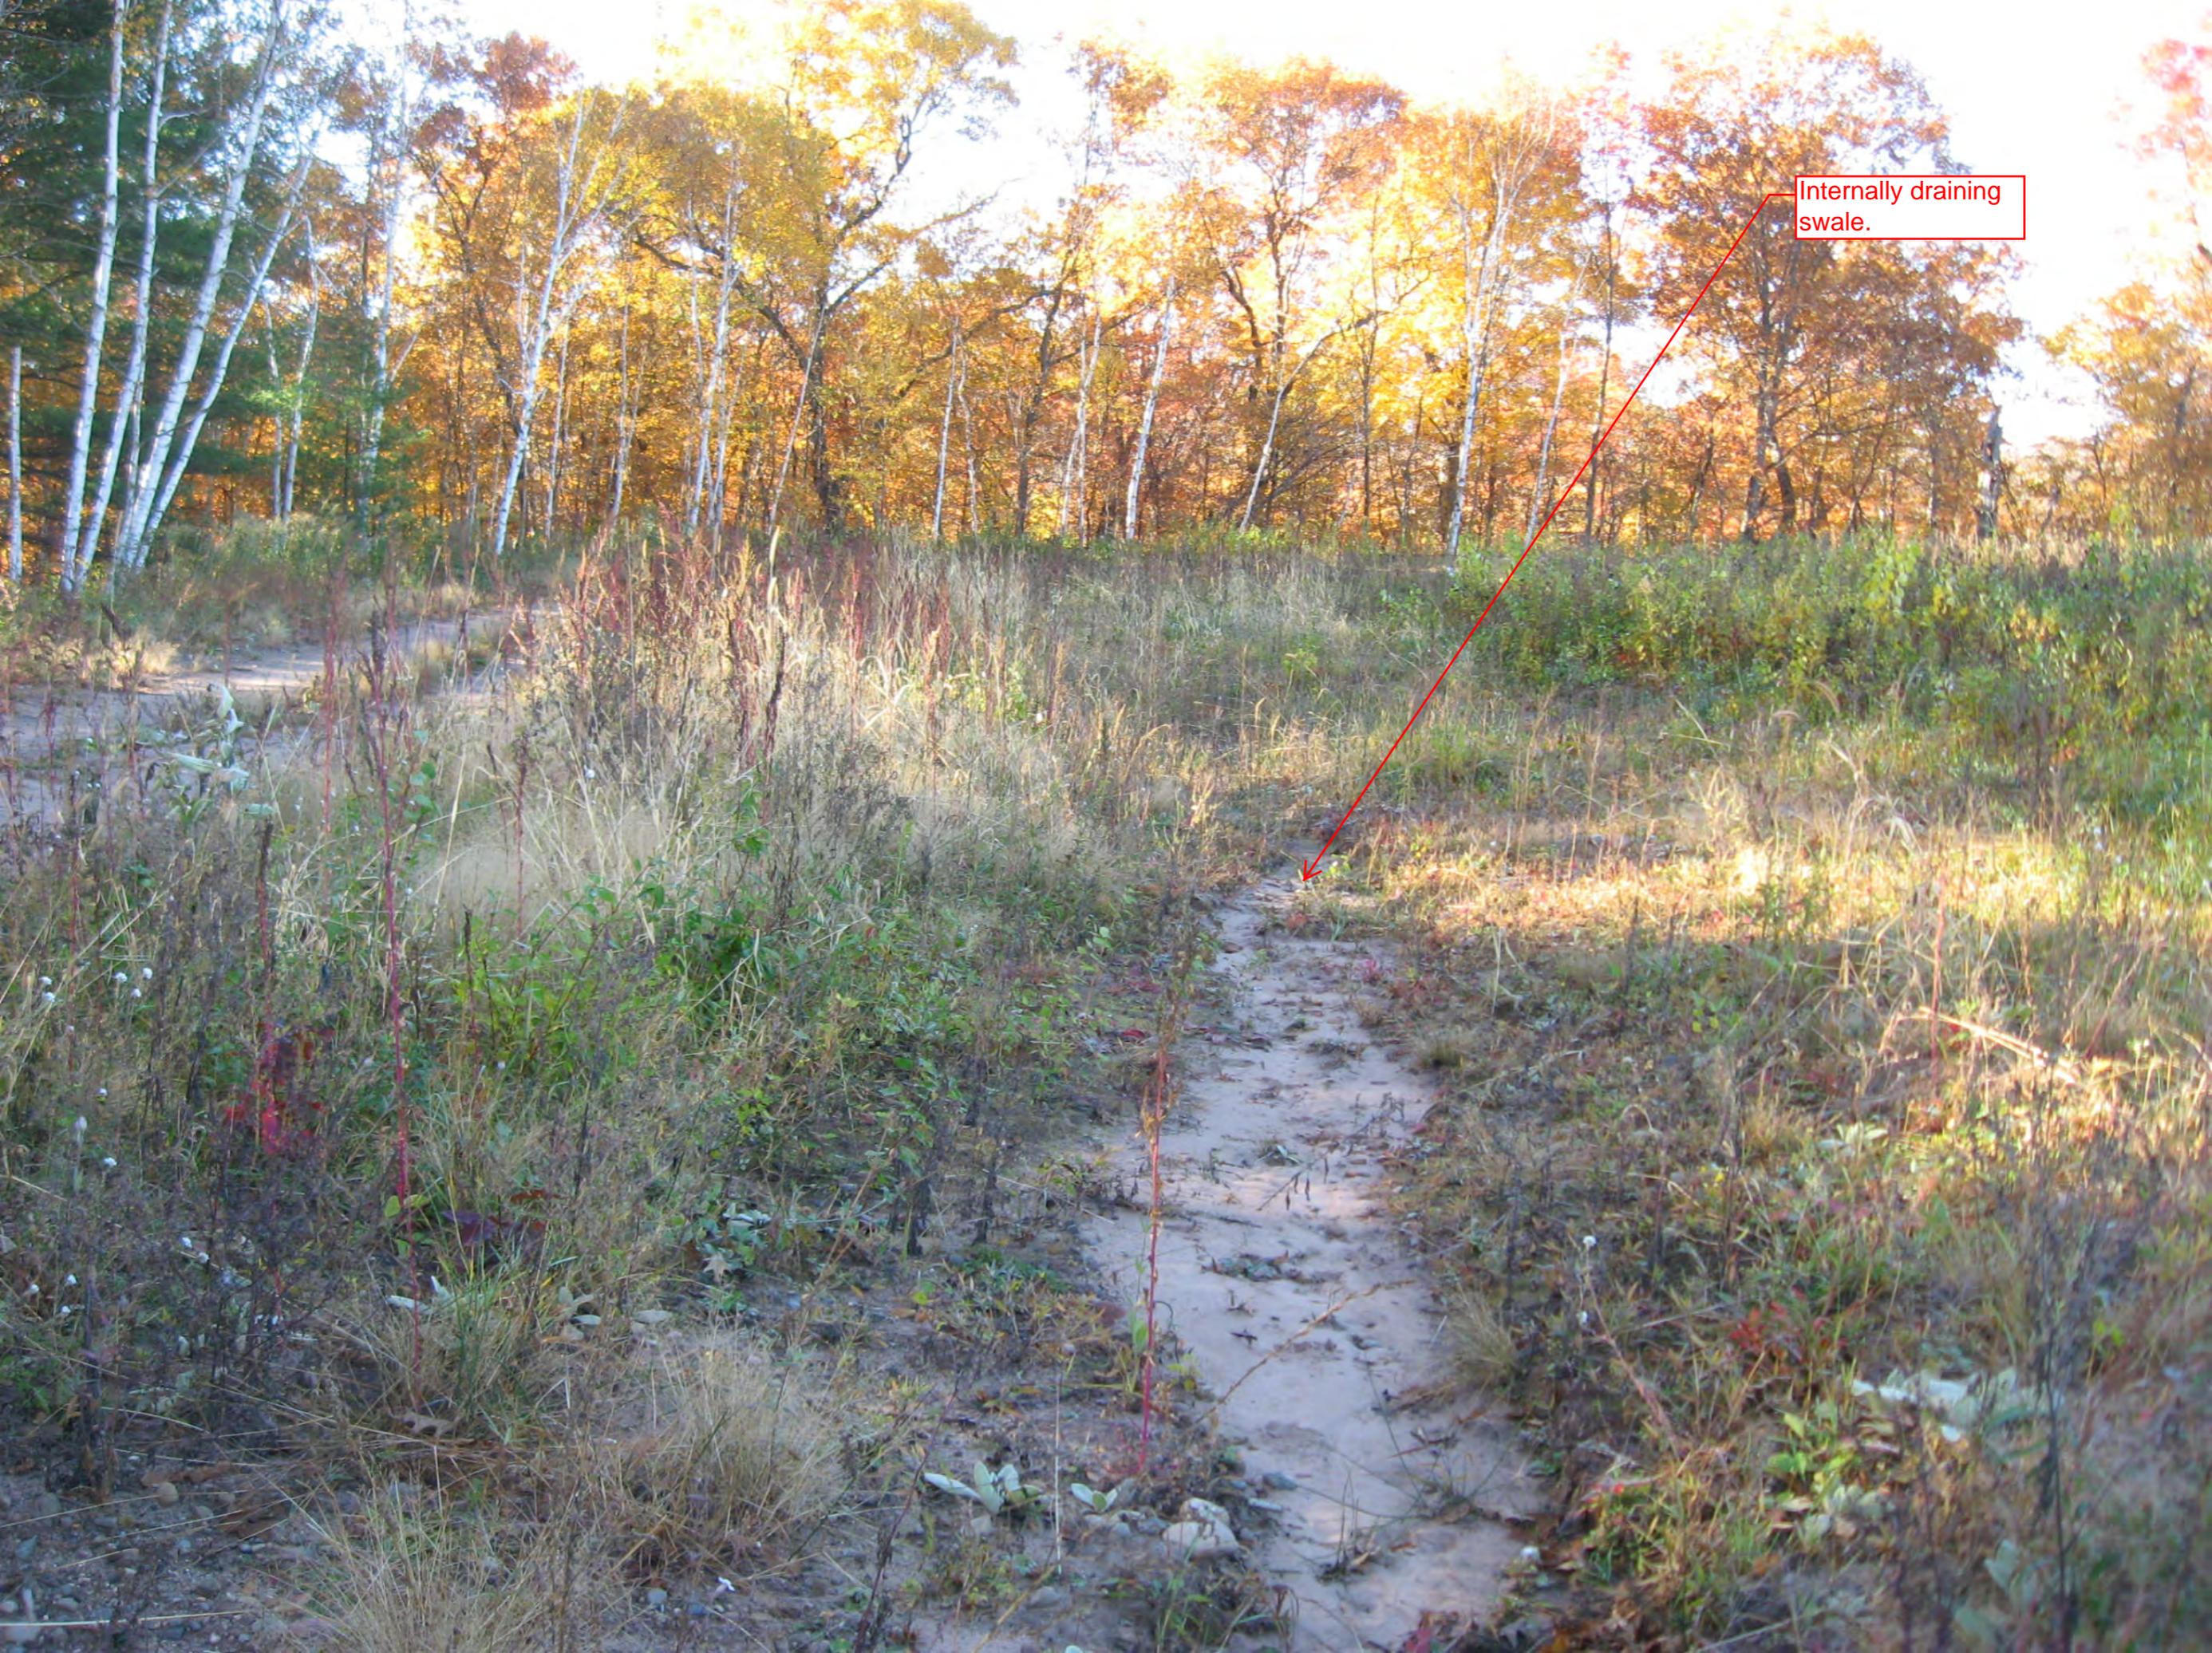
- viii. In the July report, it was noted that Tiller regraded the internal driveway road that runs along the south and east project limits so that it sloped inward to the mine and therefore runoff would be directed internally. The diversion drainage ways appeared to be functioning and were directing stormwater runoff internally to a ponding area. (see attached picture).

Internally draining swale.

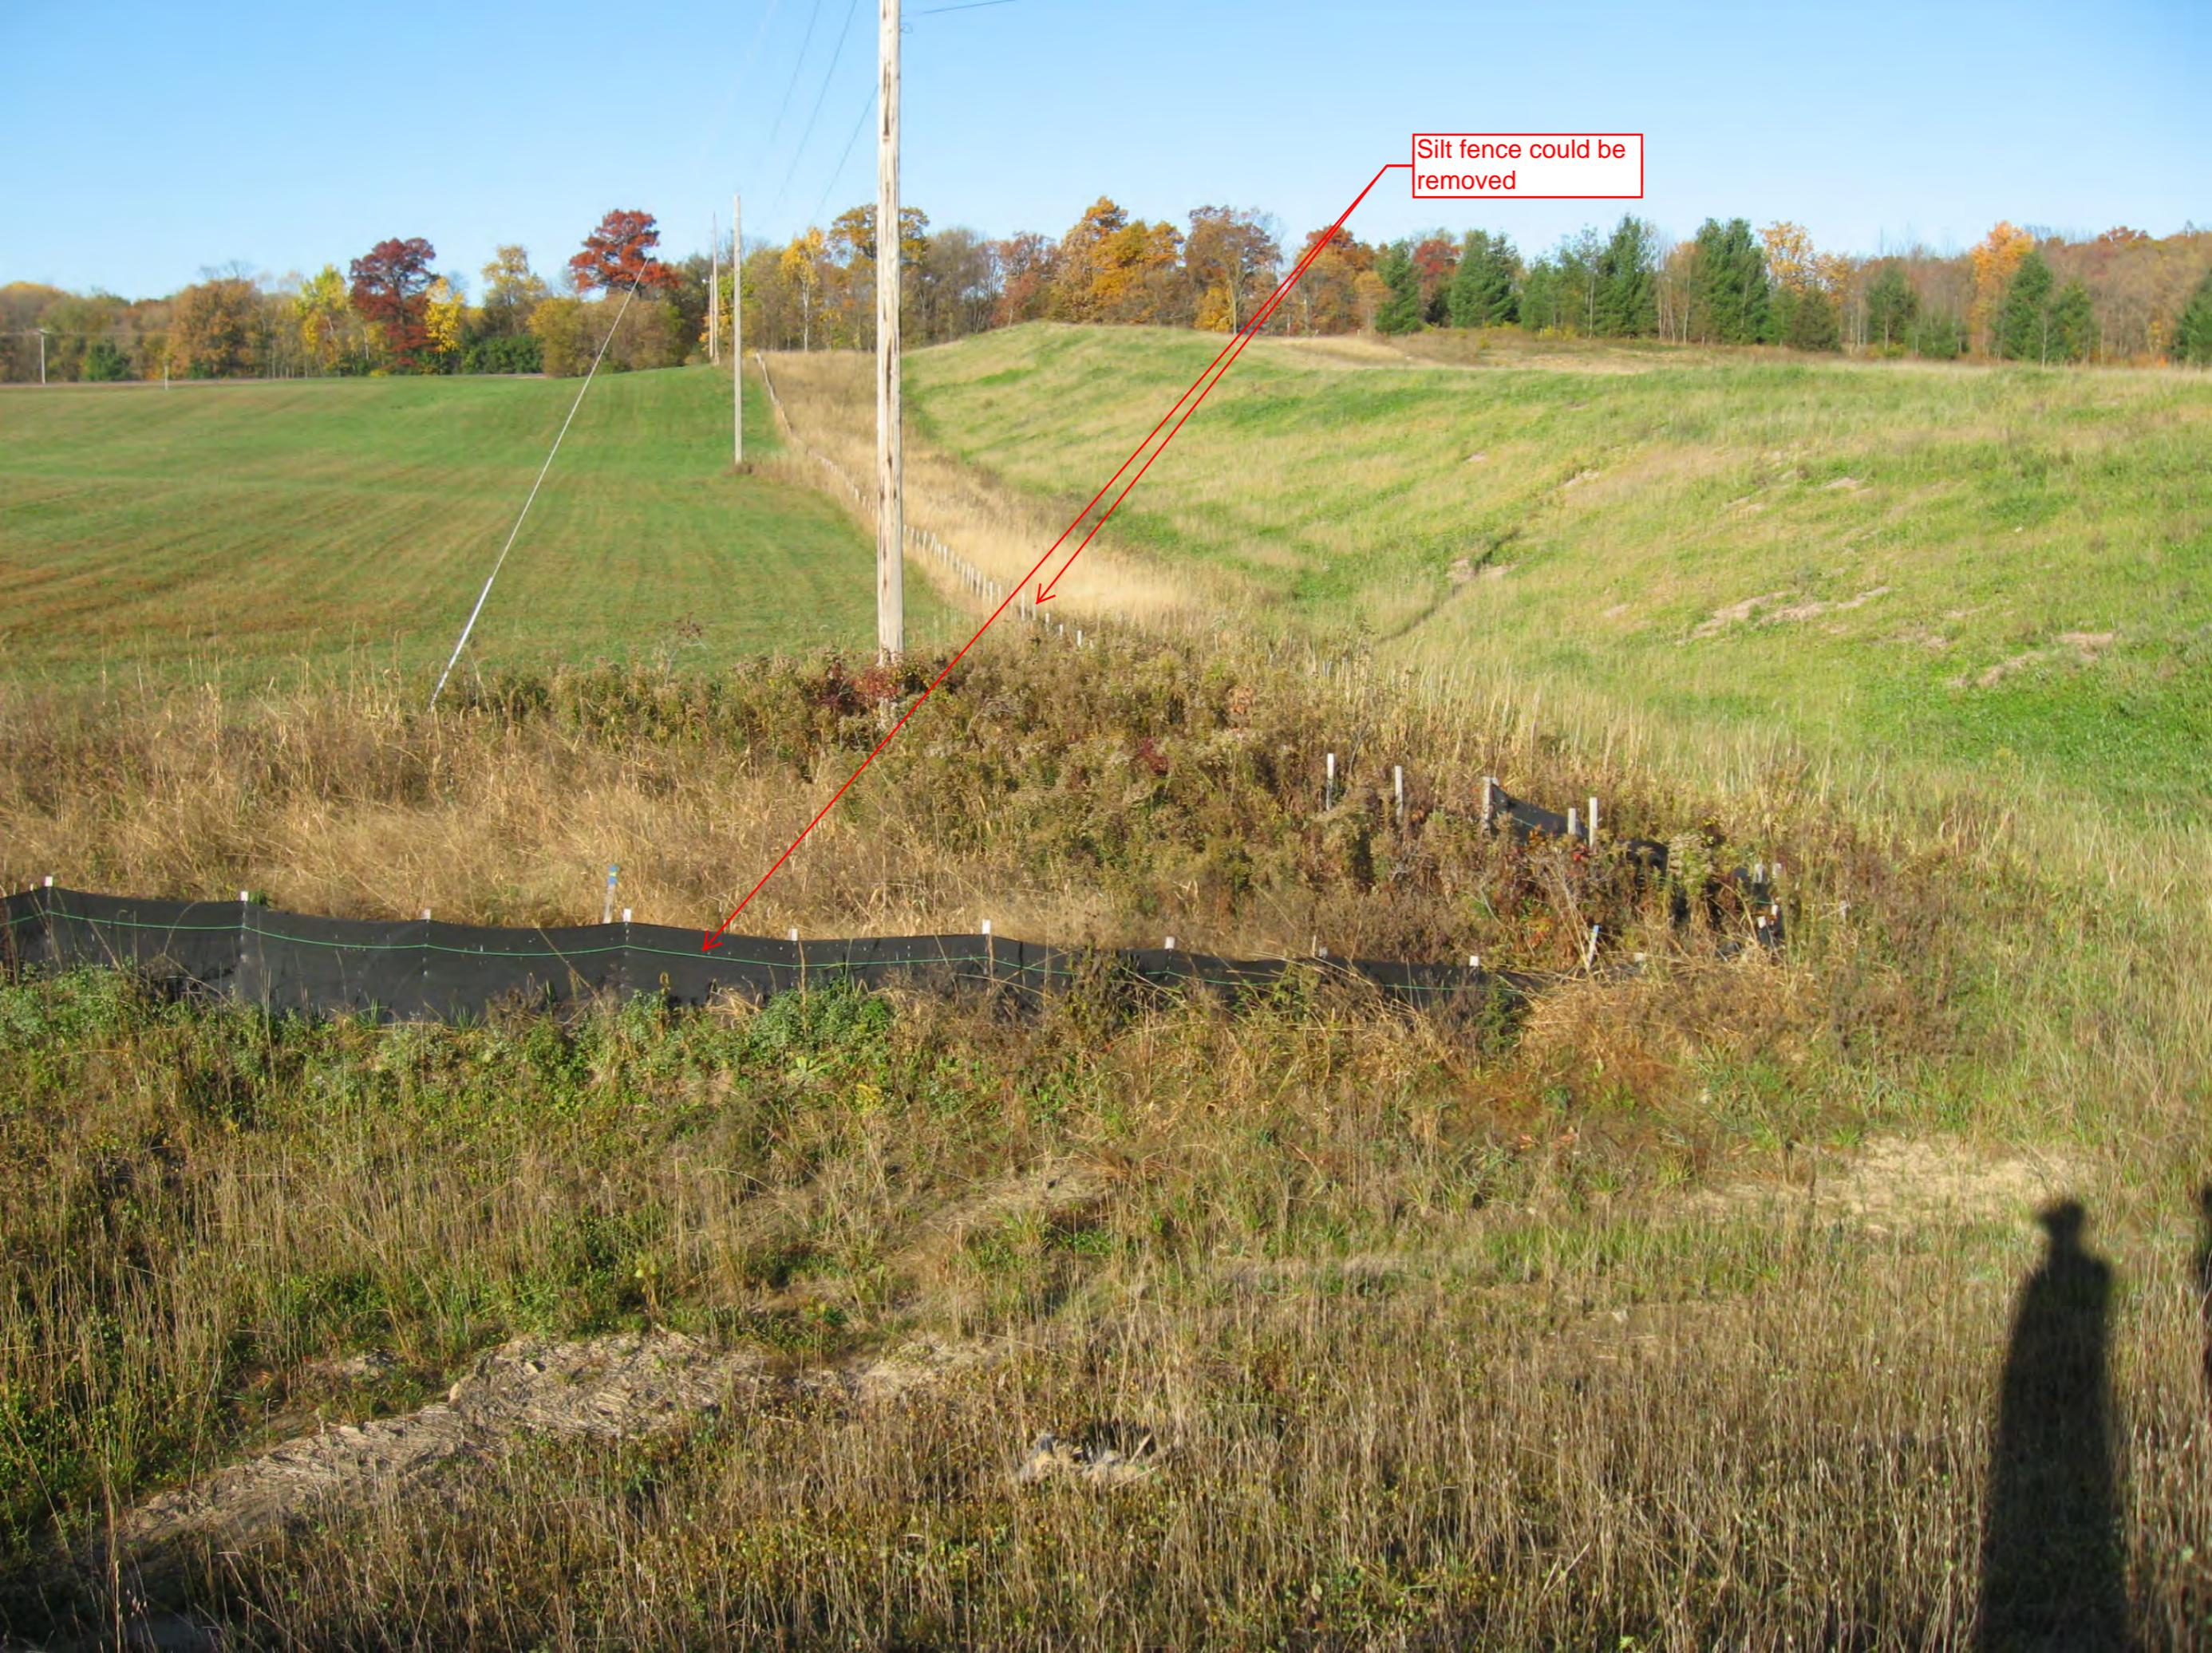
- ix. The silt fence located on the outside of the screening berms on the west side of the mine was inspected. The vegetation has become fully established in this area and therefore the silt fence is no longer necessary here. The WCD would support a recommendation by the City for the removal of the silt fence (shown in the attached picture) since there is no near-term plans for land disturbing activities on the outside edge of the screening berms. If future land disturbing activities were commenced, then the silt fence would need to be re-installed.

Silt fence could be removed

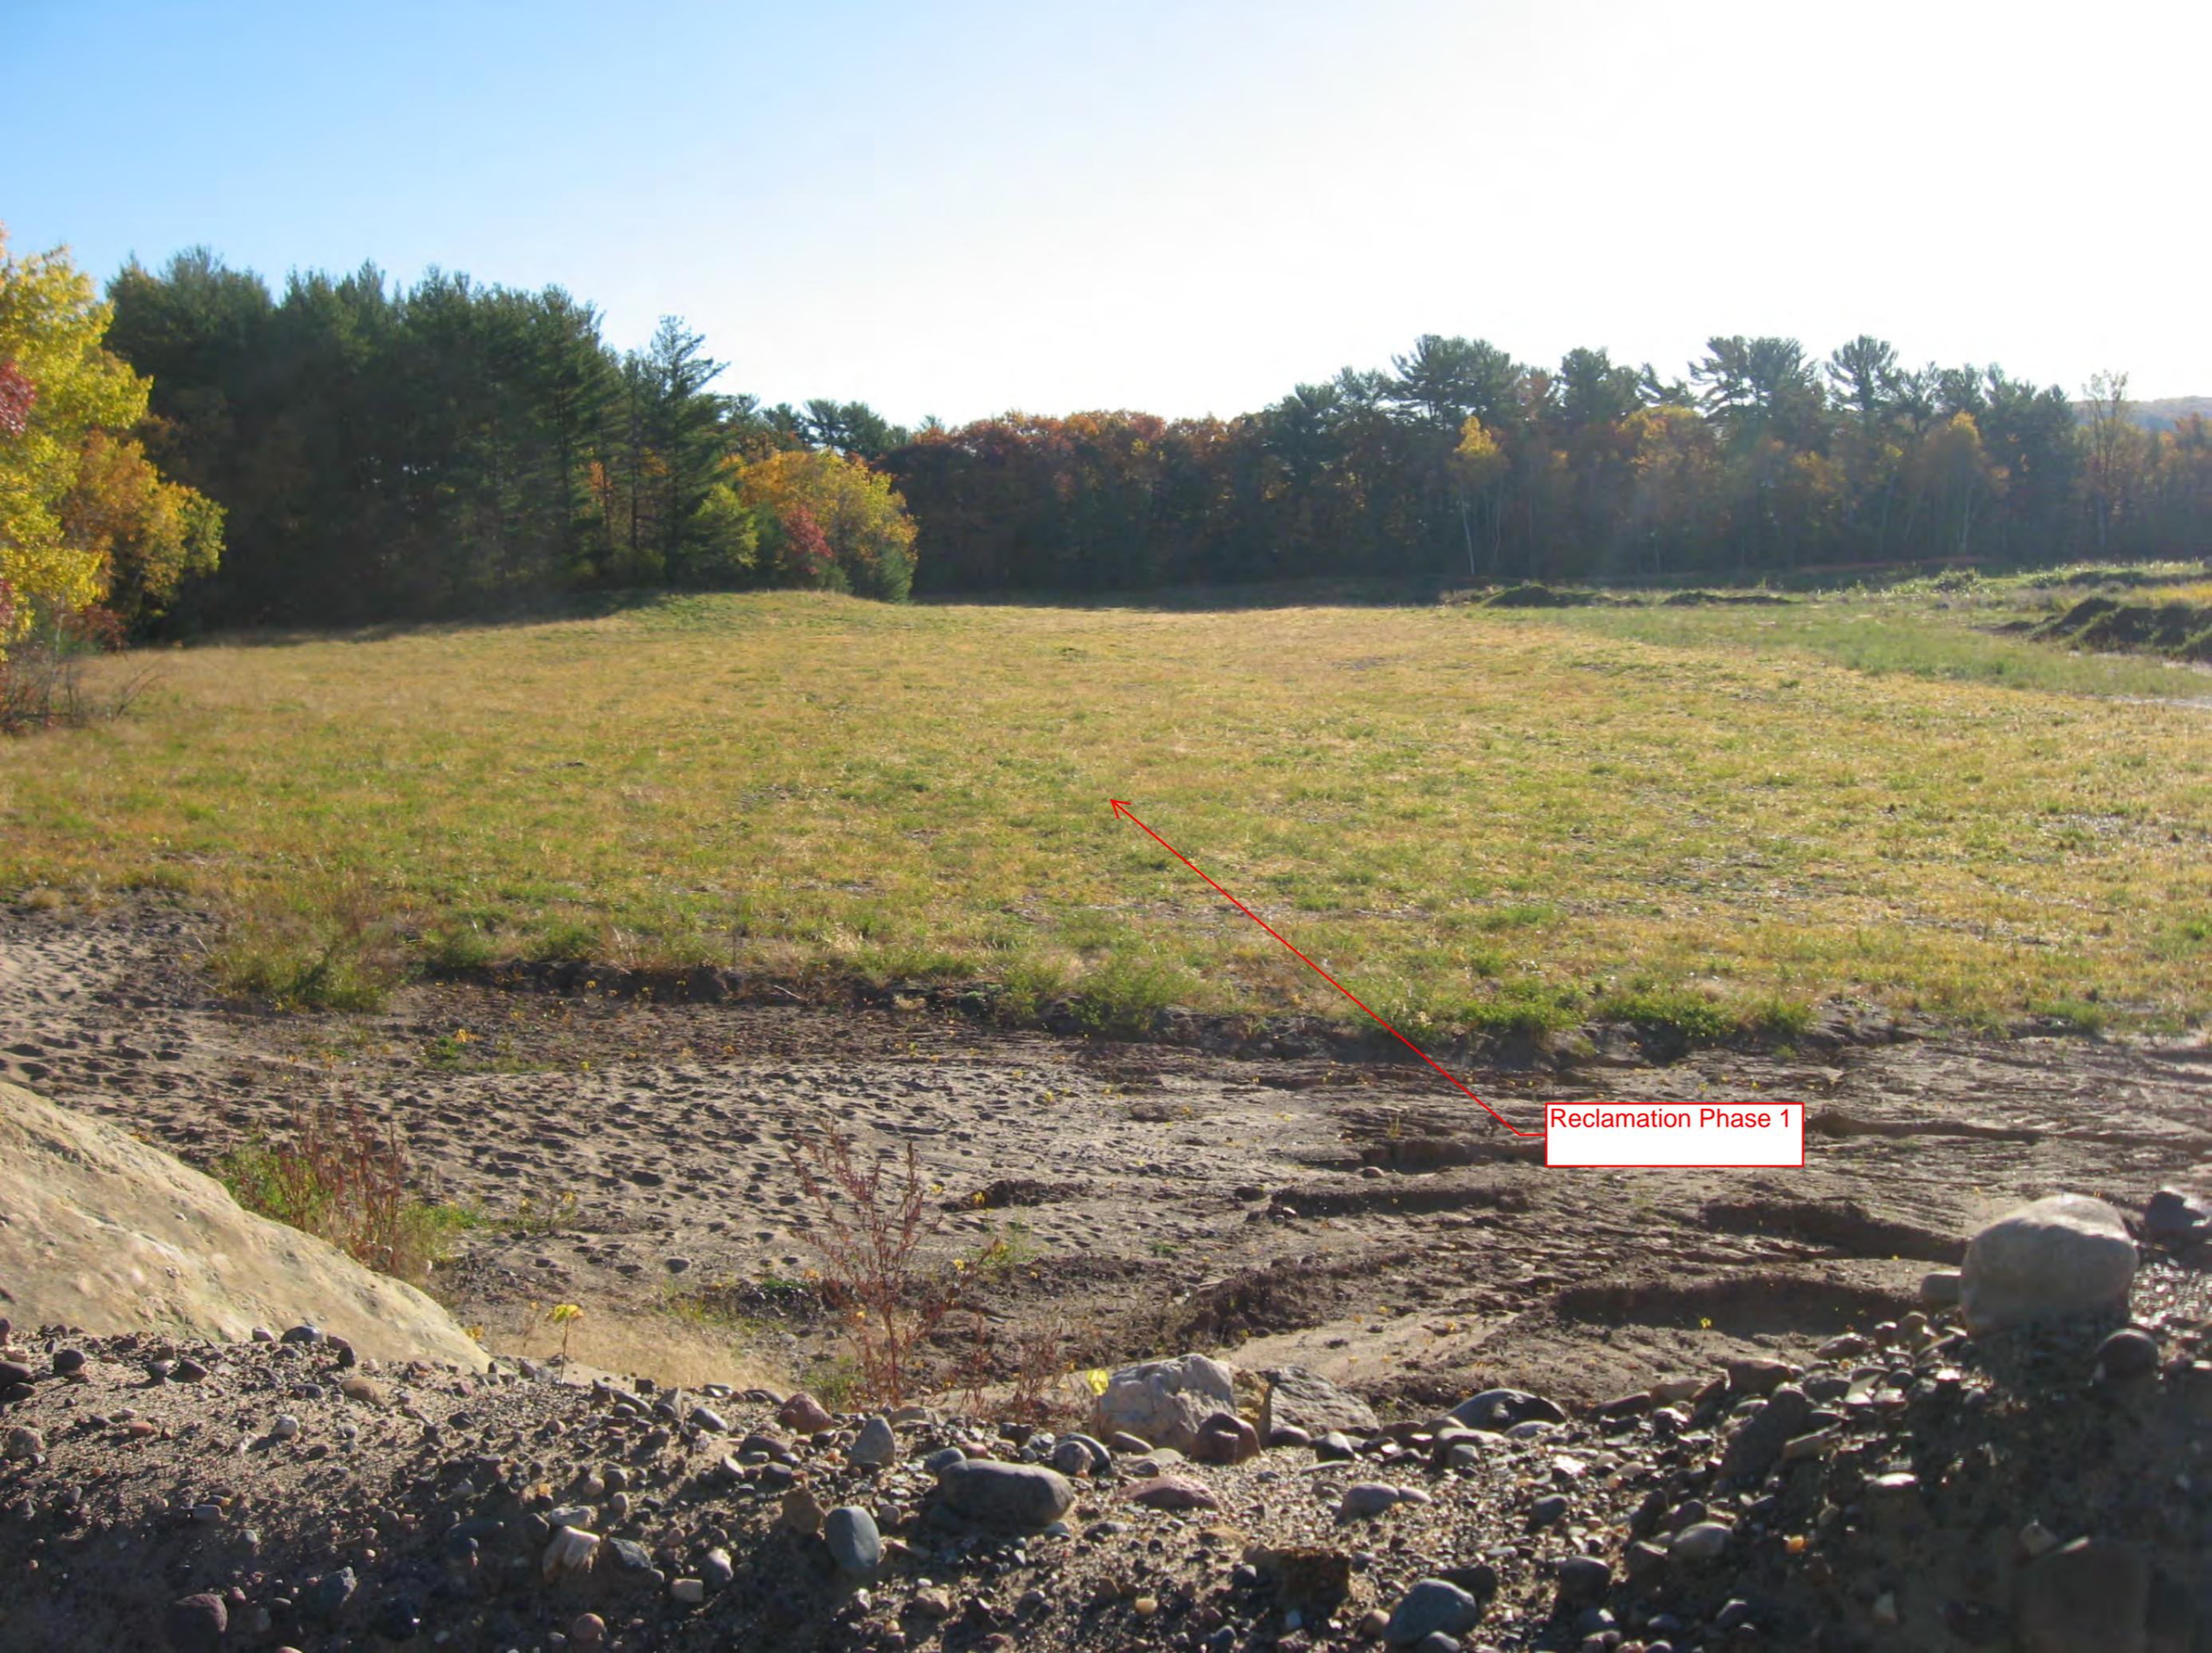
- i. A majority of Phase 1 of the reclamation was mostly complete as of the June site visit. The site was graded, topsoil had been installed and the native prairie seed was dormant seeded in the fall/winter of 2013. There was evidence of native prairie seedlings starting to germinate; mostly what appeared to be black-eyed susans. Seedlings of native grasses were observed during the October review. Based on the progress in 2014, it appears that the native prairie in Reclamation Phase 1 is establishing well. Confirmation of success will occur at the end of the monitoring period as required by the permit.
