WASHINGTON  
CONSERVATION  
DISTRICT

**RE:** **Zavoral Mining and Reclamation Project – Monitoring and Inspection Report  
2015 Inspection #6 –September 23, 2015**

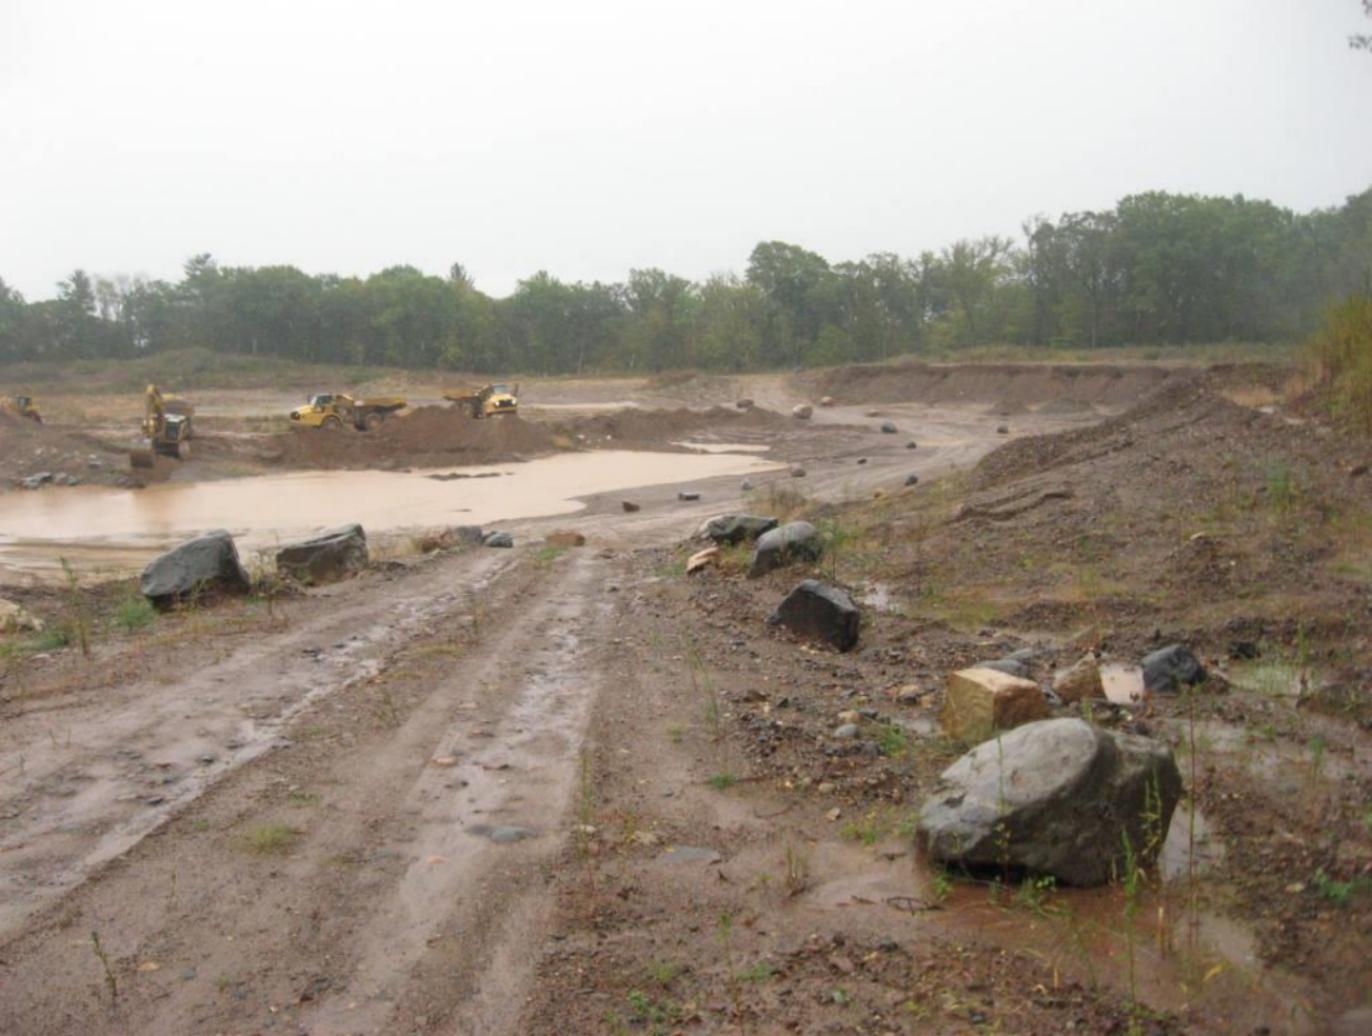
2. Technical Service 3 – Erosion and Sediment Control Inspections
  - a. Task 1 – Site Inspection
    - i. Active mining was not occurring during the site visit. However there was activity within the mine that consisted of moving material in preparation for mining and preparing and mixing material for the next phase of reclamation.

Moving material

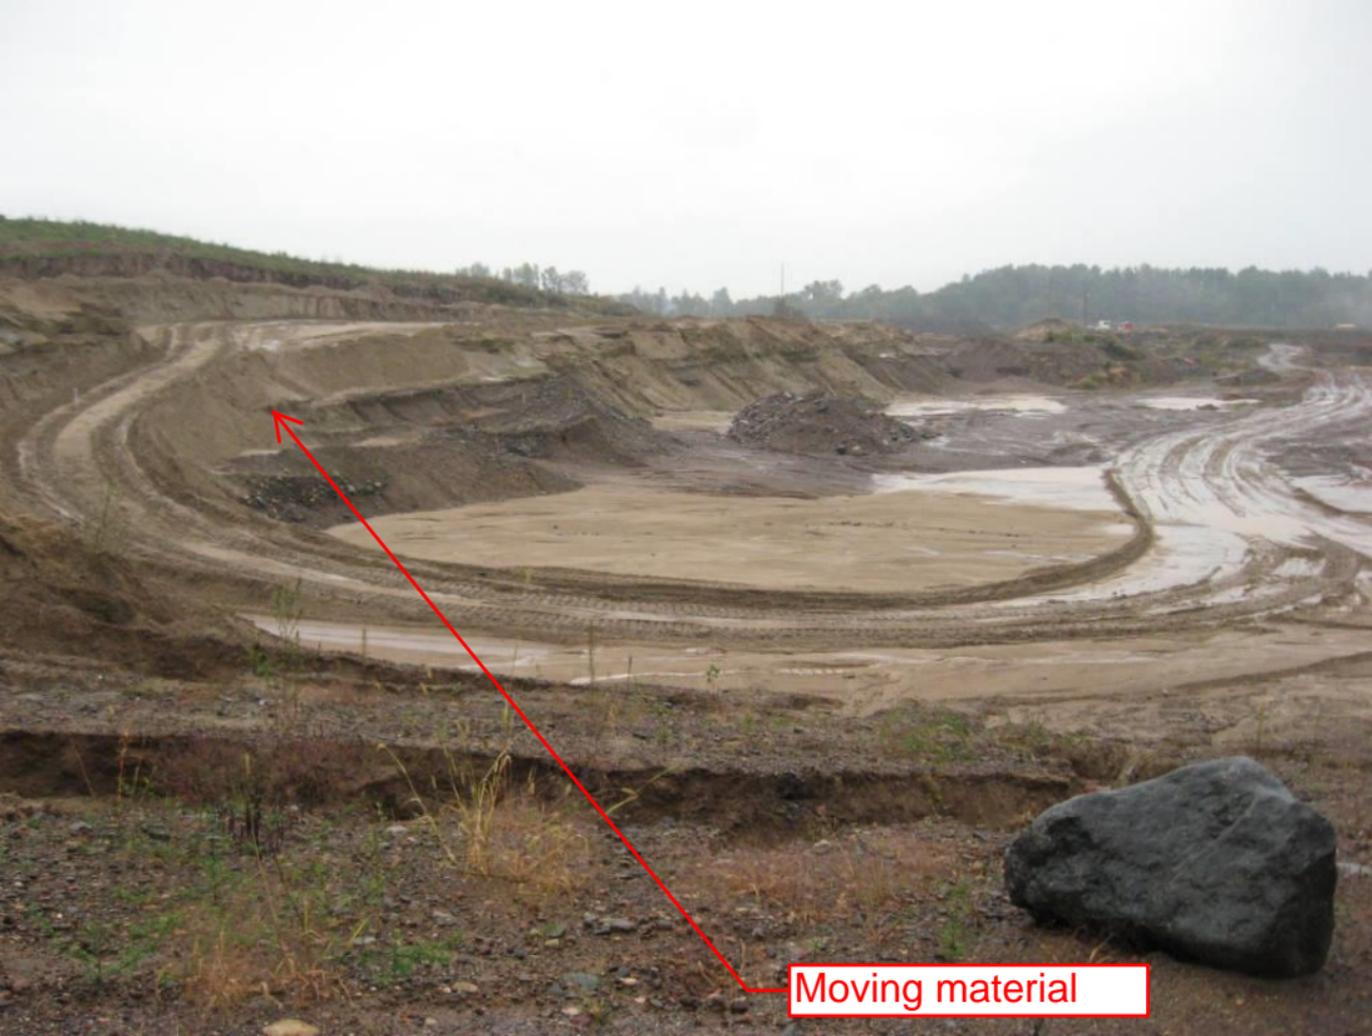
- iii. Nearly the entire mine site now drains internally, with one exception where the landowner’s driveway exits the mine area and begins its descent towards the river. This area had sufficient perimeter control for erosion and sediment control.

Site drains internally

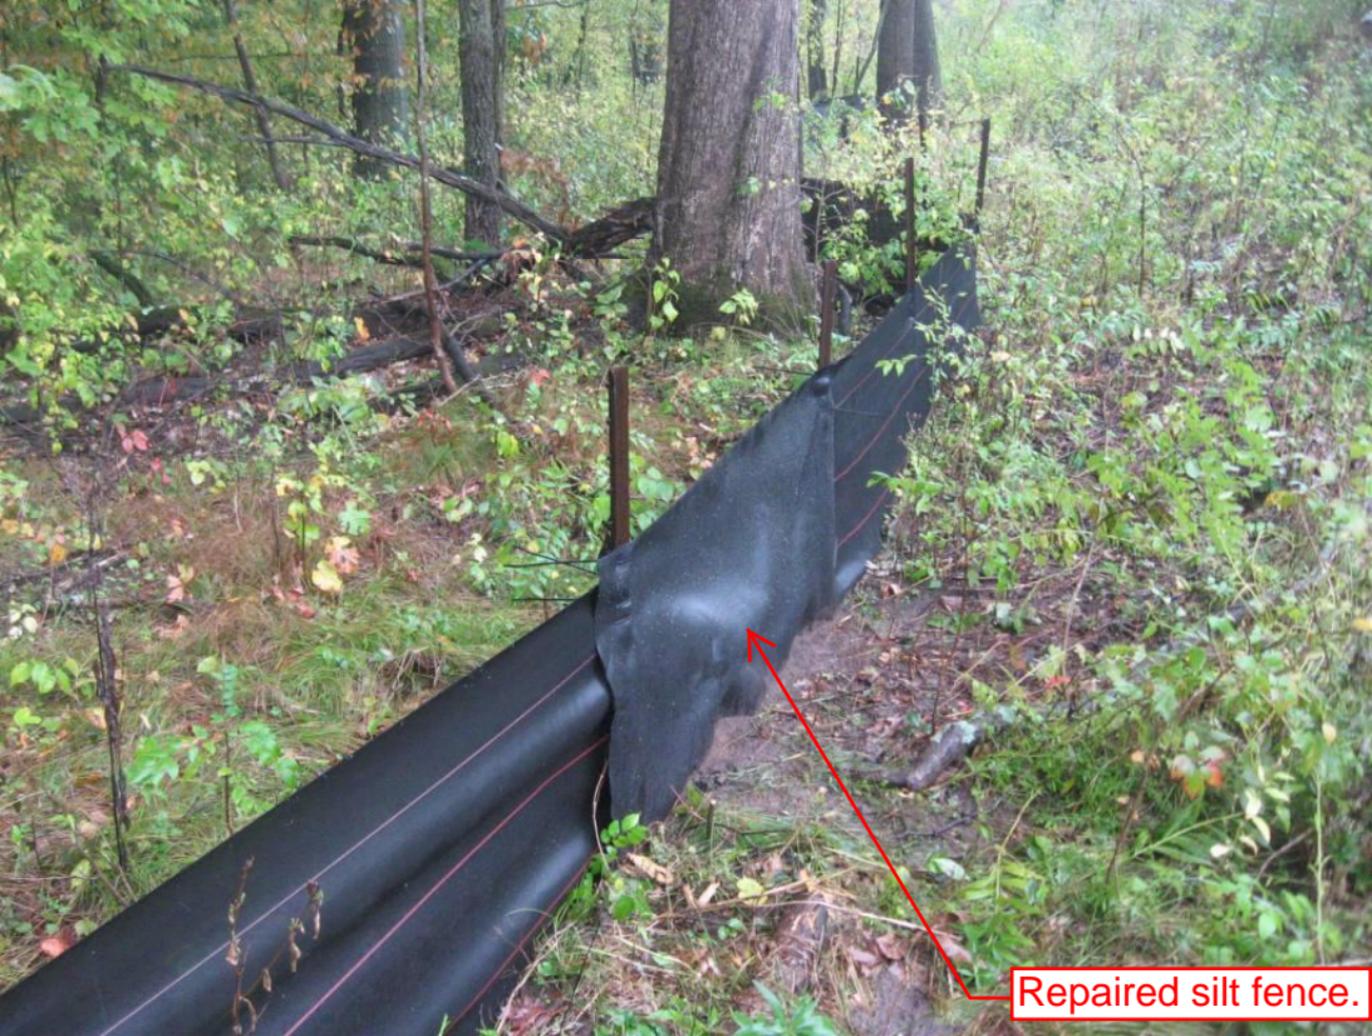
- iv. Tiller’s representative noted that a portion of silt fence on the eastern project limit had been damaged. The silt fence had been immediately repaired and the repair was done well. The damaged silt fence was well away from any mining activity so there is no threat of stormwater or sediment discharge off the site in the area of the damaged and subsequently replace silt fence (see picture).

Repaired silt fence.
