## MEMORANDUM

**FROM:** Jed Chesnut, Wetland/Natural Resource Specialist

**RE:** **Zavoral Mining and Reclamation Project – Monitoring and Inspection Report  
2014 Inspection #3 – July 28, 2014**

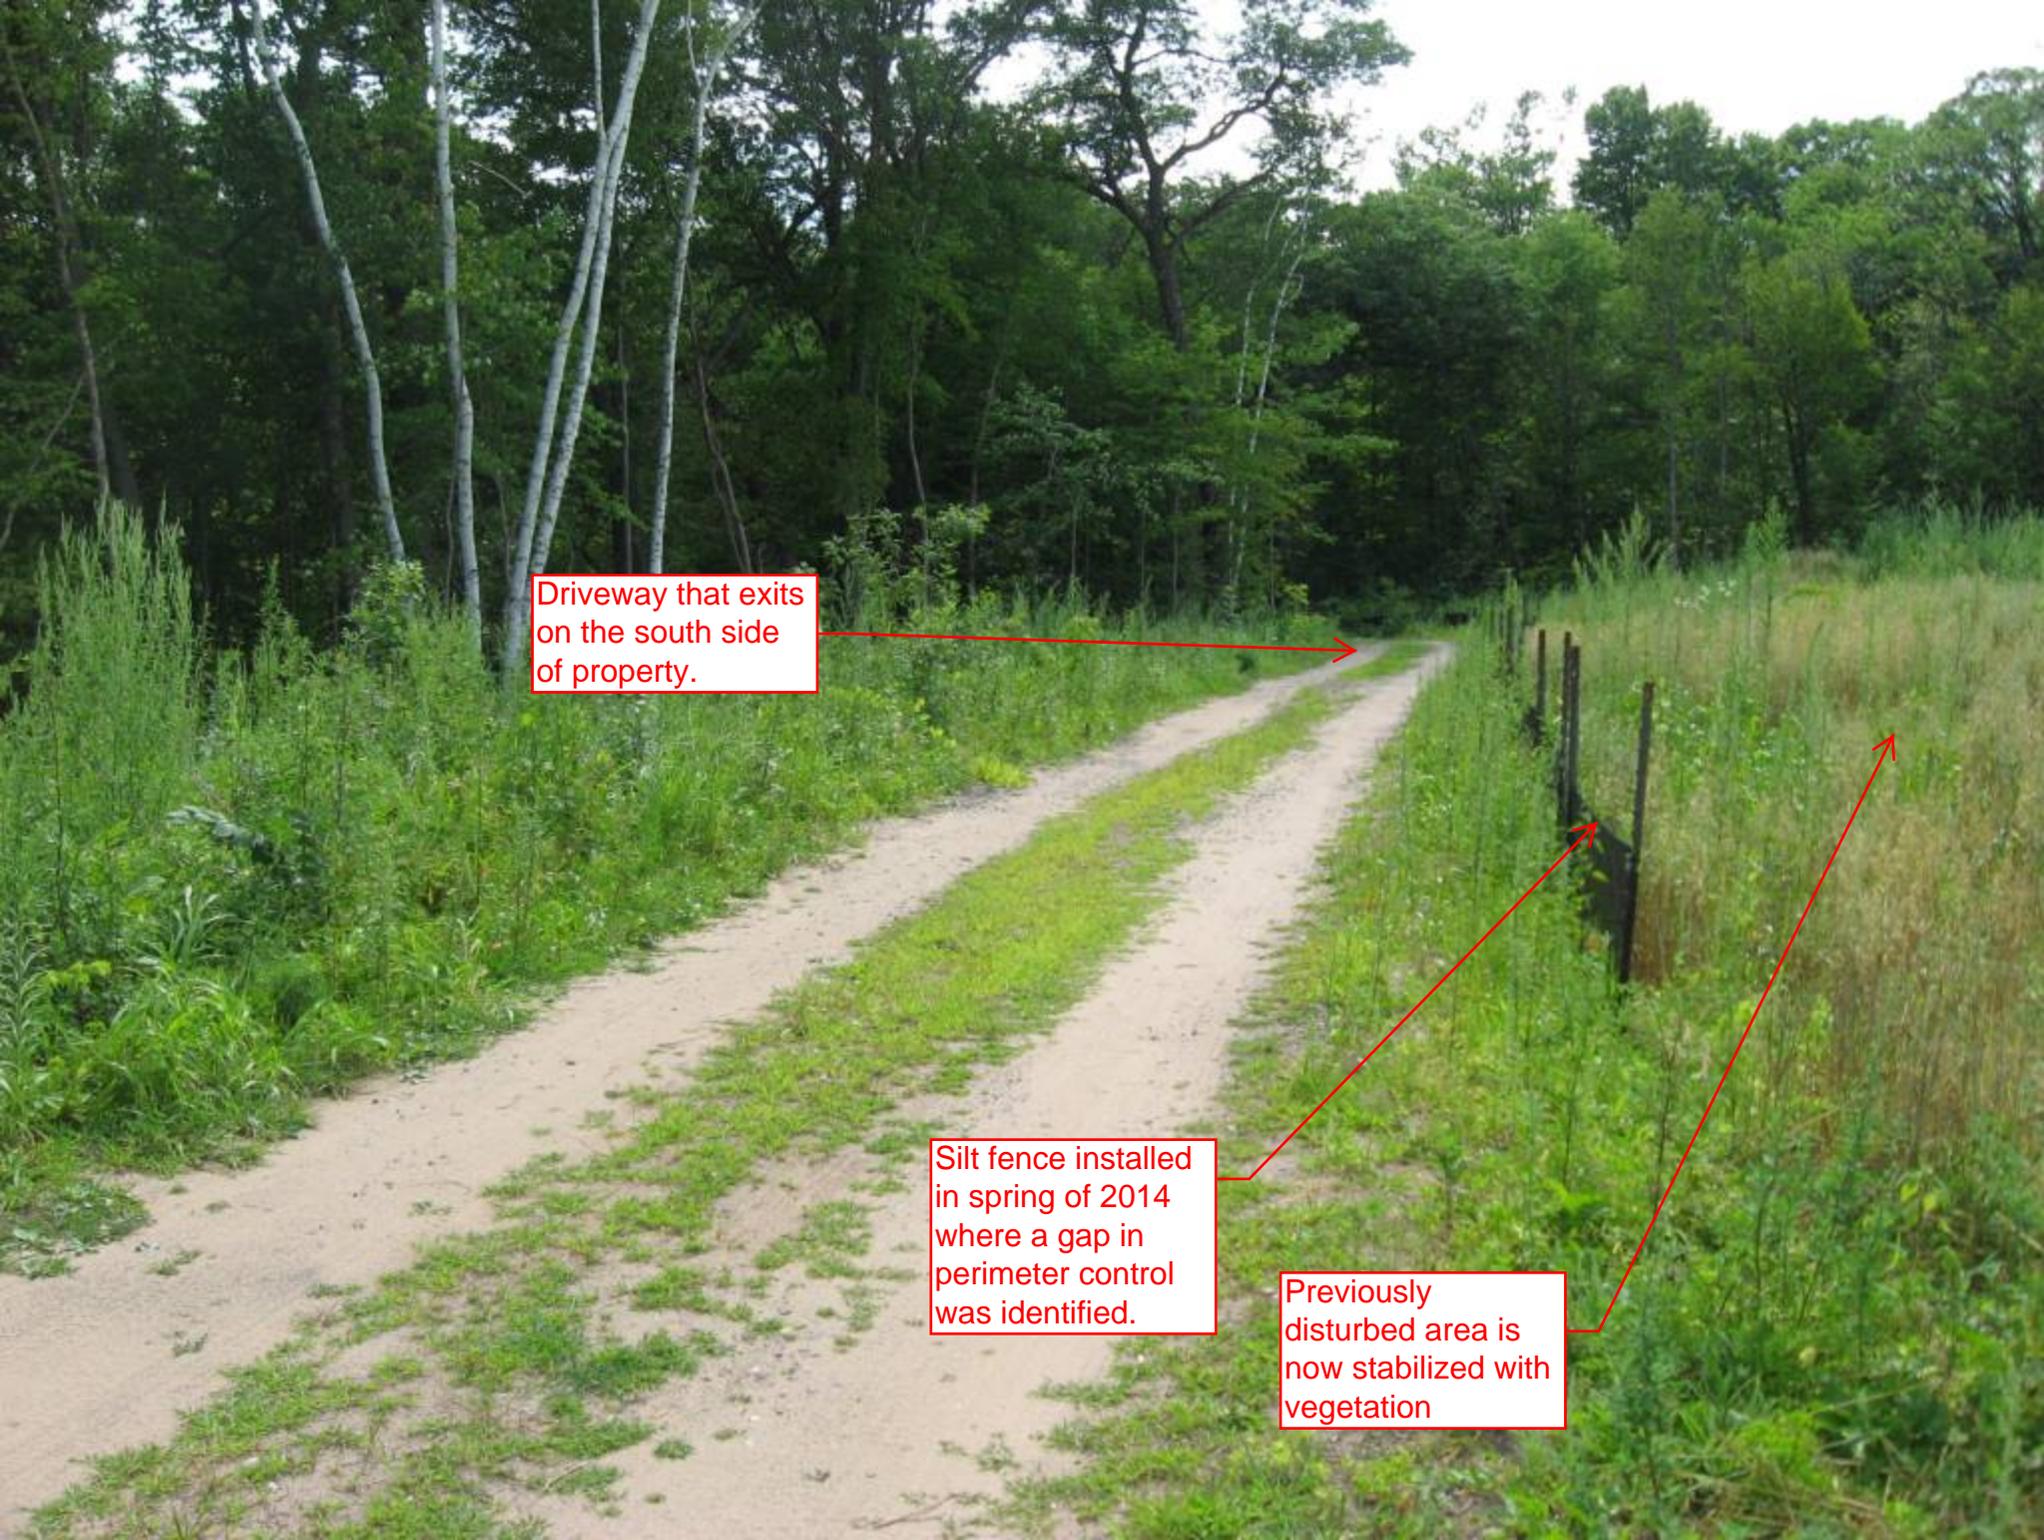
- vii. There was an area along the southern project limits where a gap in perimeter control was identified in 2013. This silt fence has since been installed and was noted in the June report. Vegetation in this area, upslope from the silt fence, is now well established and is stabilizing the previously disturbed soils (see attached photo).

Driveway that exits on the south side of property.

Silt fence installed in spring of 2014 where a gap in perimeter control was identified.

Previously disturbed area is now stabilized with vegetation

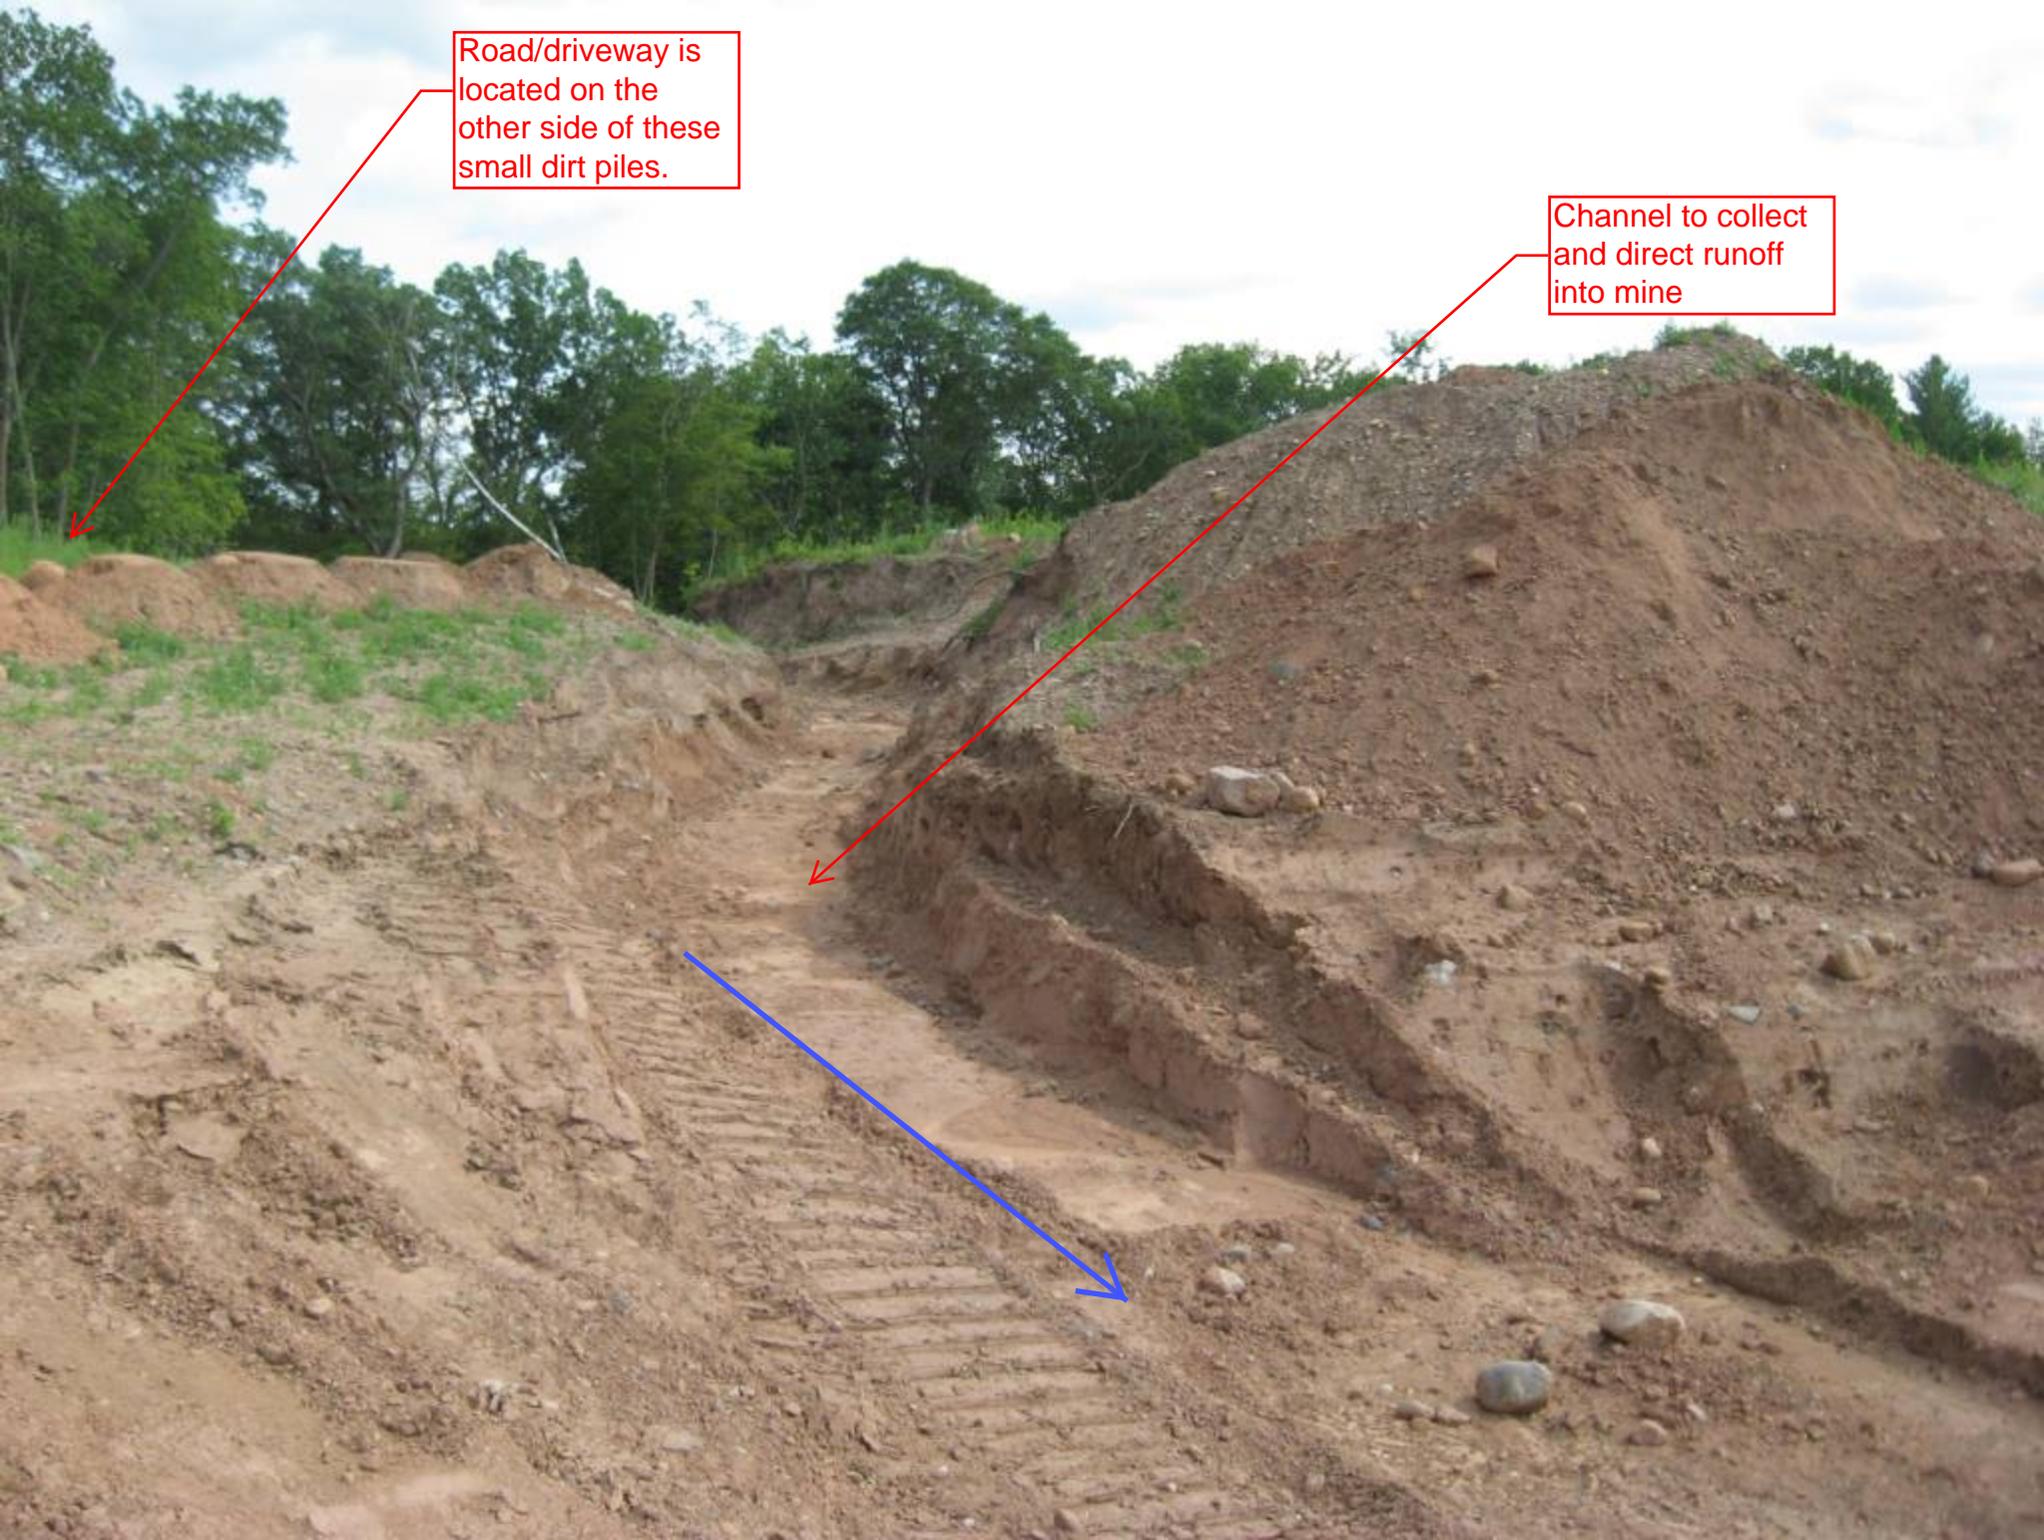
- viii. In the June report, it was noted that Tiller planned to regrade the internal driveway road that runs along the south and east project limits so that it slopes inward to the mine and therefore runoff will be directed internally. This work had been completed prior to the July site inspection. Along the length of the road, Tiller graded on the mine side to create drainageways that direct and collect runoff into the mining area. This significantly reduces the potential for stormwater discharge off the mine site along the south and southeast edge of the mine (along the owner's driveway). Tiller

Road/driveway is located on the other side of these small dirt piles.

Channel to collect and direct runoff into mine

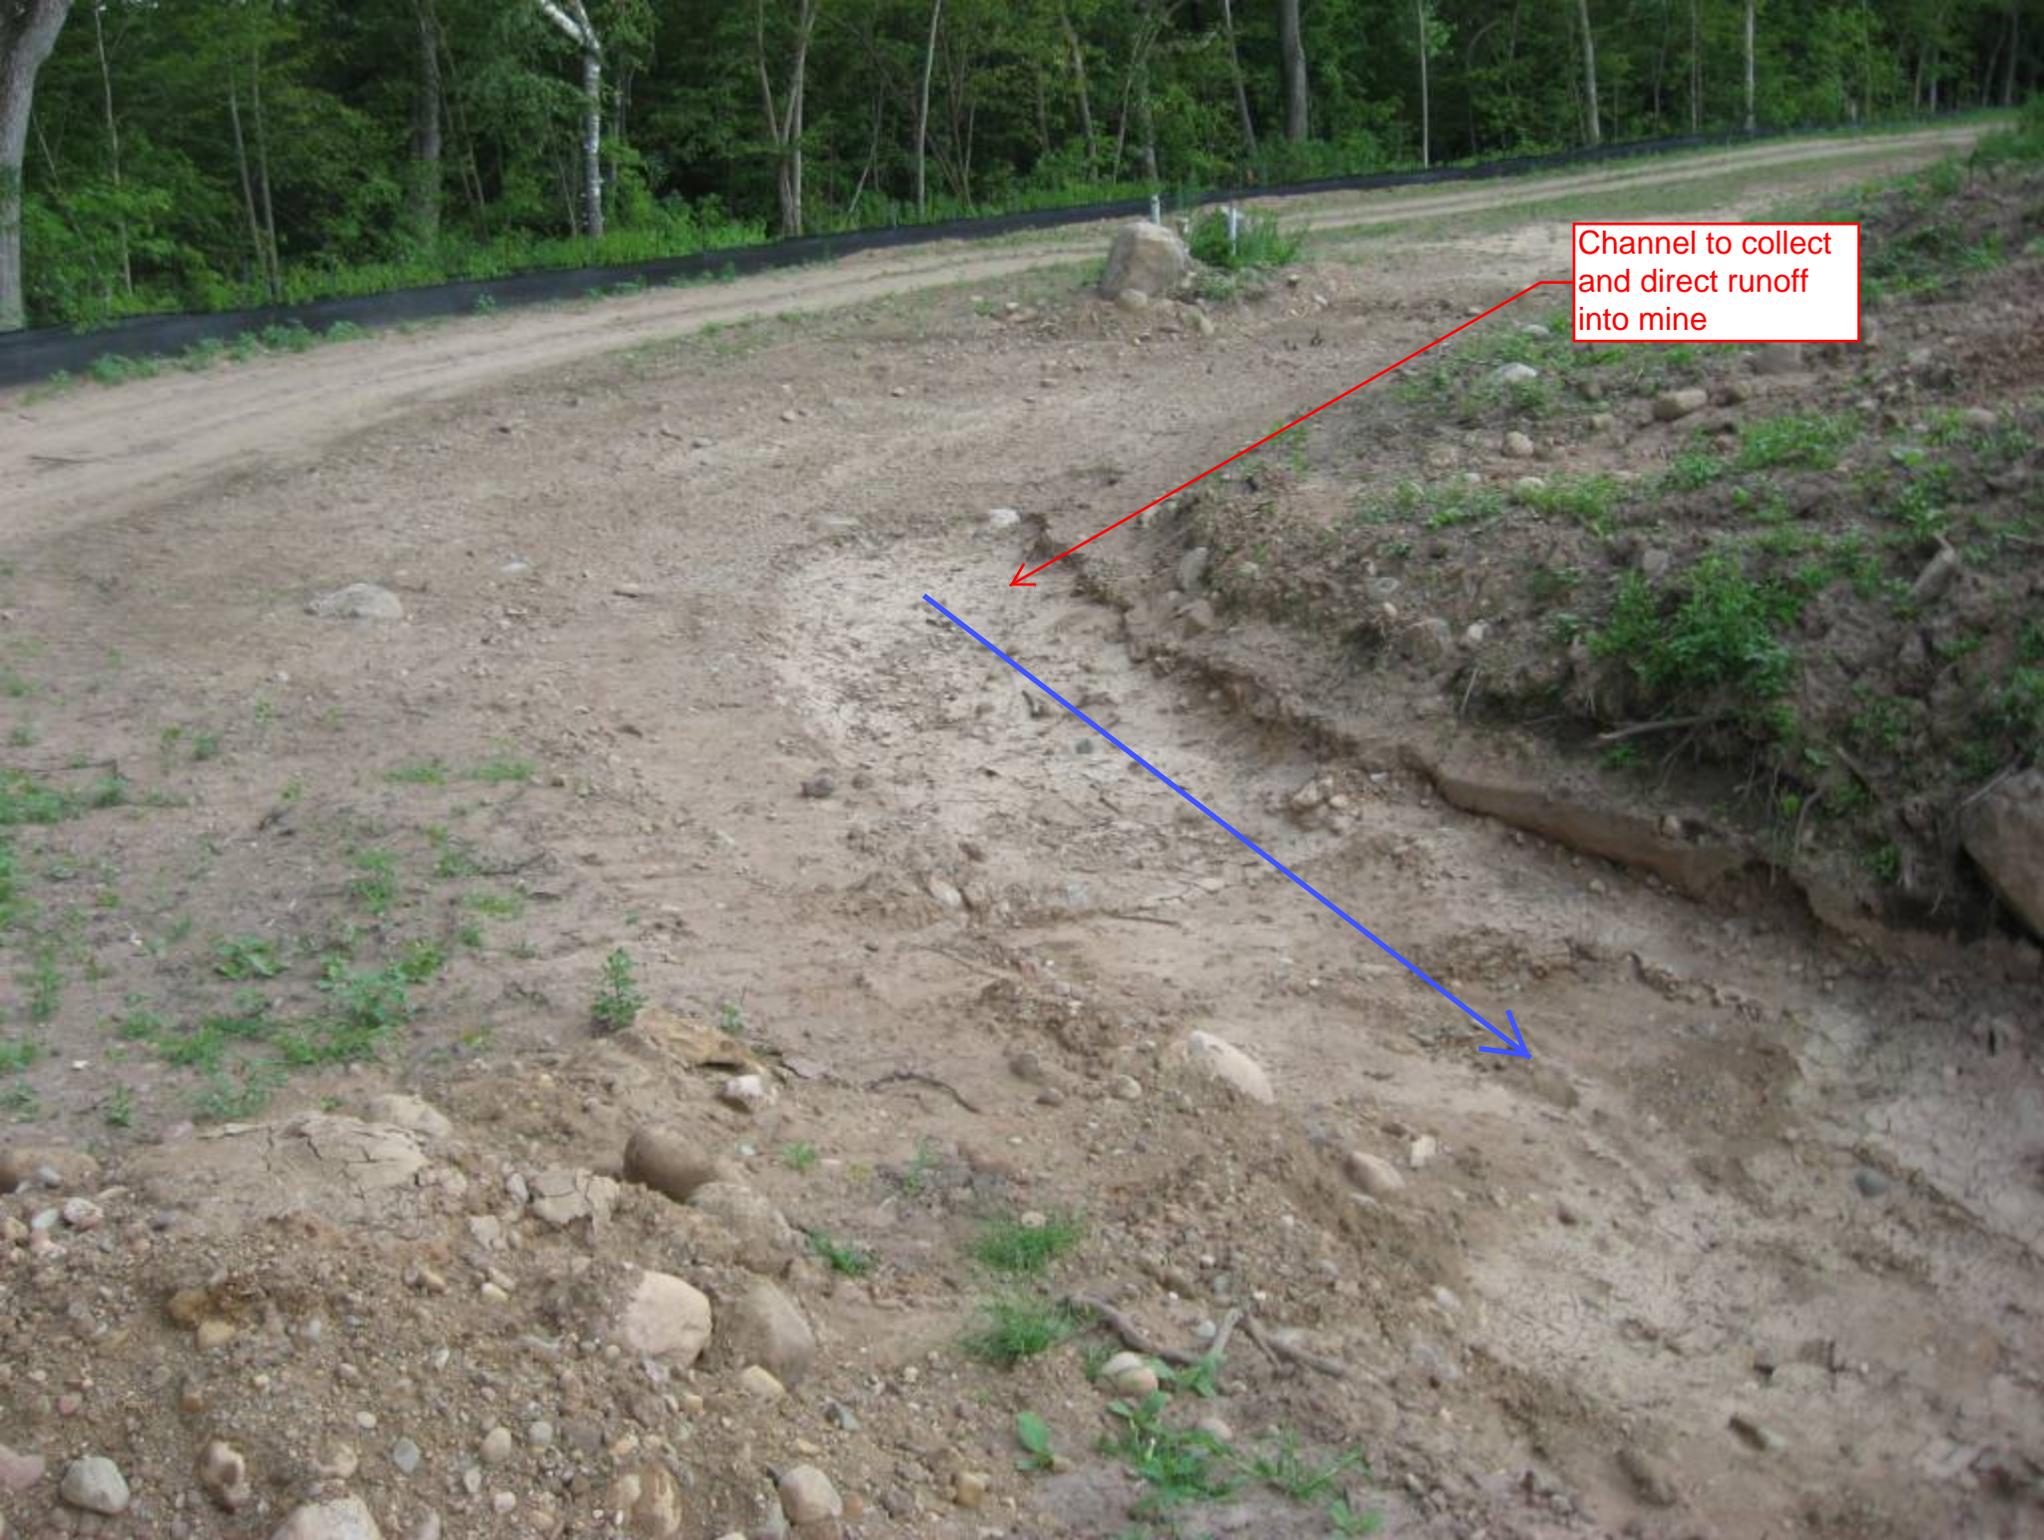
Grading to collect and direct runoff into mine

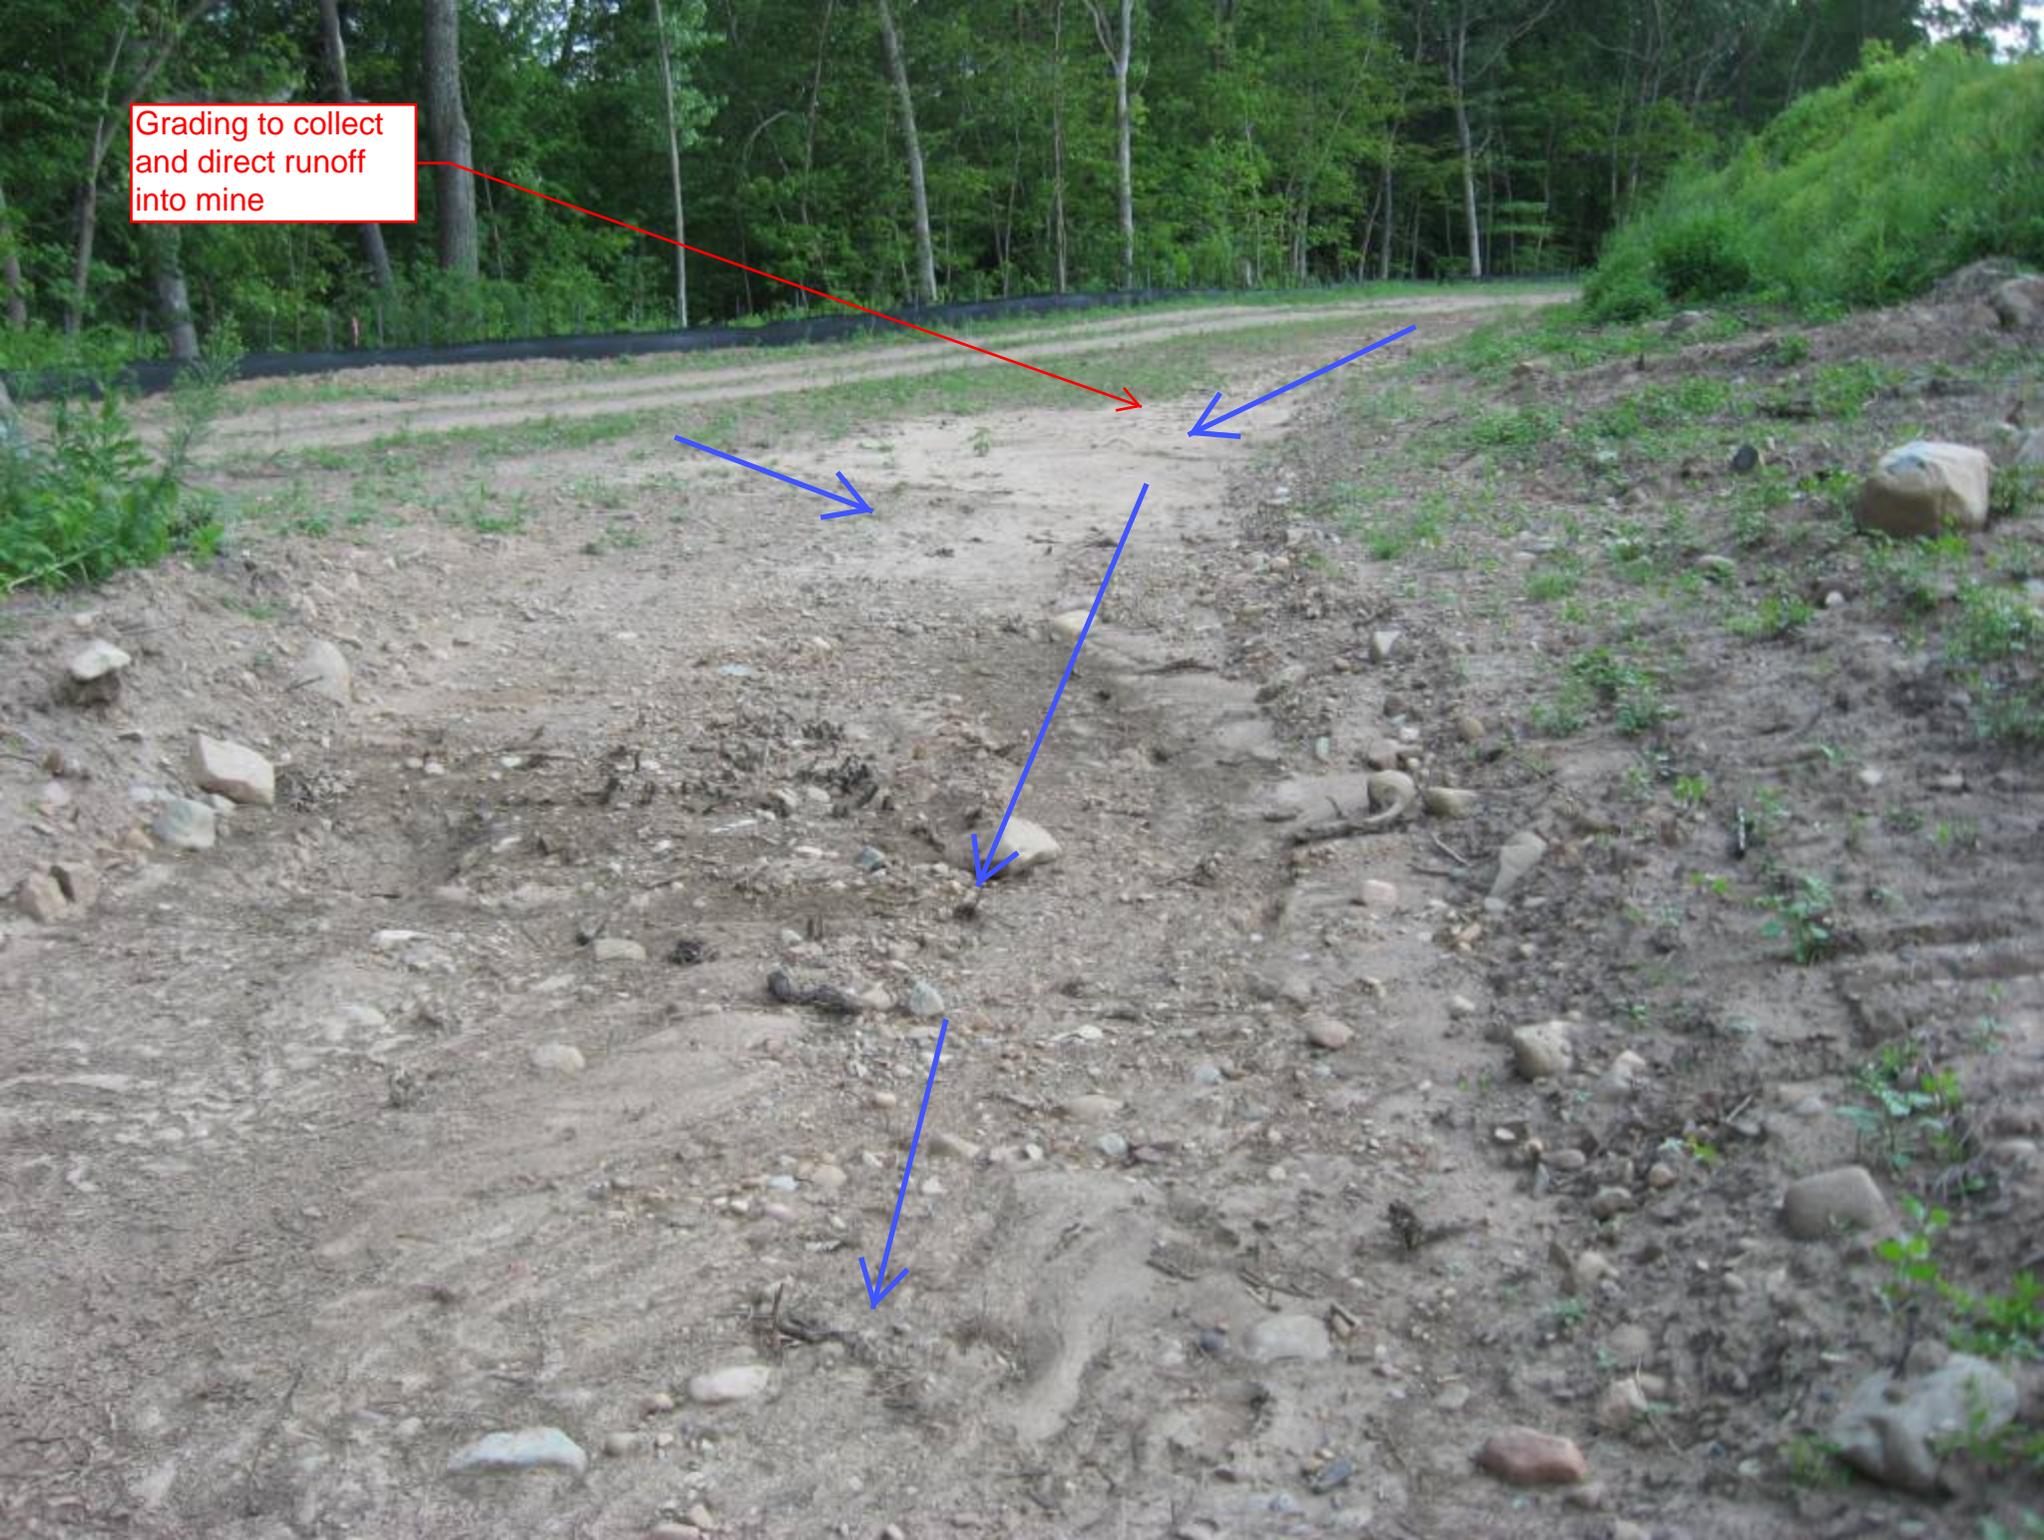
Grading to collect and direct runoff into mine

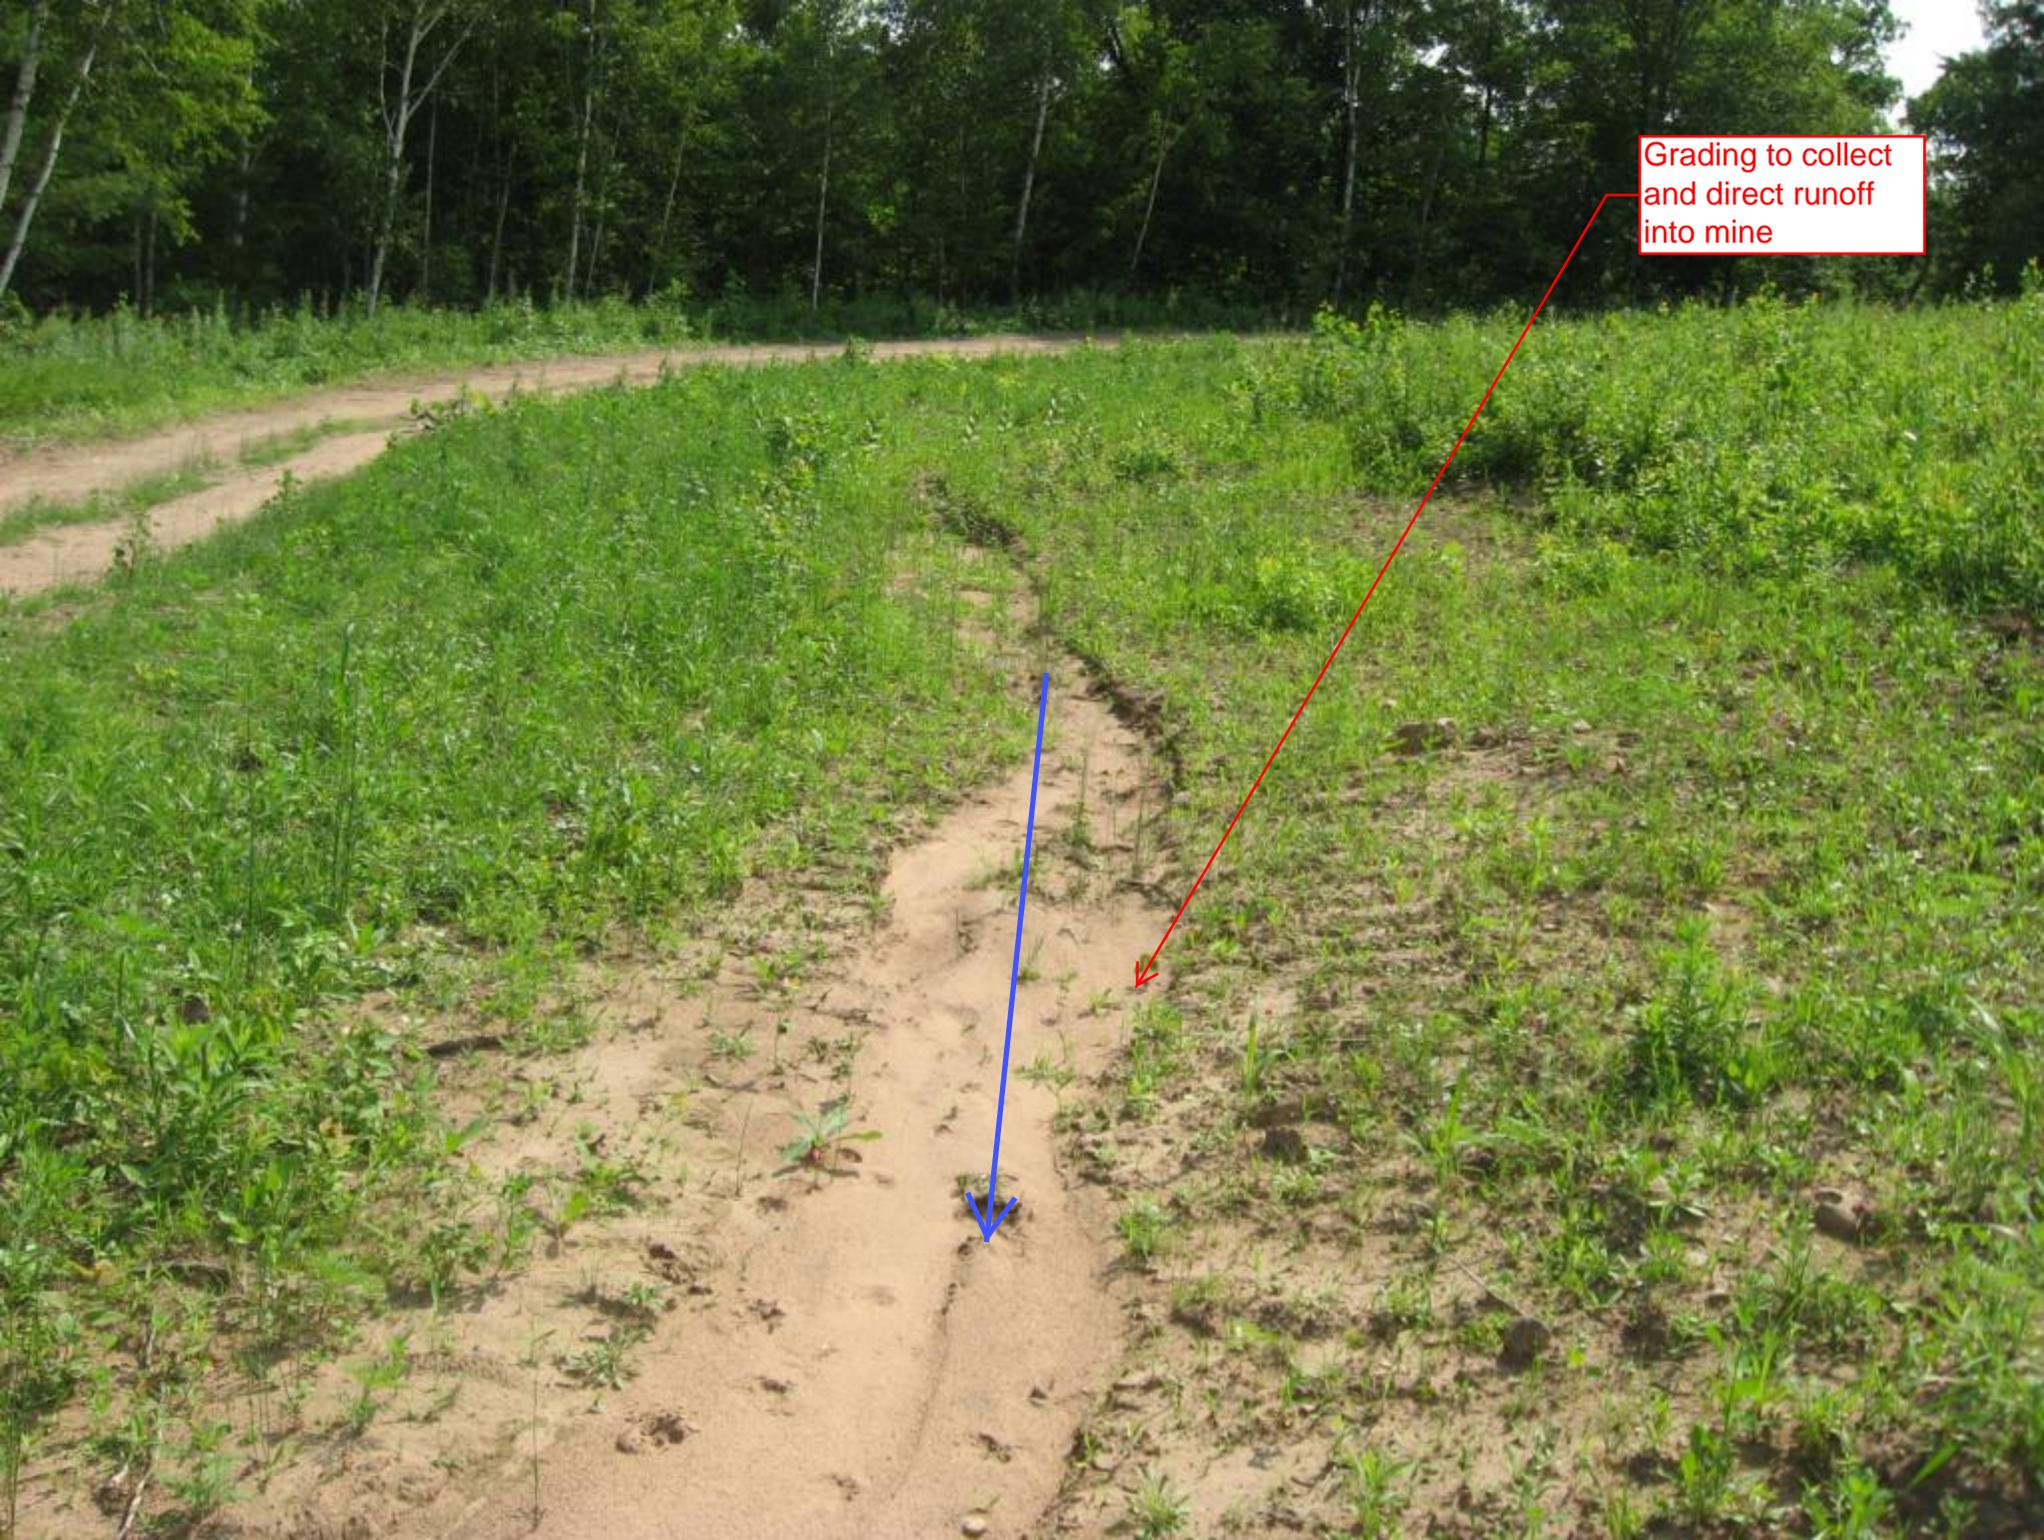
is leaving the silt fence in place as perimeter control for the very small area of road and edge that drains away from the mining area (see attached pictures).

Silt fence left in place

Grading to collect and direct runoff into mine

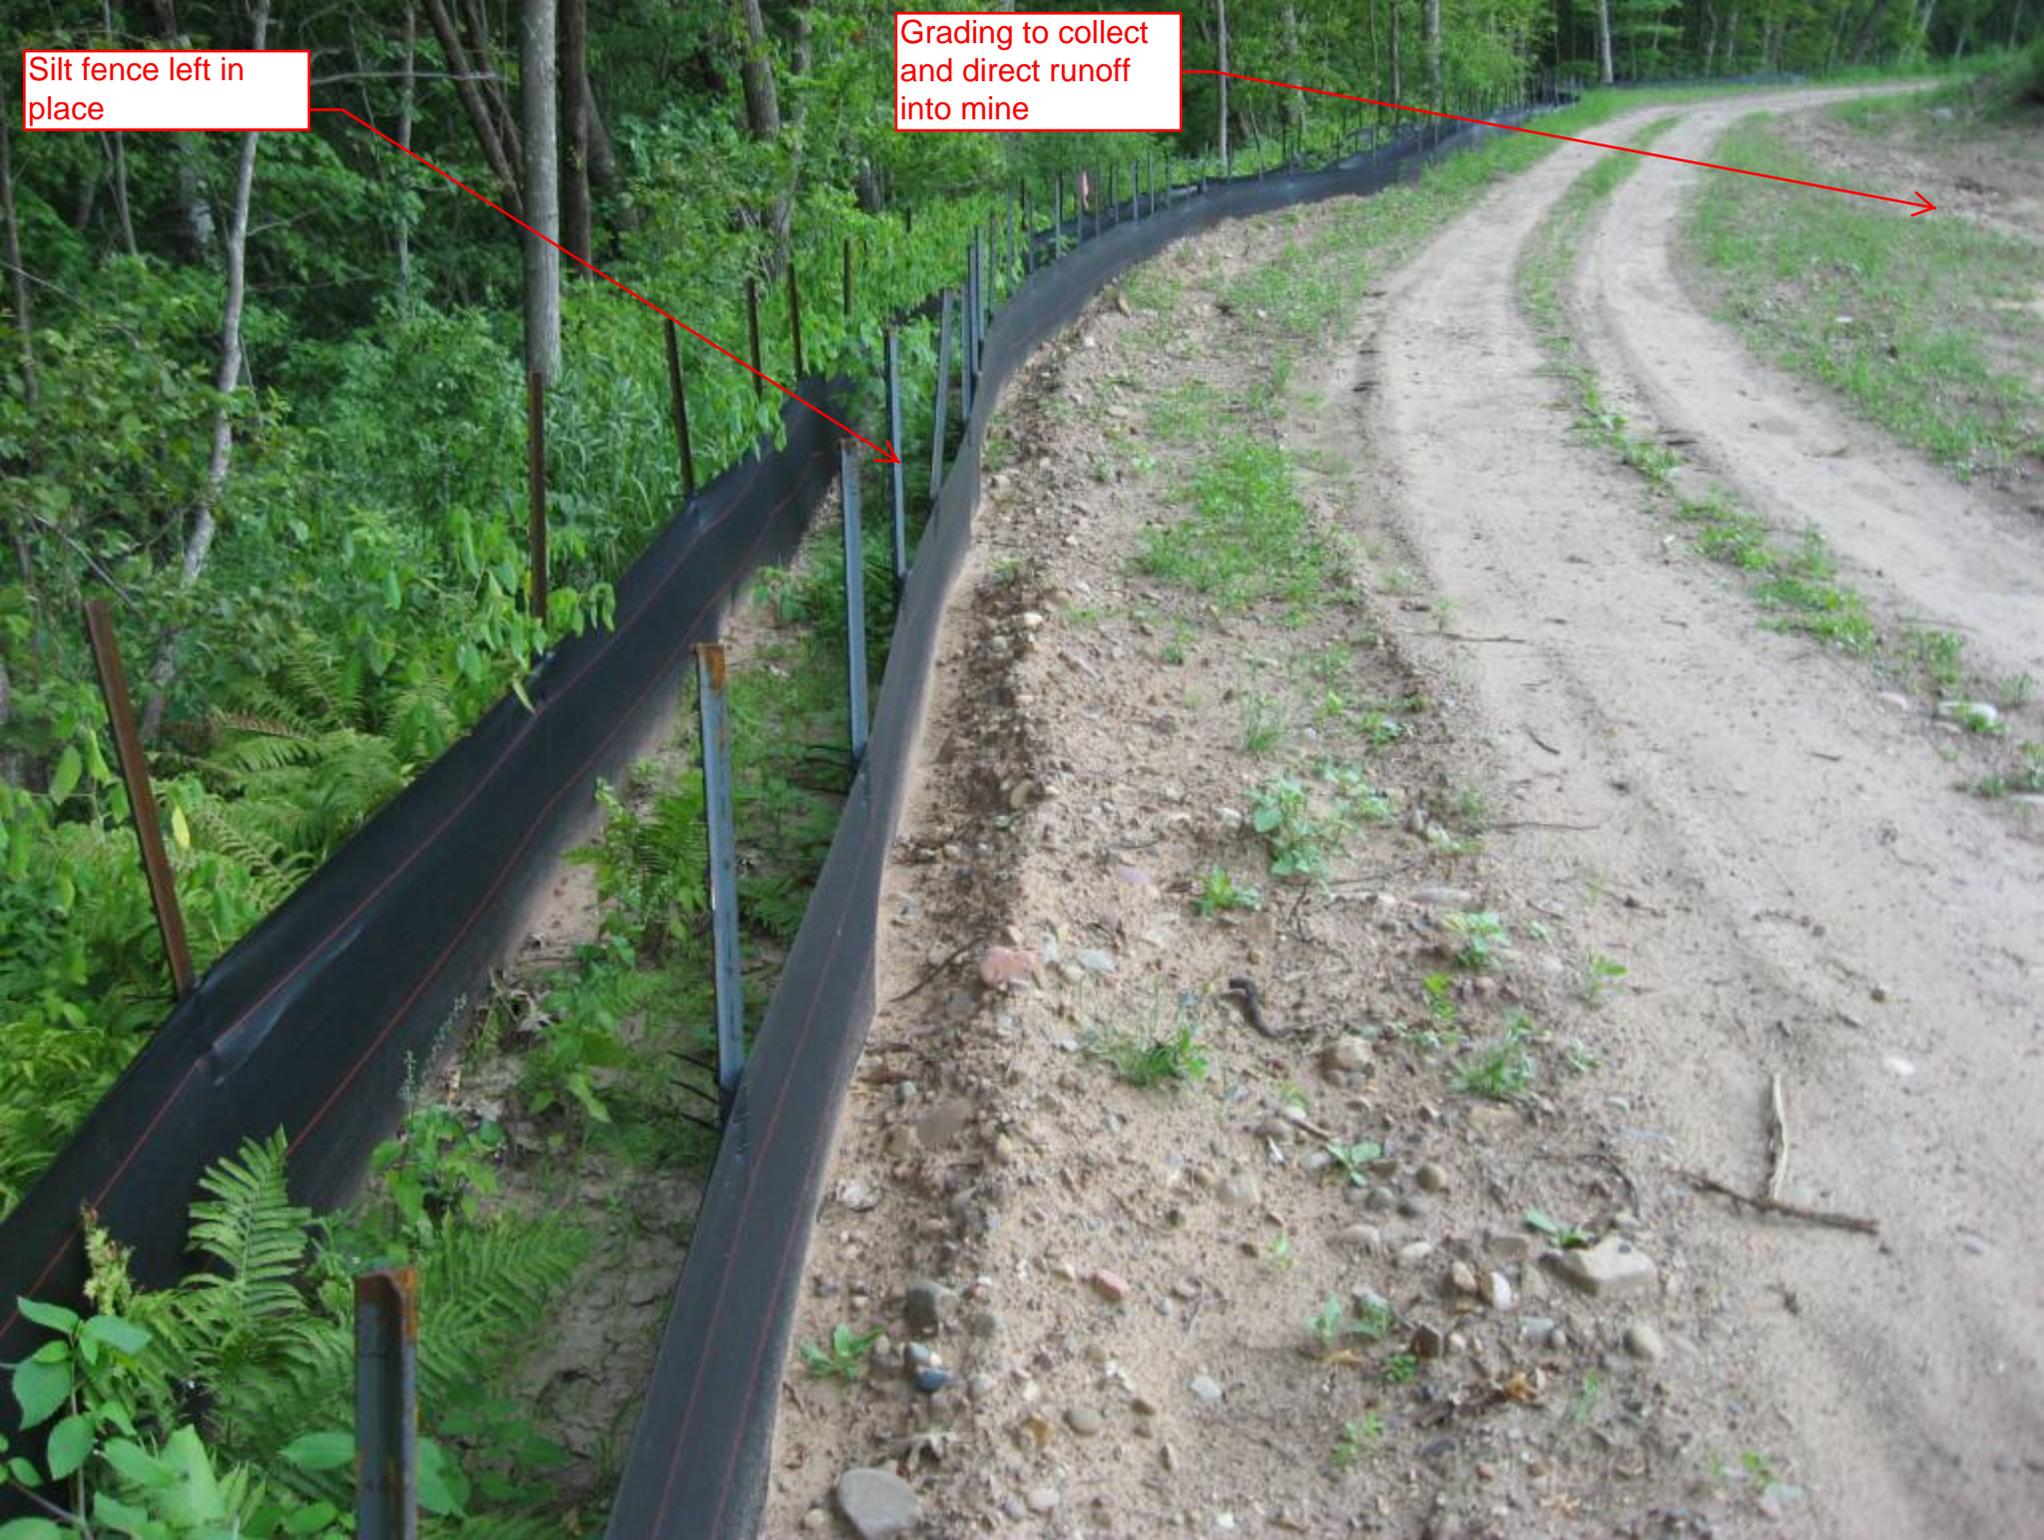
Grading to collect and direct runoff into mine

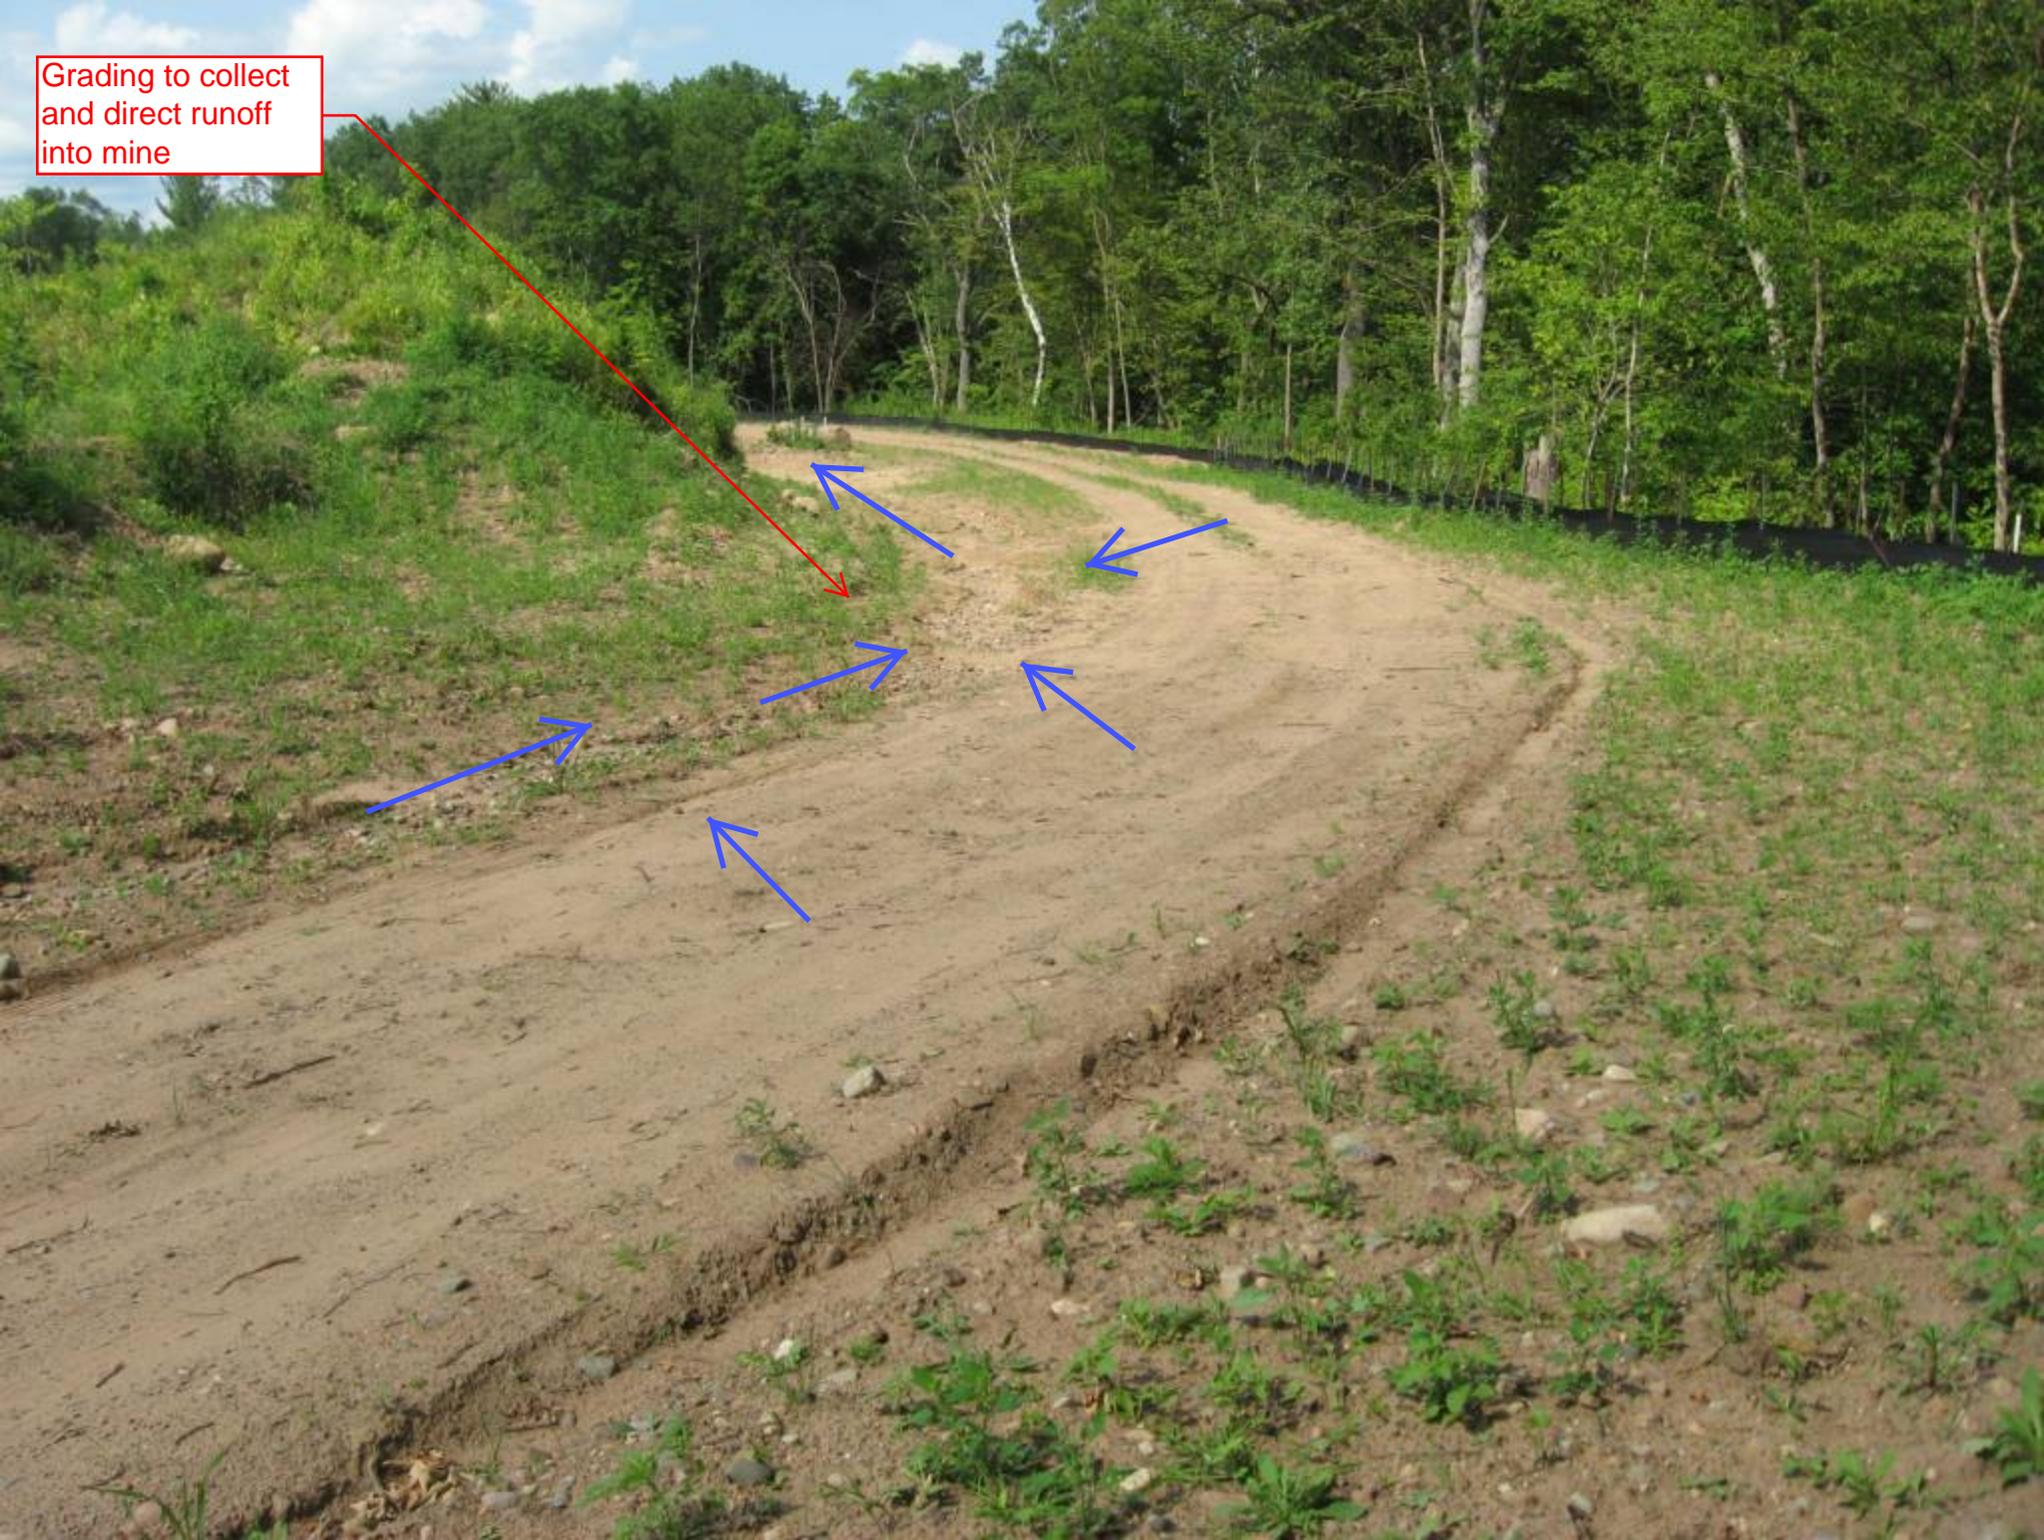
Grading to collect and direct runoff into mine
