## MEMORANDUM

**FROM:** Jed Chesnut, Wetland/Natural Resource Specialist

**RE:** **Zavoral Mining and Reclamation Project – Monitoring and Inspection Report  
2014 Inspection #3 – July 28, 2014**

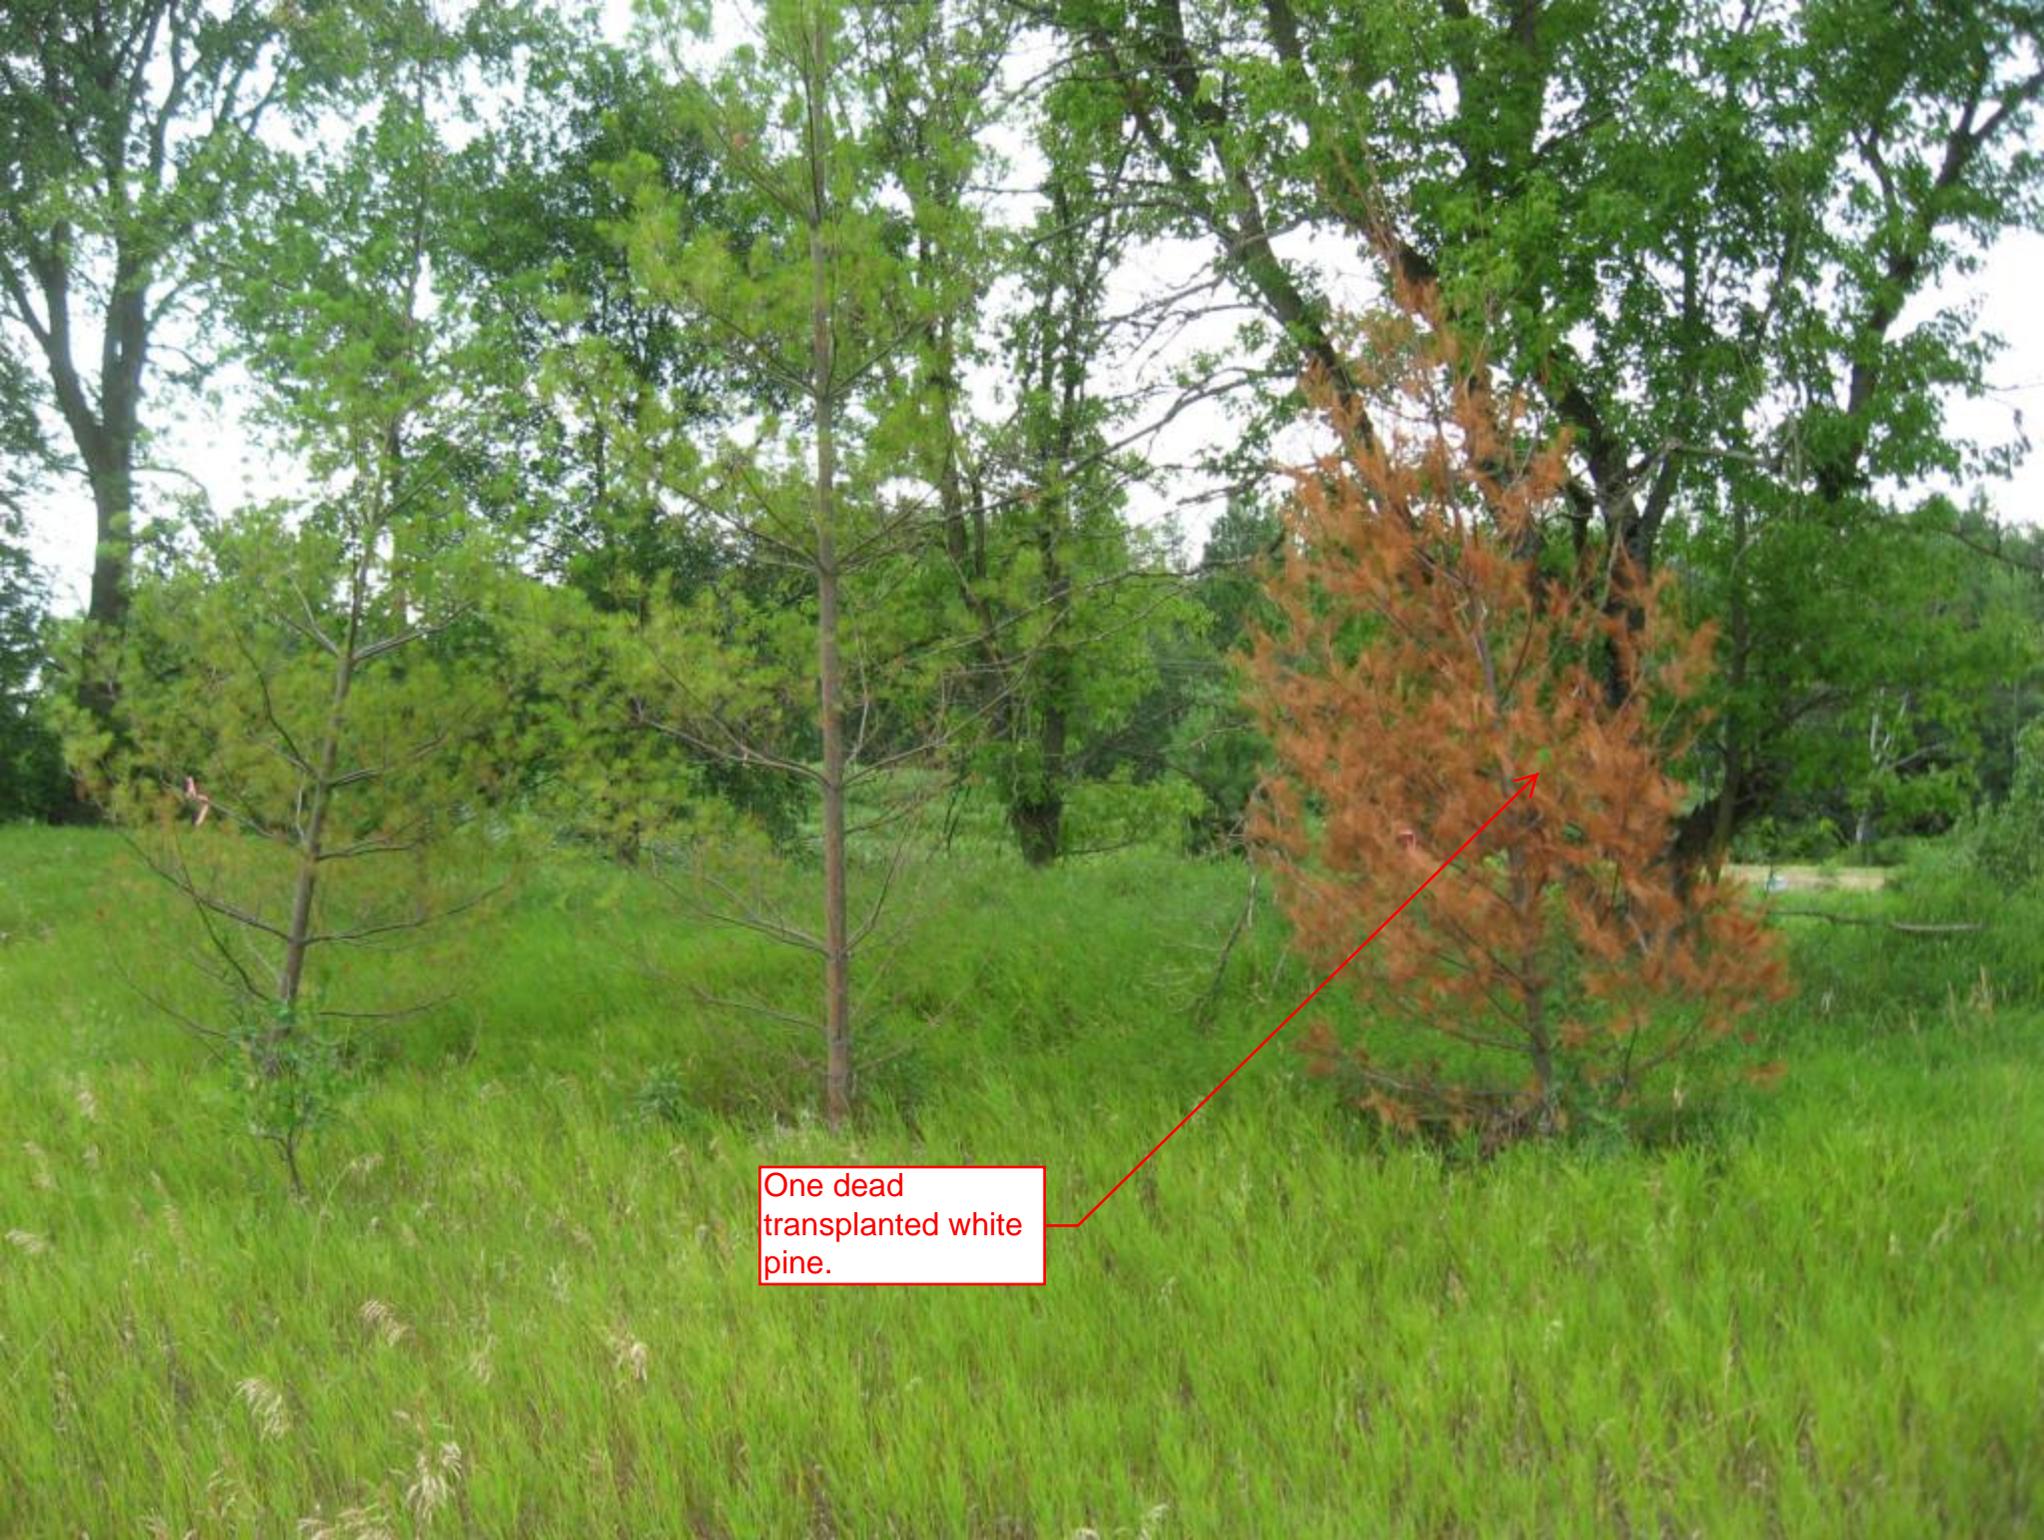
- ii. One of the 25 transplanted white pines appeared dead during the July site inspection suggesting that it was not successfully transplanted. The trees will continue to be monitored.

One dead  
transplanted white  
pine.
