MEMORANDUM

RE: **Zavoral Mining and Reclamation Project – Monitoring and Inspection Report
2014 Inspection #2 – June 5, 2014**

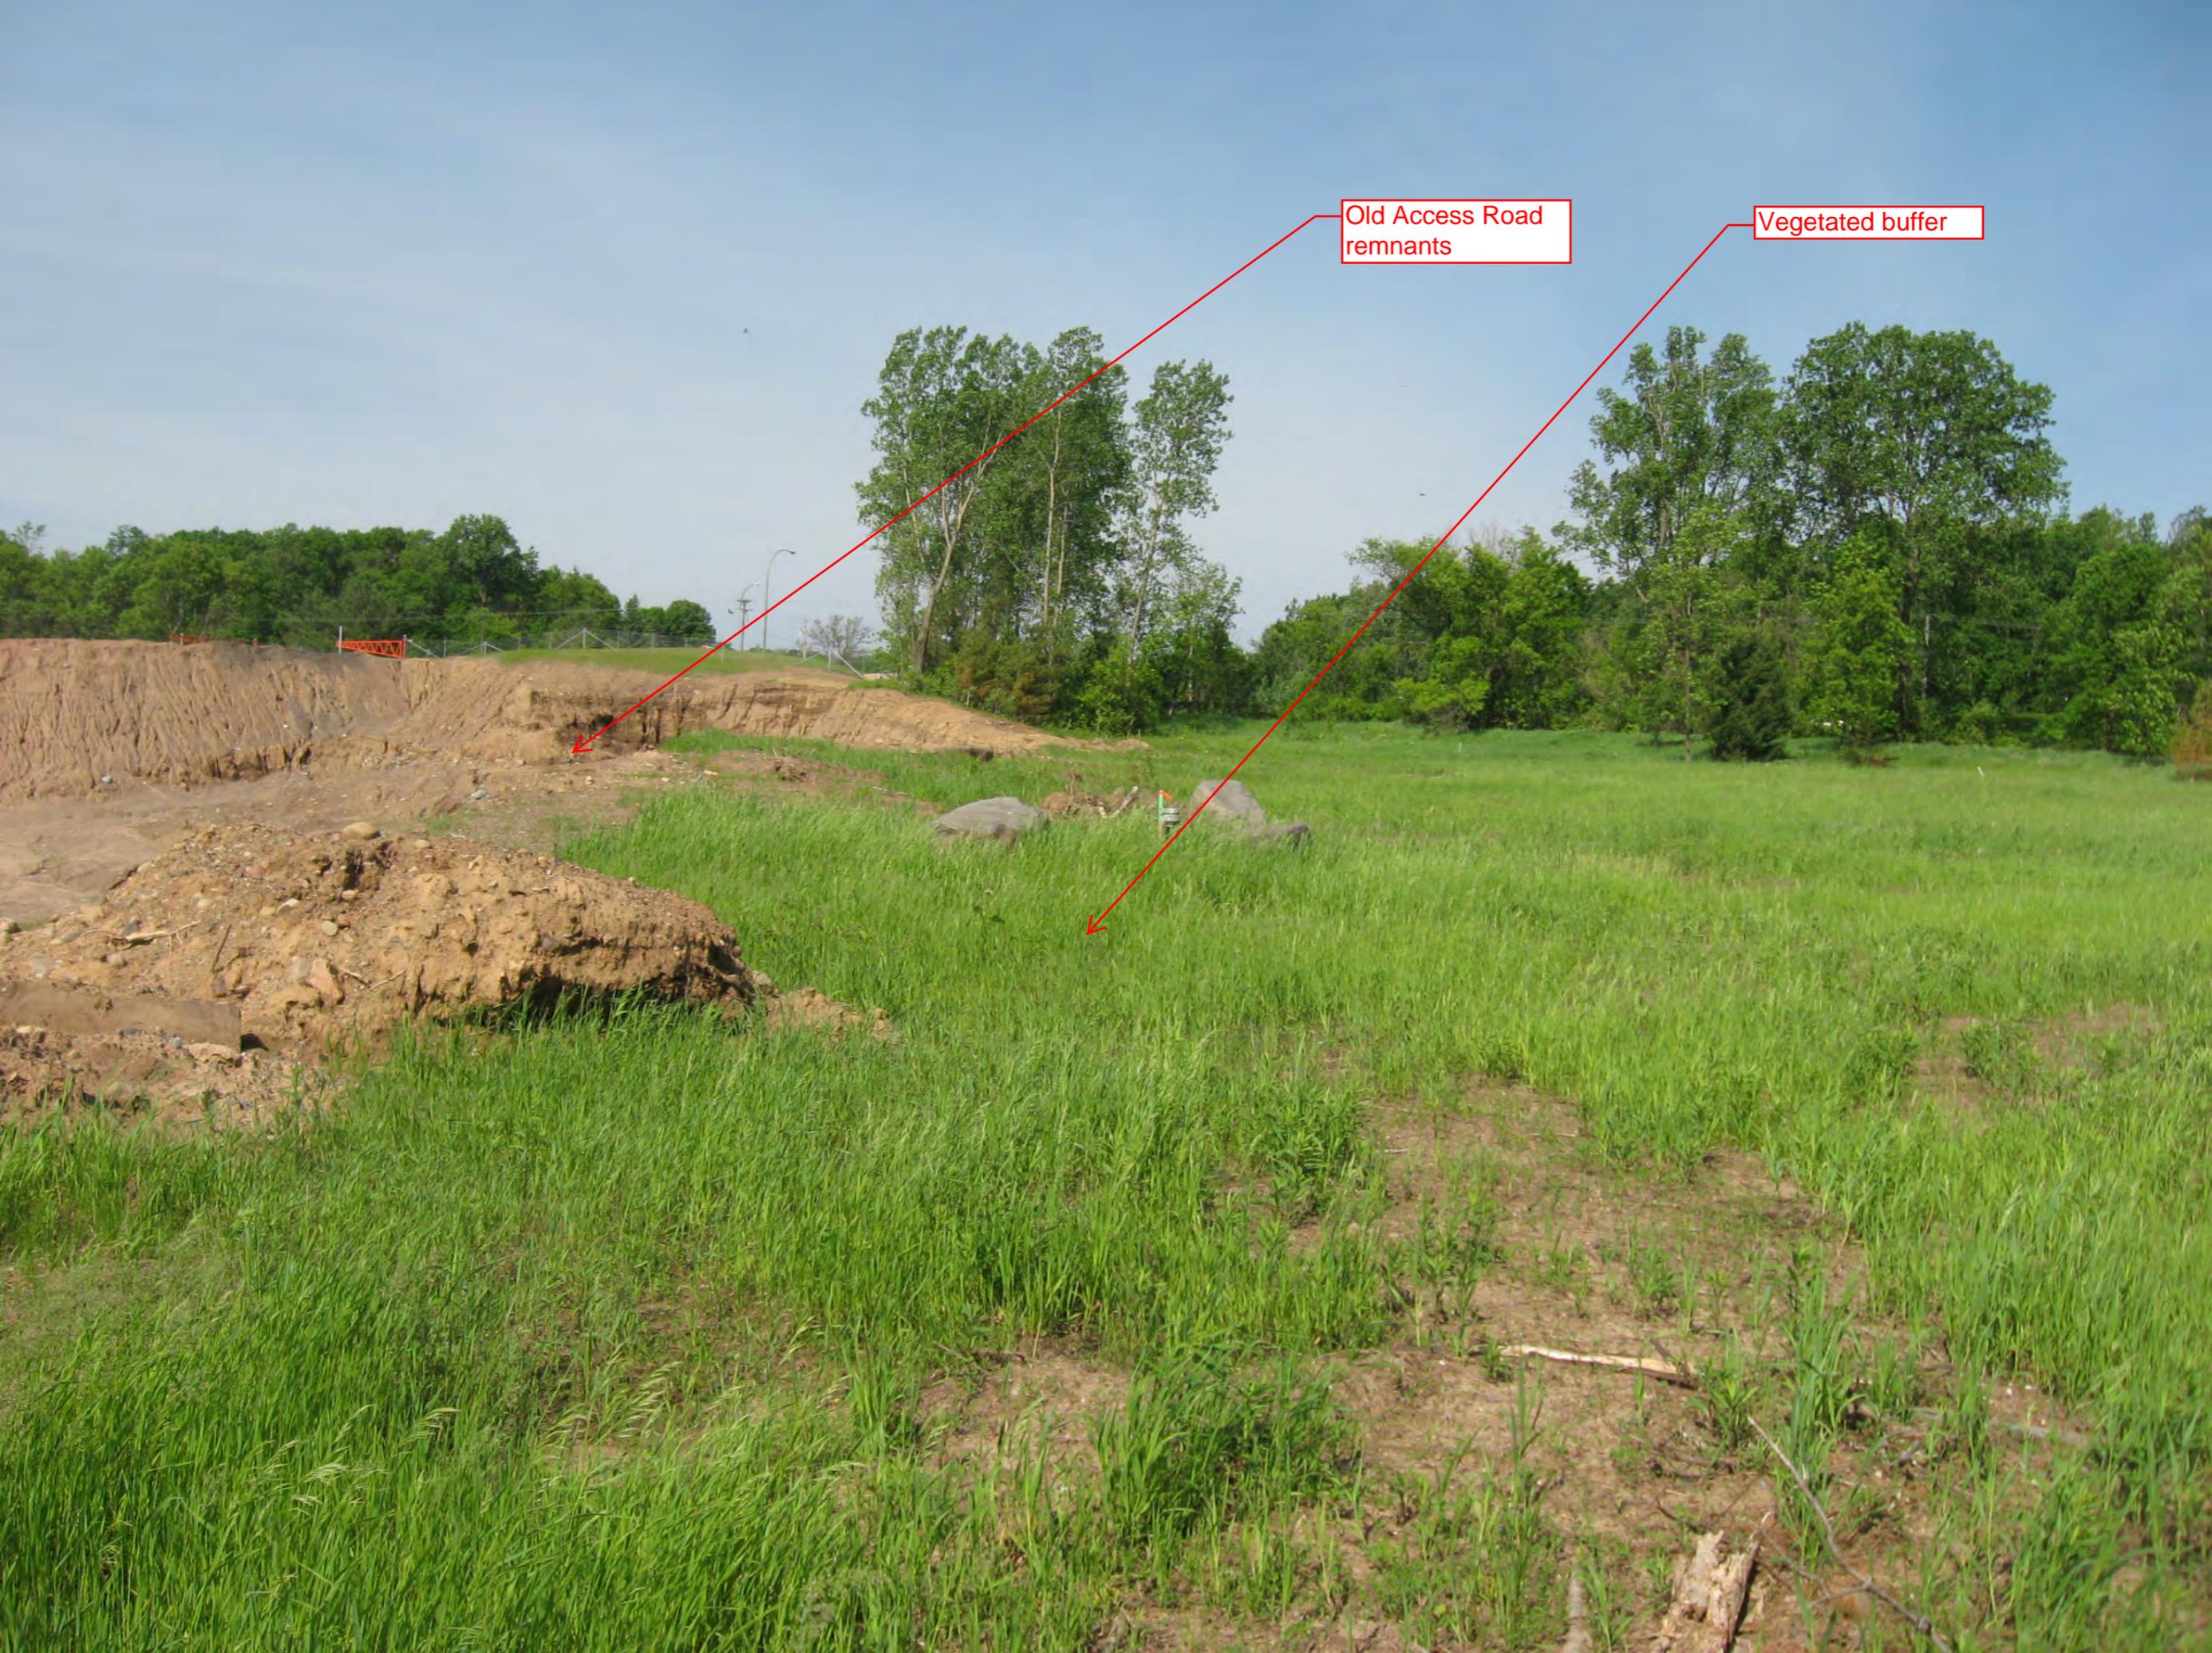
- iii. There was still no major land disturbing activities in the northern portion of the project area, just north of where the old access road was.
 - iv. The old access road was mostly removed; however there was still a small area of disturbed land that sloped toward the buffered area. But, since there was still a very large vegetated buffer between the land disturbing activity and the project boundary, the installation of silt fence was still deemed unnecessary (see attached photo). This was noted in the April report and is still valid.

- vi. The disturbed land near the old access road does drain along the edge of the mining area and back into the mine area. There was some erosion here, but it is inconsequential since it drains internally.

Old Access Road remnants

Vegetated buffer

Surface runoff directed down into mining area, not offsite.

Early growth of newly seeded prairie

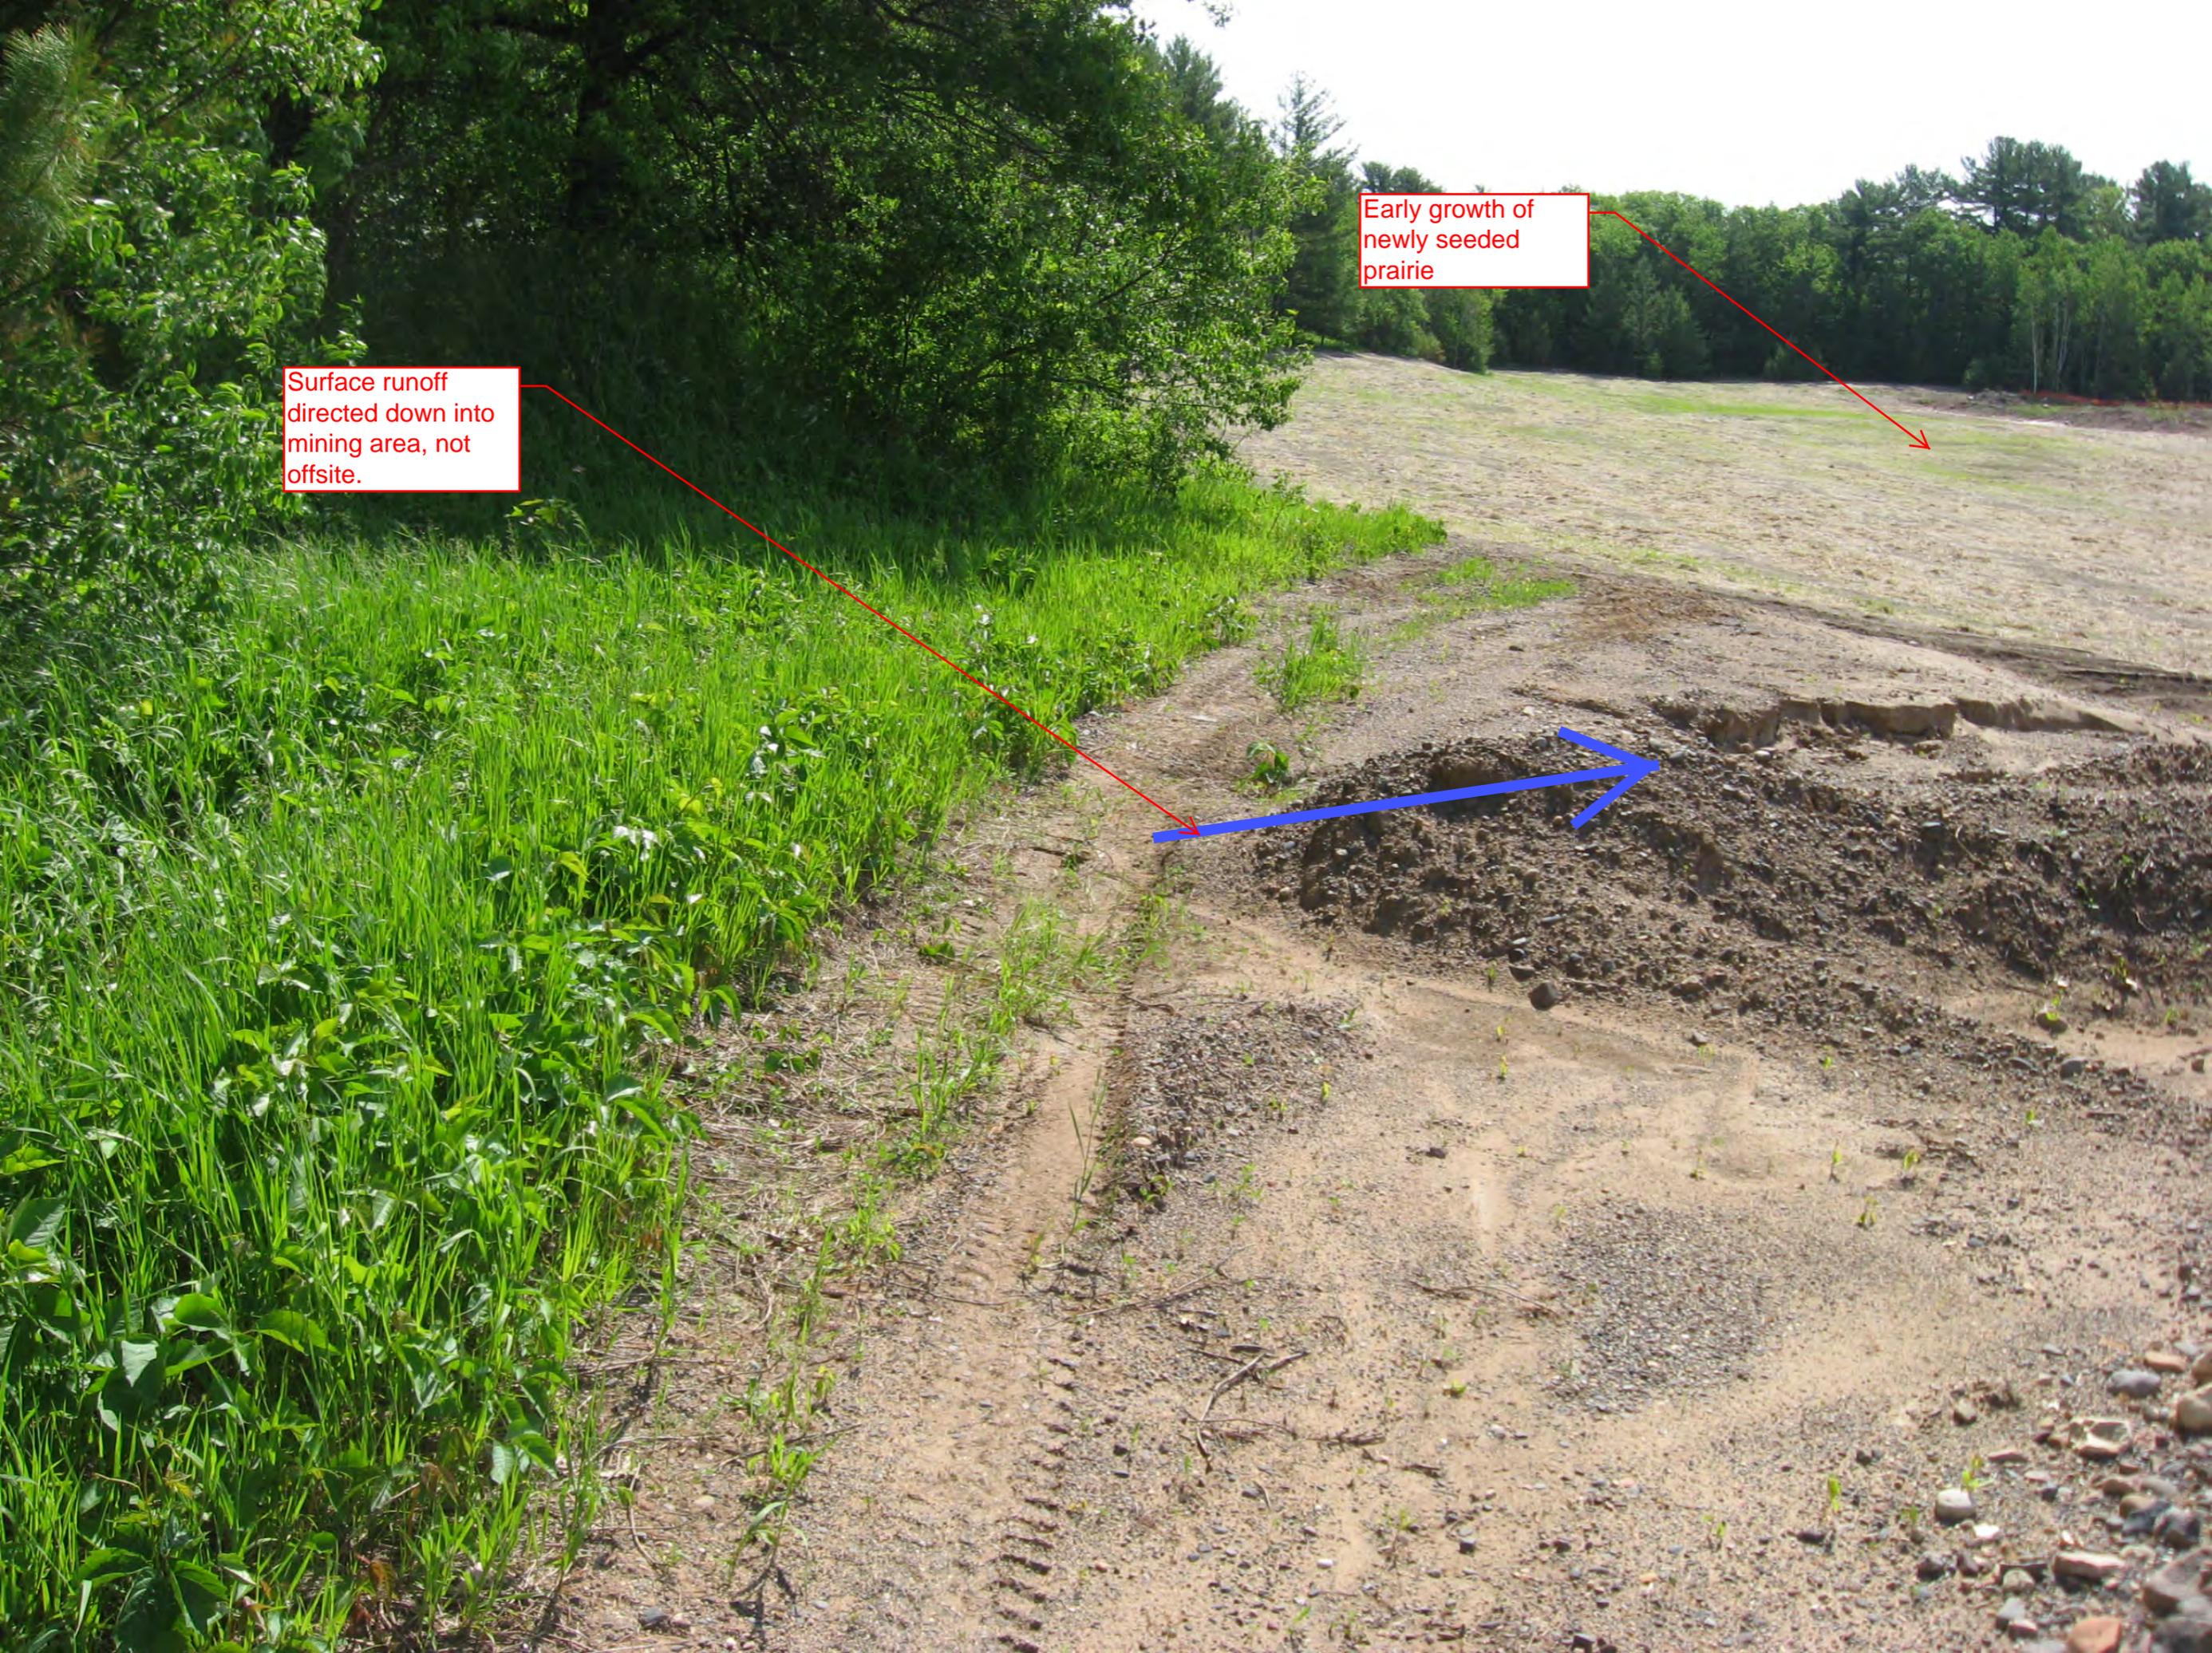
- ii. Silt fence that had been installed in 2013 as per the stormwater pollution and prevention plan (SWPPP) was in good shape. During the April inspection a couple of areas with slightly damaged silt fence were noted. This damage has been sufficiently repaired. The silt fence throughout the project area is still effective for perimeter control.

Silt fence is in good condition

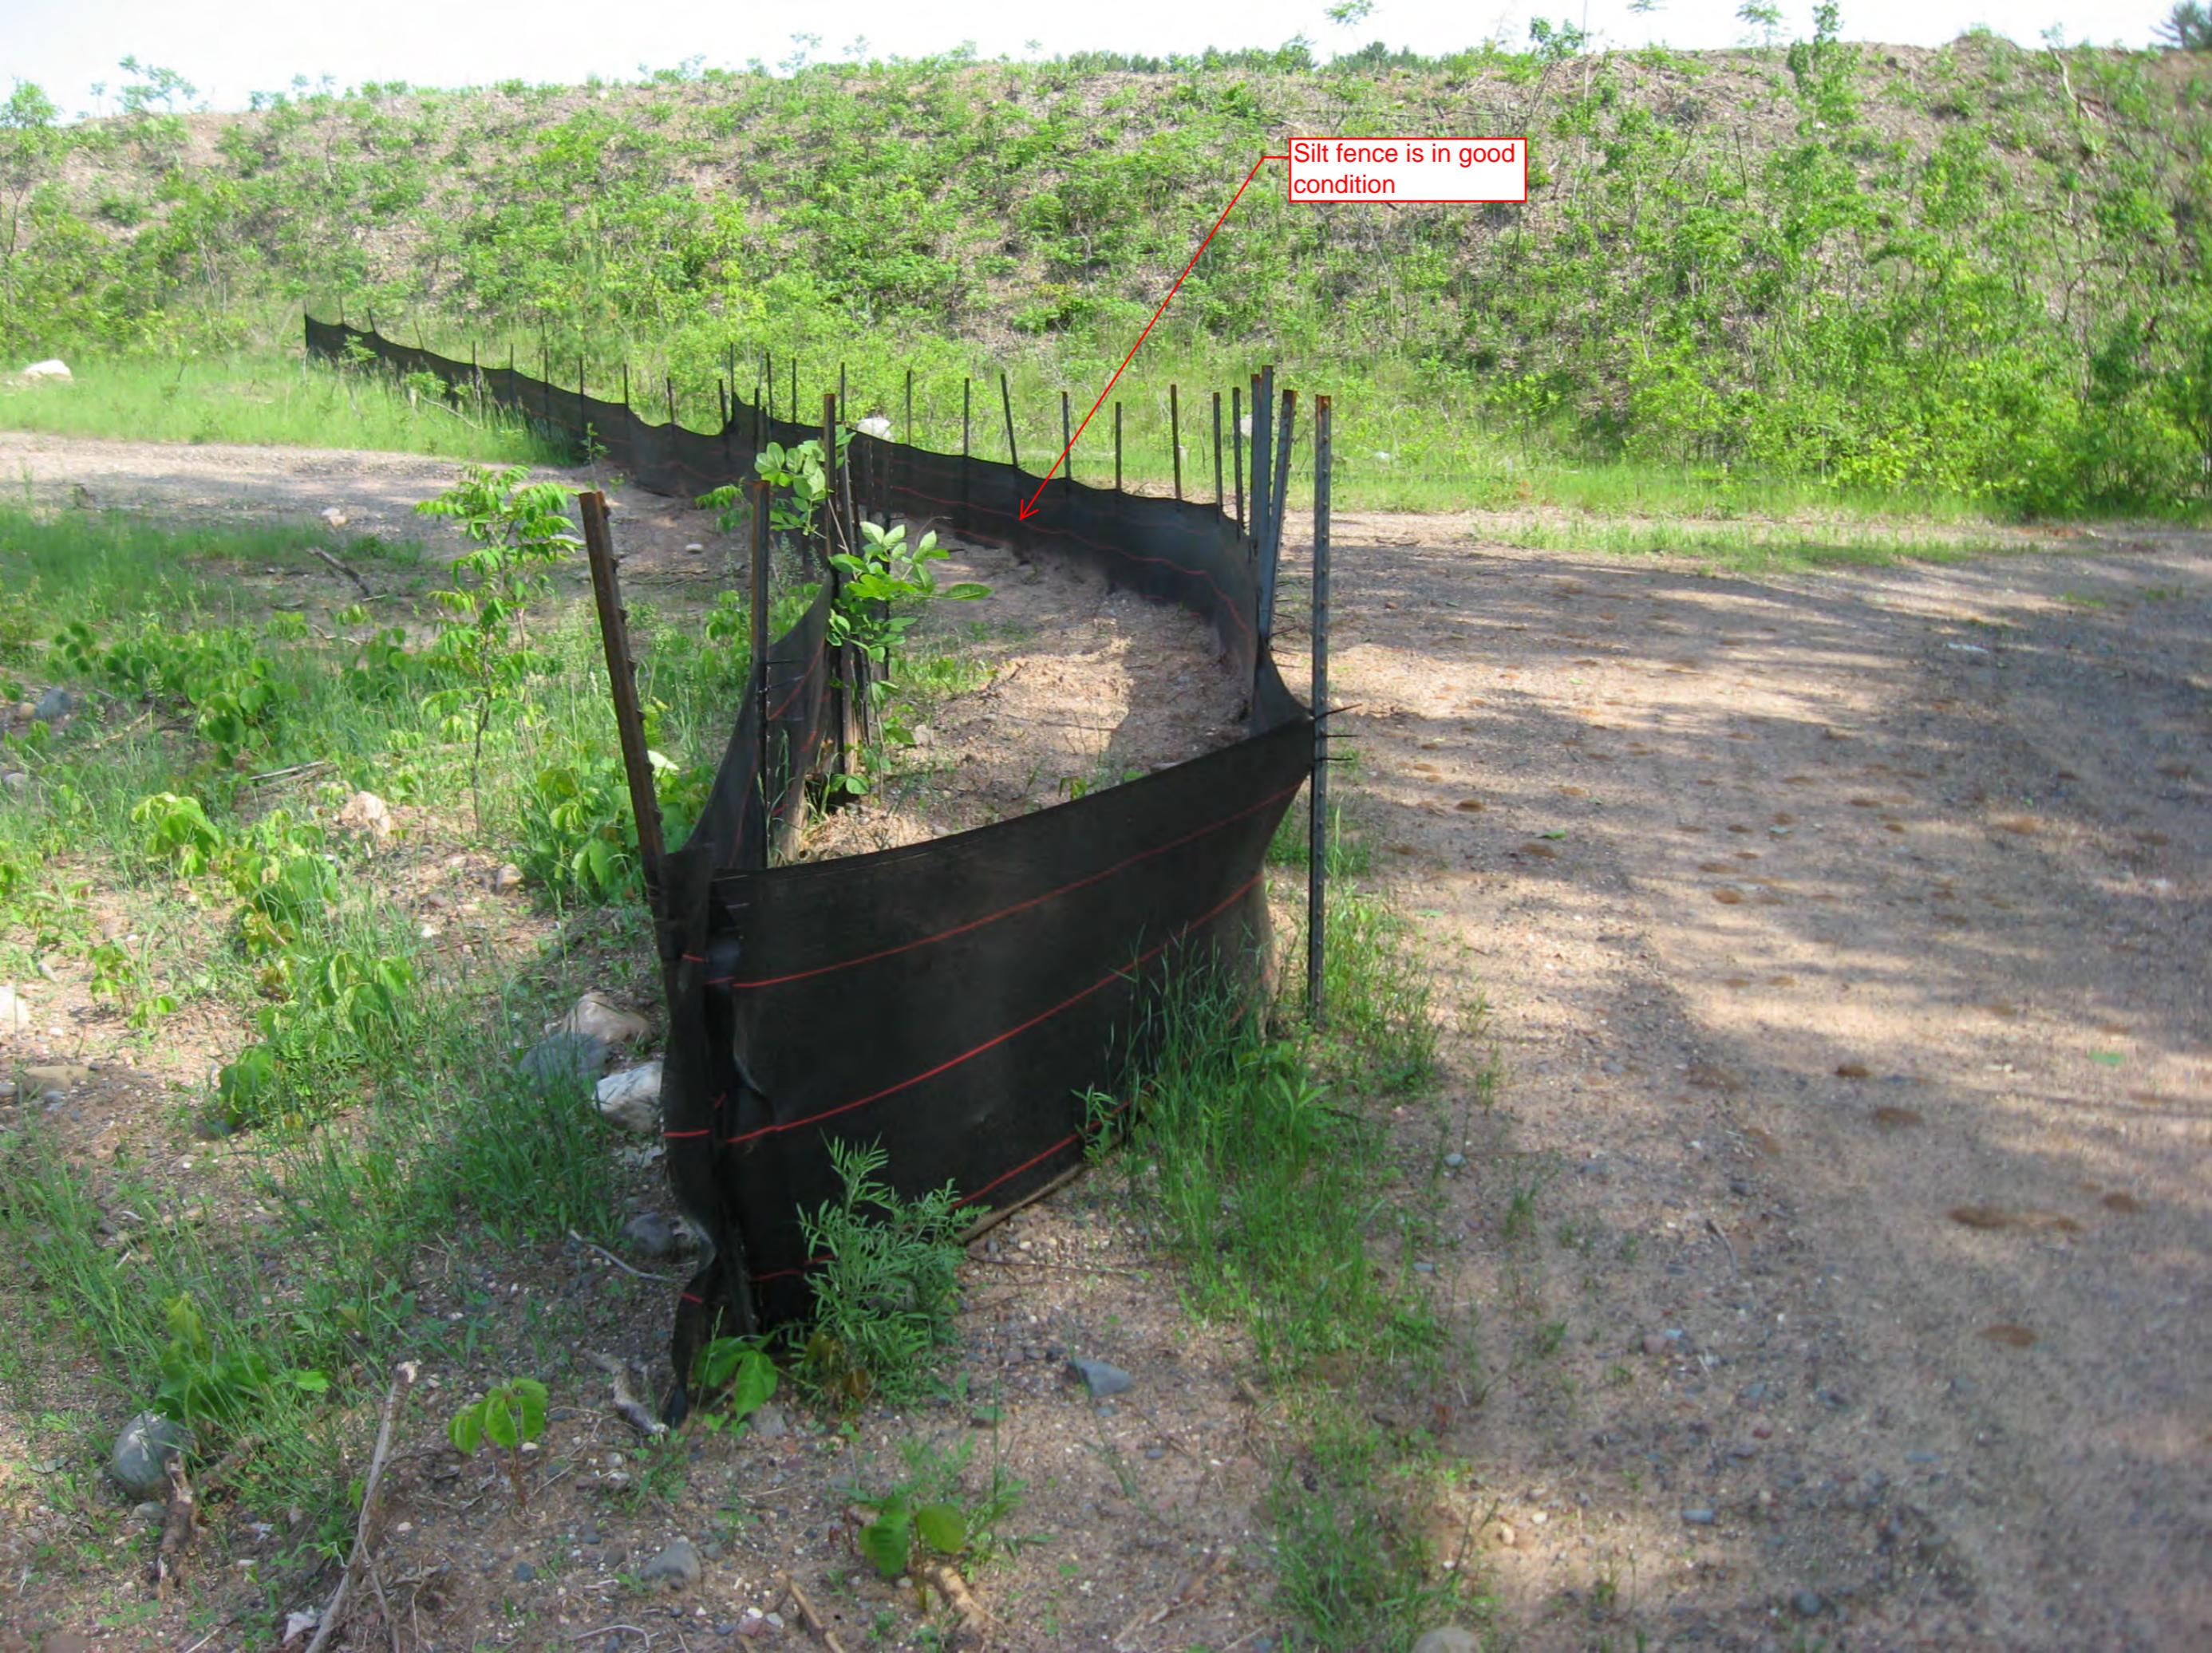
- vii. There was an area along the southern project limits where a gap in perimeter control was identified in 2013. Tiller had installed bio-rolls as sediment control with the intention of installing silt fence as soon as ground conditions would allow. This silt fence has since been installed.

Biologs and silt fence in place for perimeter control. Both in functional condition

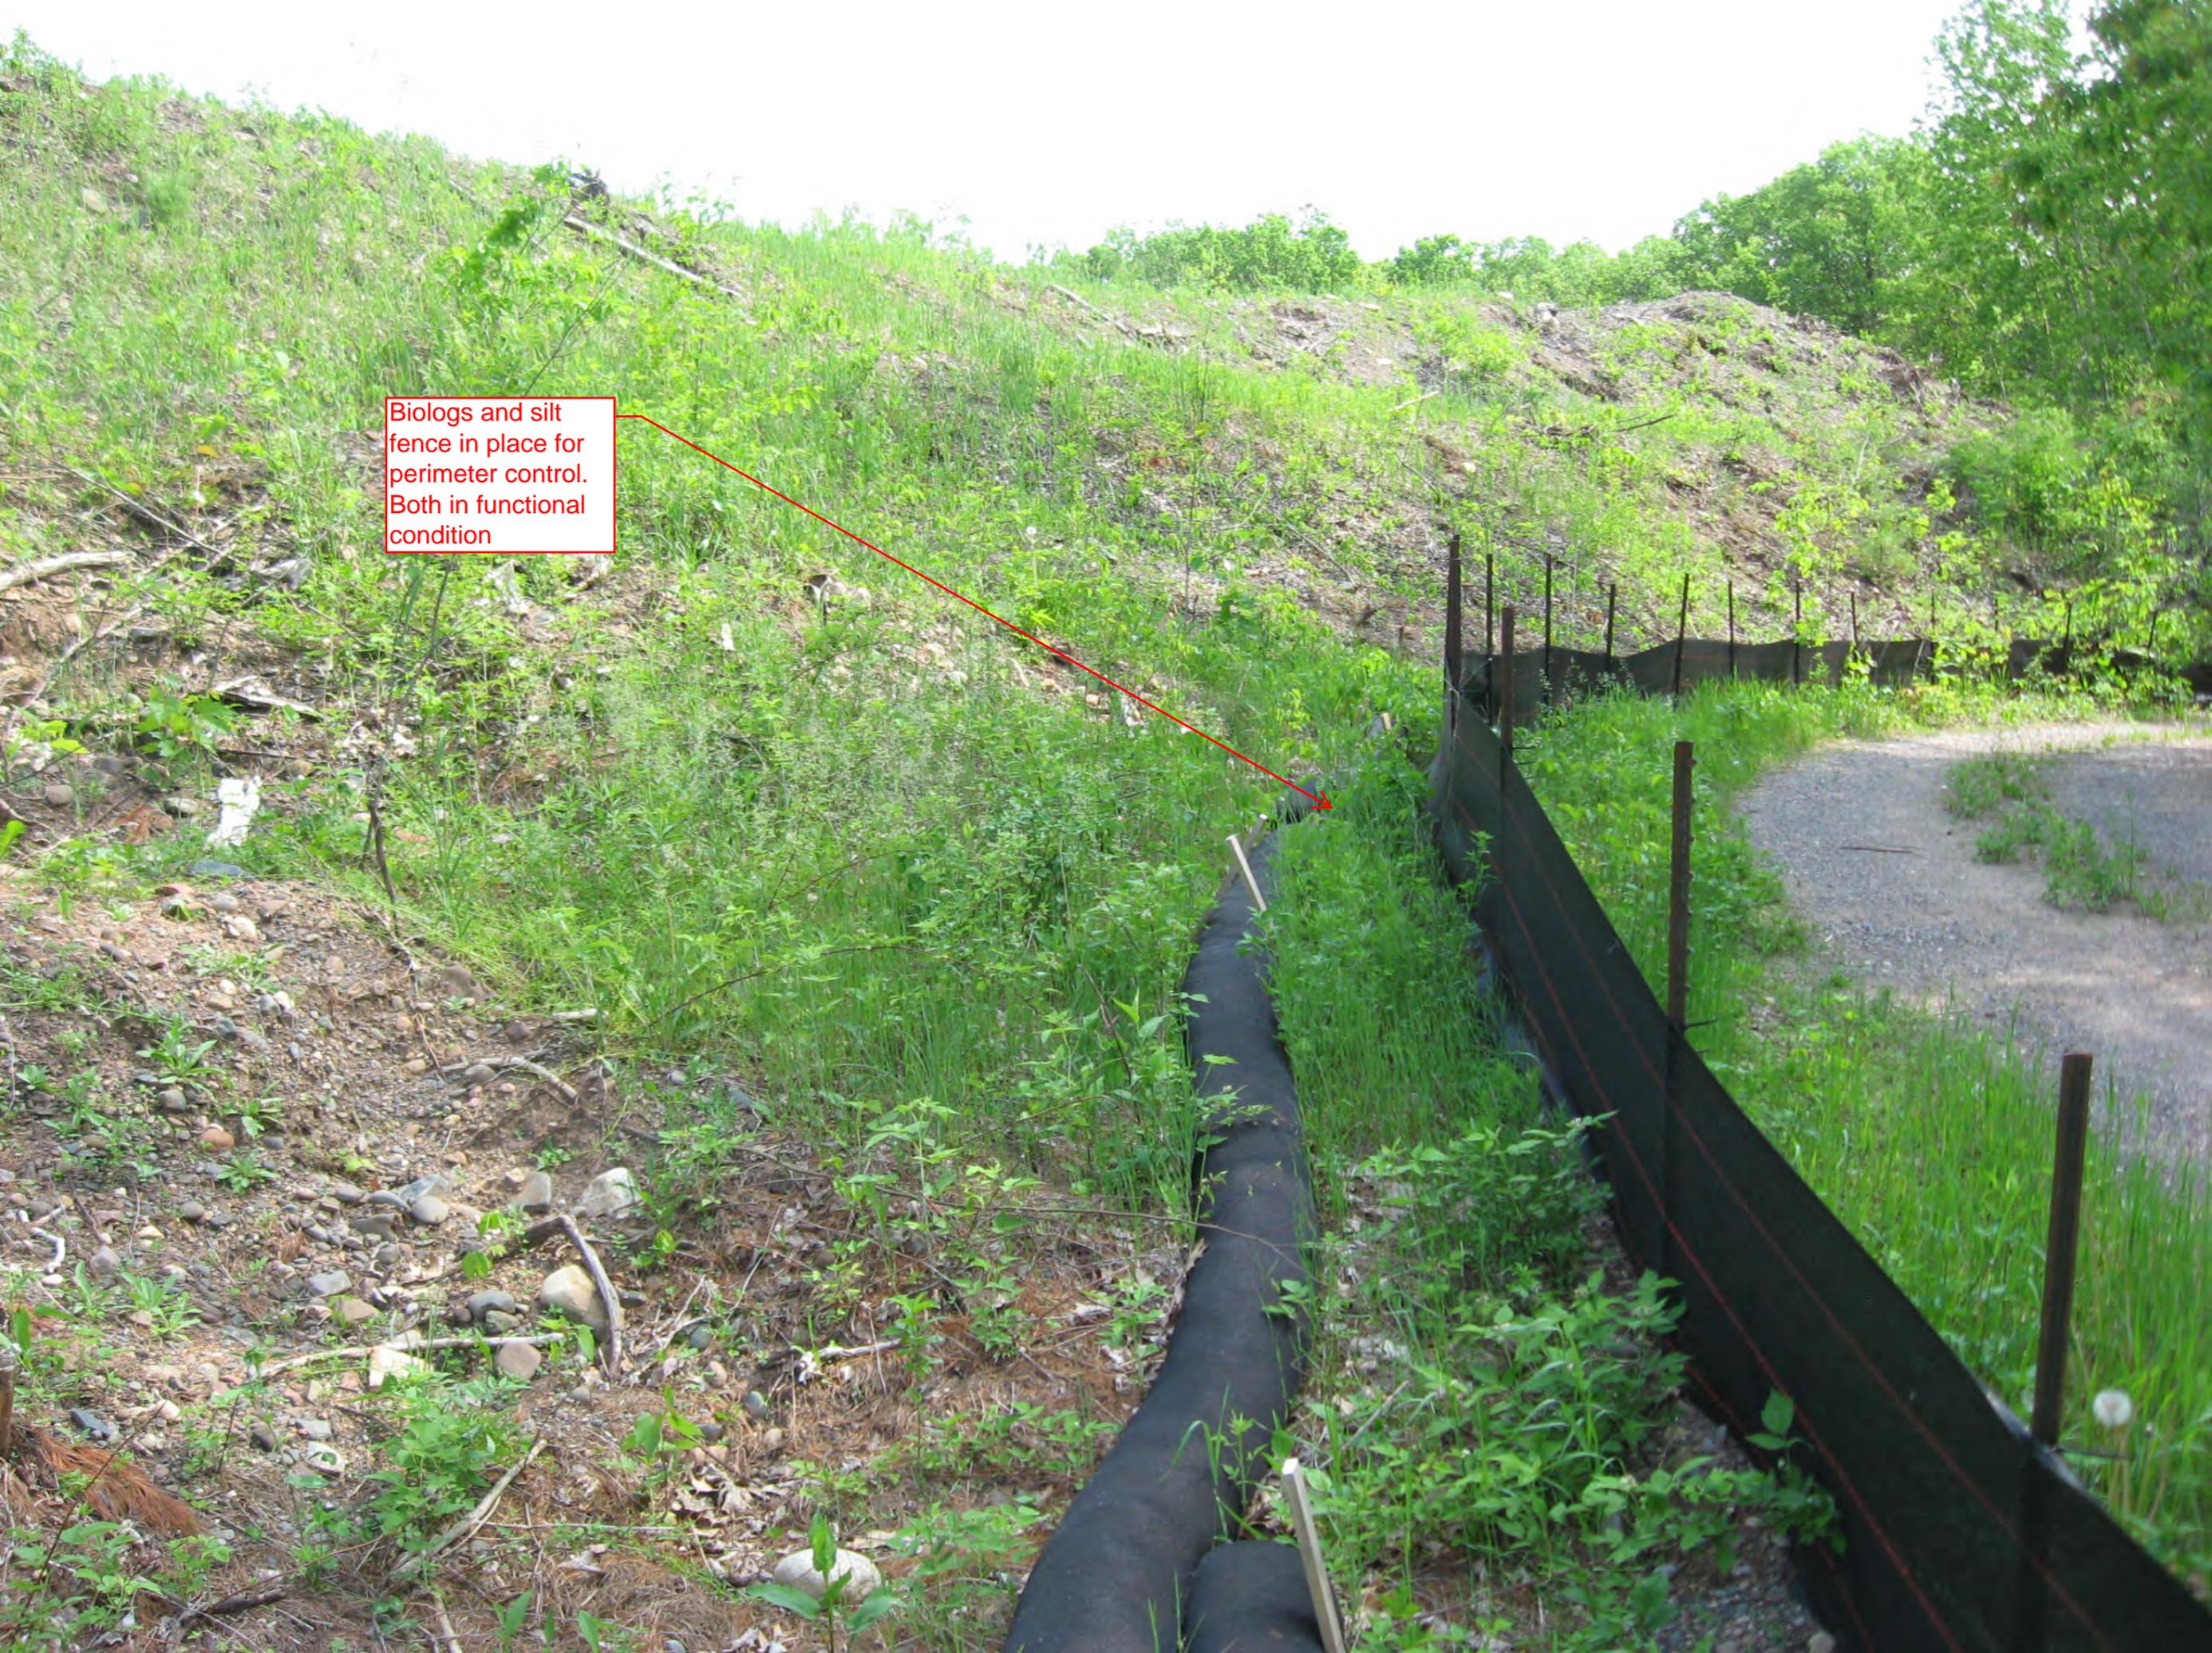
- viii. Another layer of redundant silt fence has also been installed along the owner's access road on the southern edge of the mining area. Since there is a gradual slope parallel to the silt fence in this area, there was some undercutting of the fence. Tiller plans to regrade the road so that it slopes inward to the mine and therefore runoff will be directed internally.

Extra layer of silt fence has been installed.

Tiller stated they are considering regrading owner's access driveway so that it tilts towards the mine and therefore redirecting runoff into the mine area.

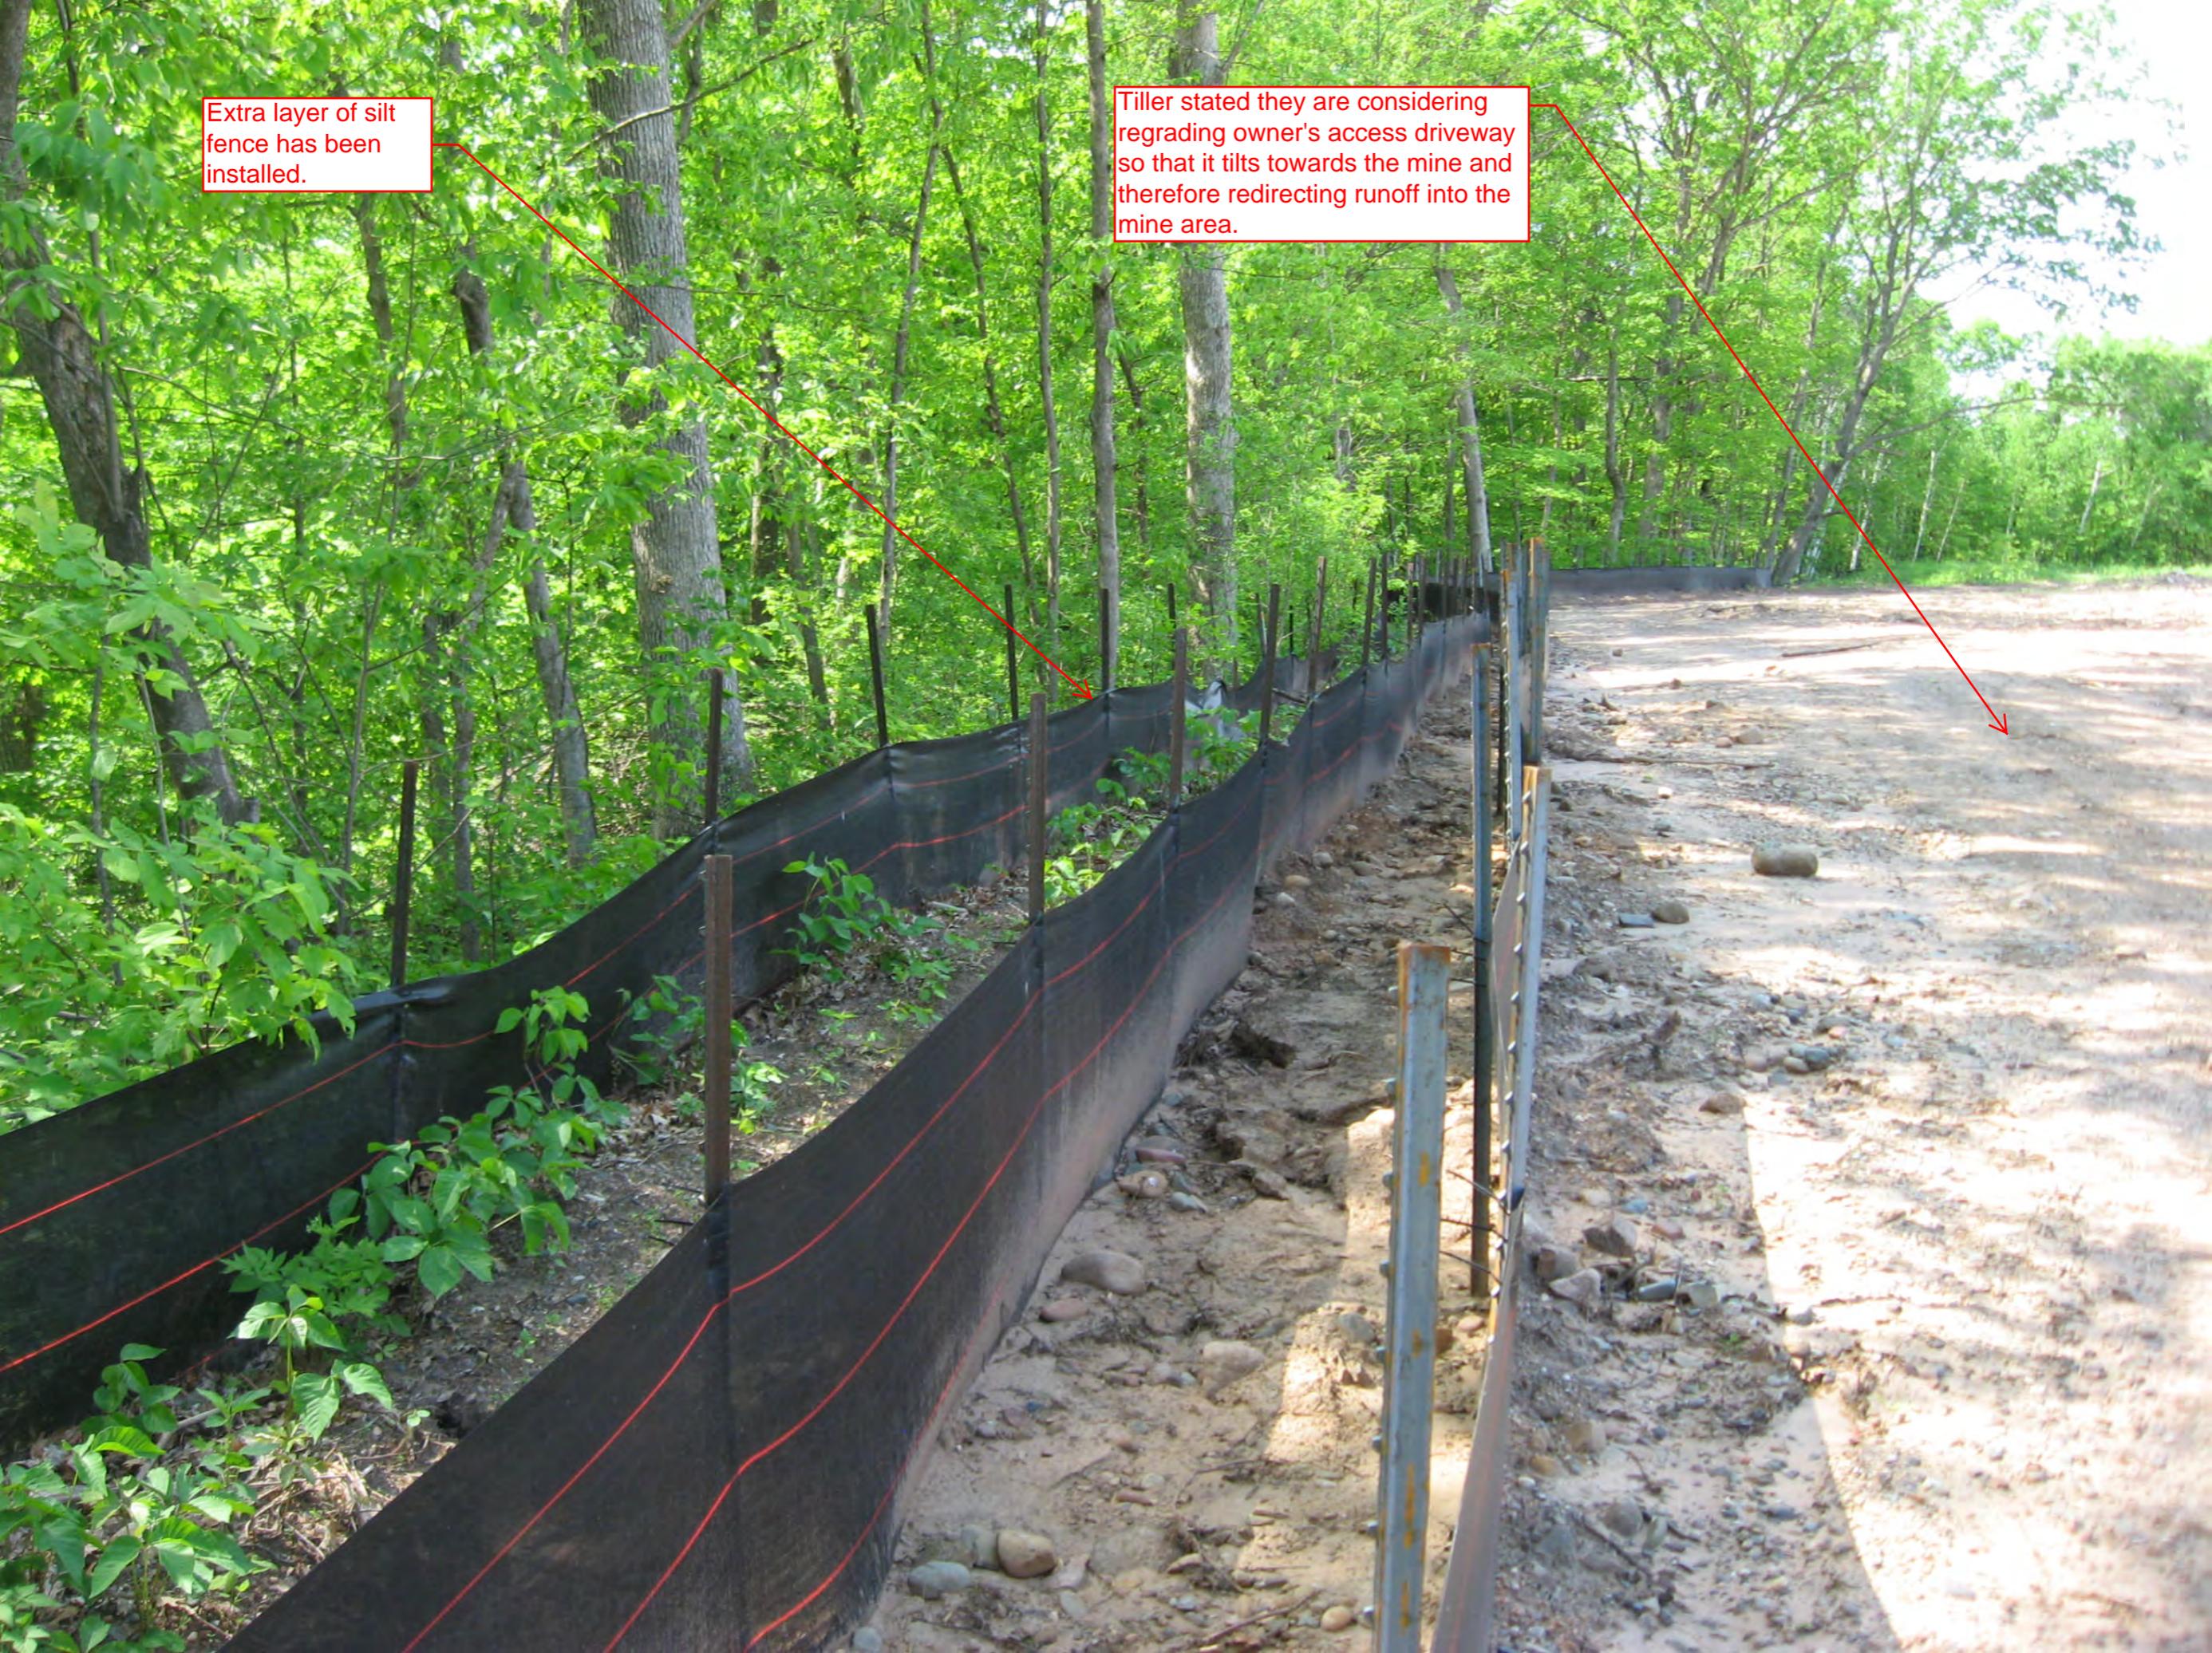
New silt fence that
was installed this
spring
