MEMORANDUM

RE: **Zavoral Mining and Reclamation Project – Monitoring and Inspection Report
2015 Inspection #1 – April 27, 2016**

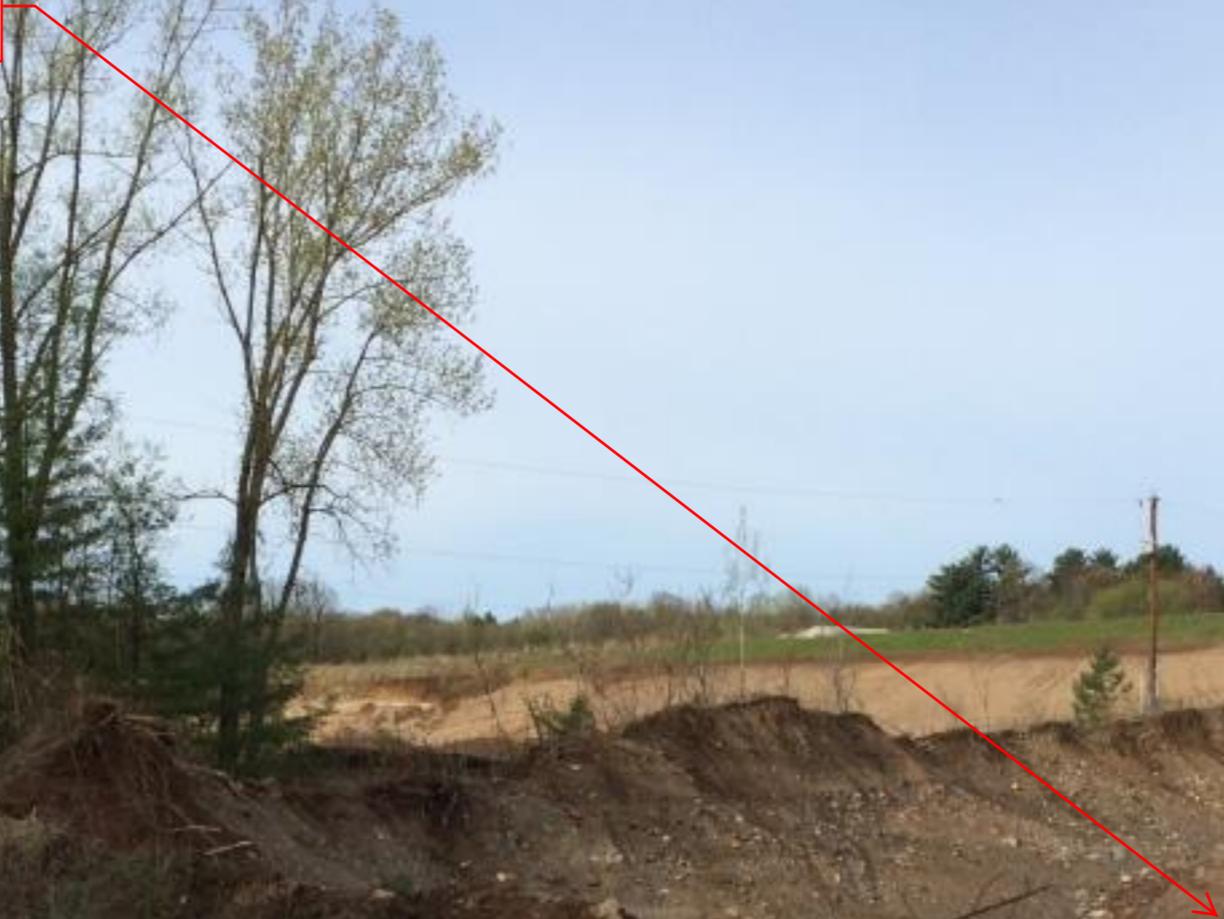
Phase 3 mining
area

- iii. Much of the Phase III mining area had been excavated over the winter. The eastern project limits north of the driveway to the owner’s cabin were inspected. The silt fence in this area was still fully functional and there was no disturbance of the vegetated buffer outside of the fenced-in mining area (see photo).
