WASHINGTON
CONSERVATION
DISTRICT

MEMORANDUM

RE: **Zavoral Mining and Reclamation Project – Monitoring and Inspection Report
2014 Inspection #6 – December 9, 2014**

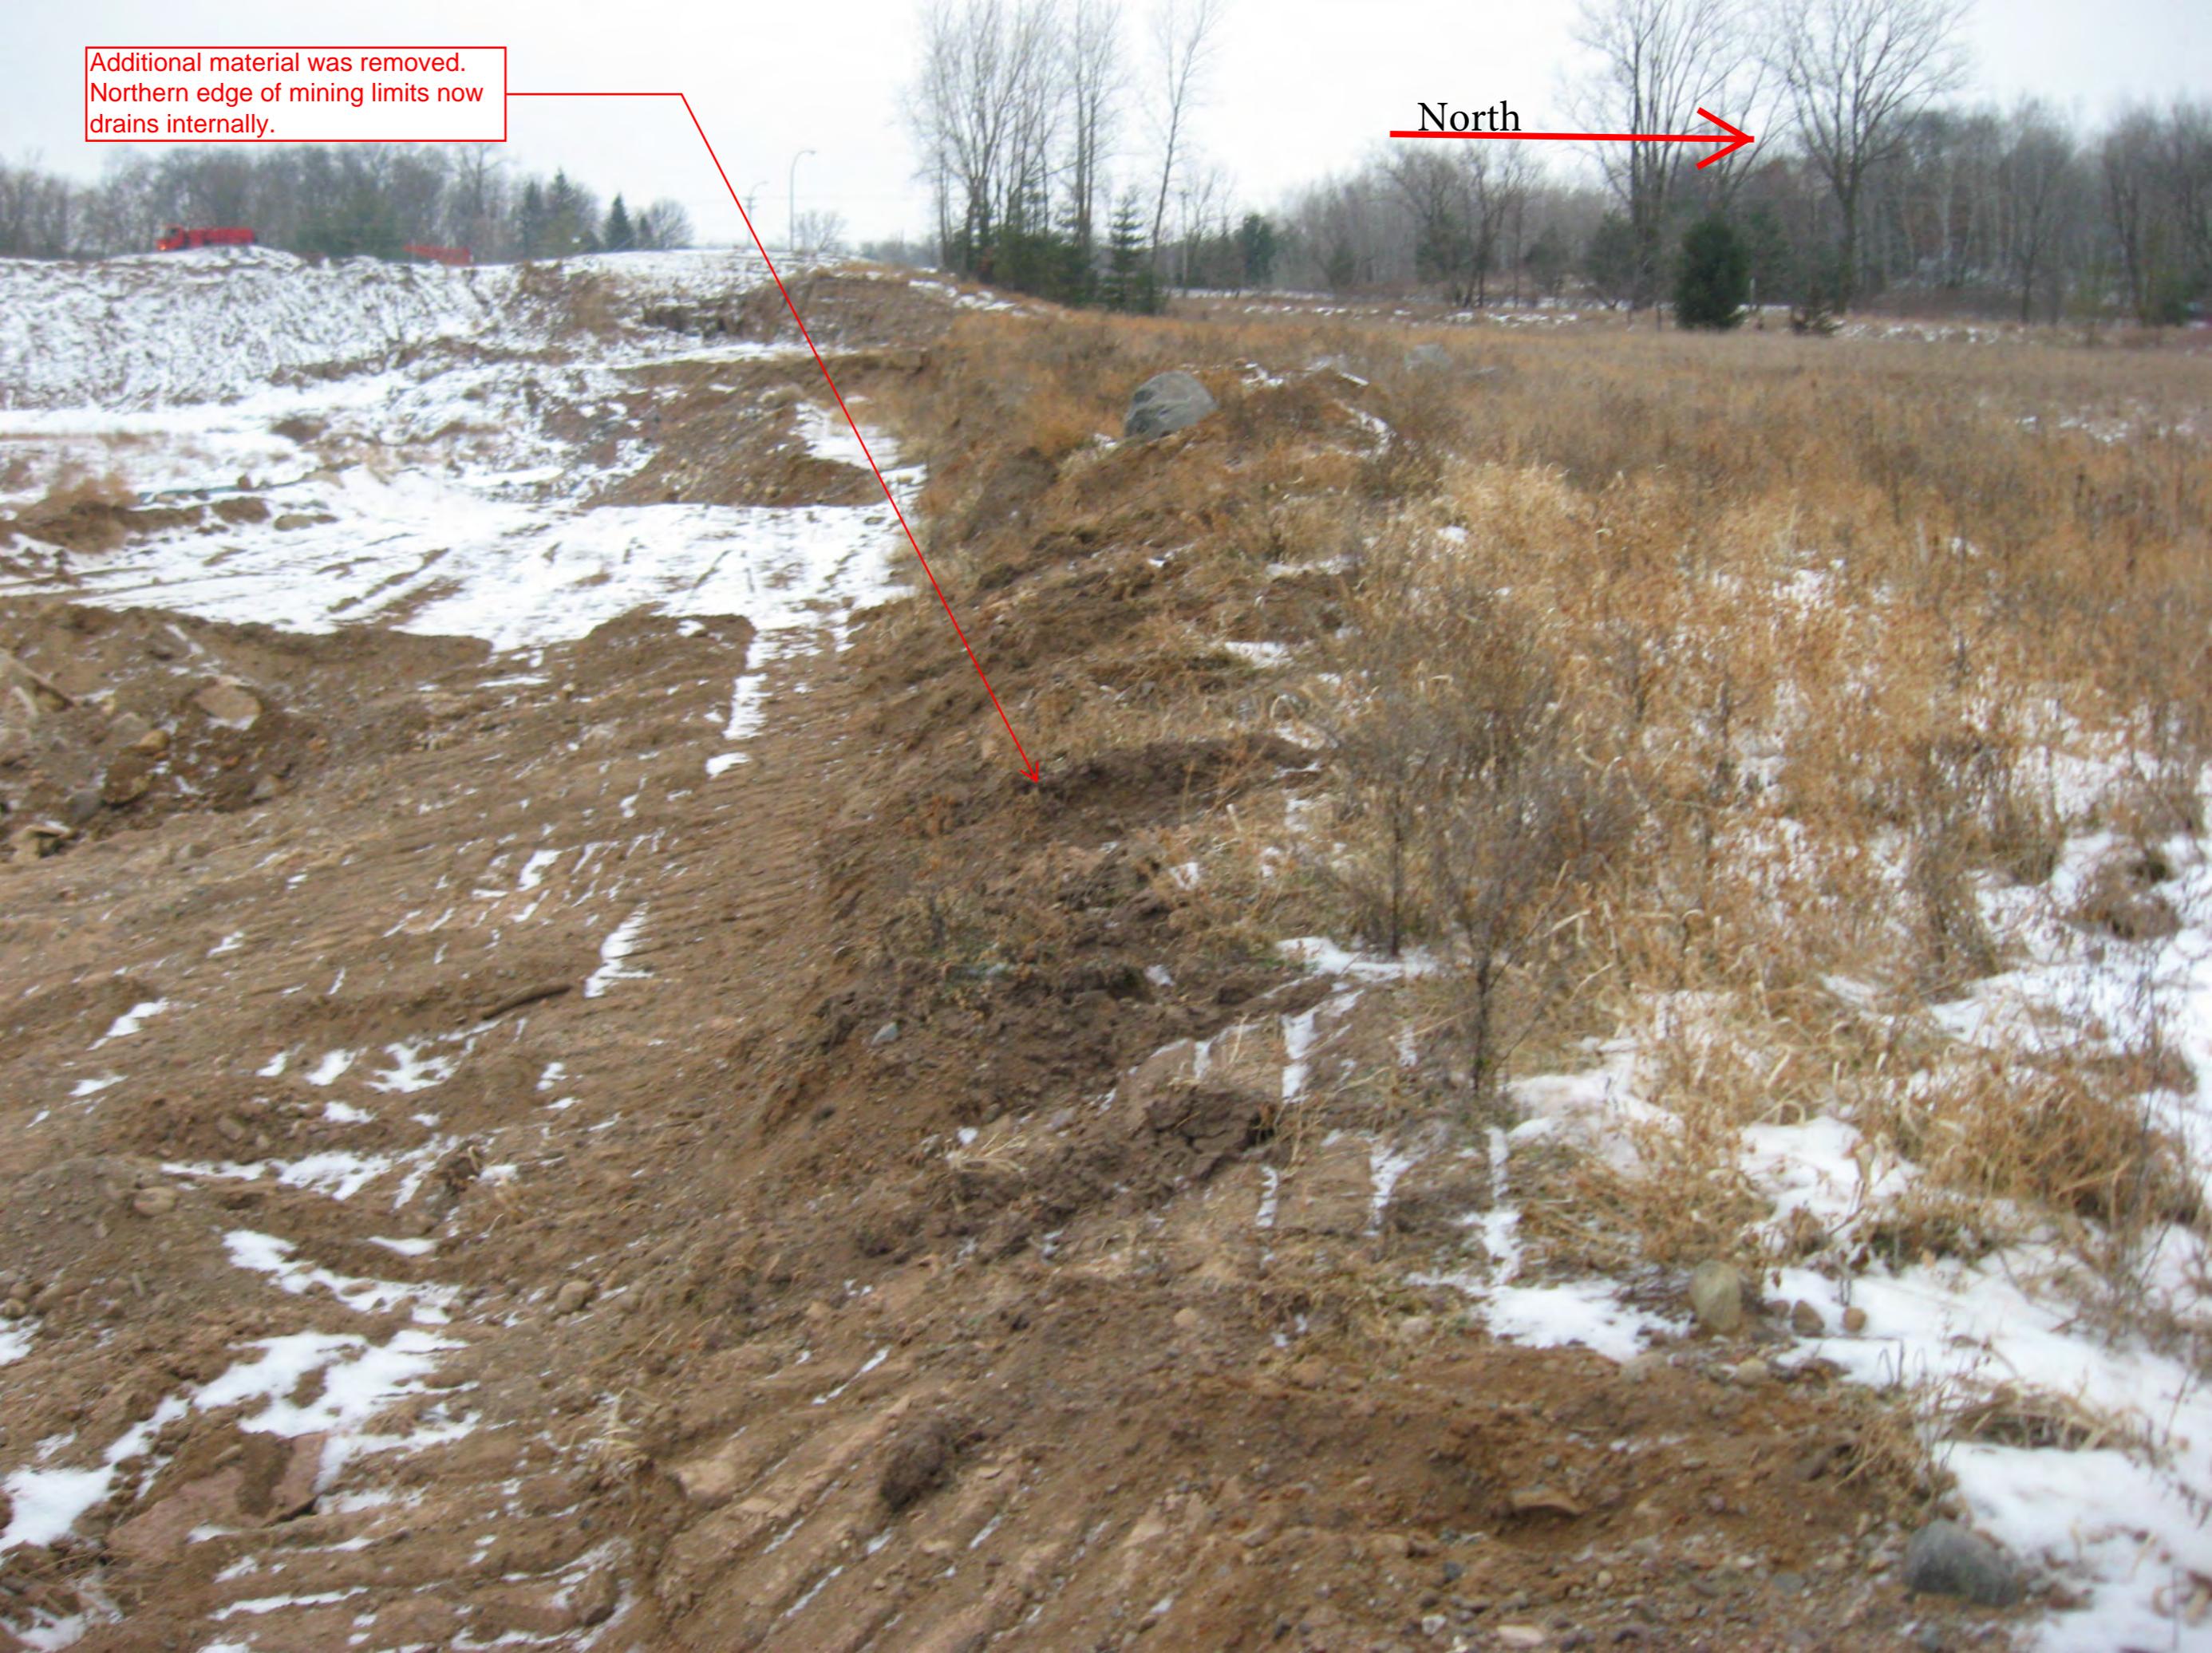
Additional material was removed.
Northern edge of mining limits now
drains internally.

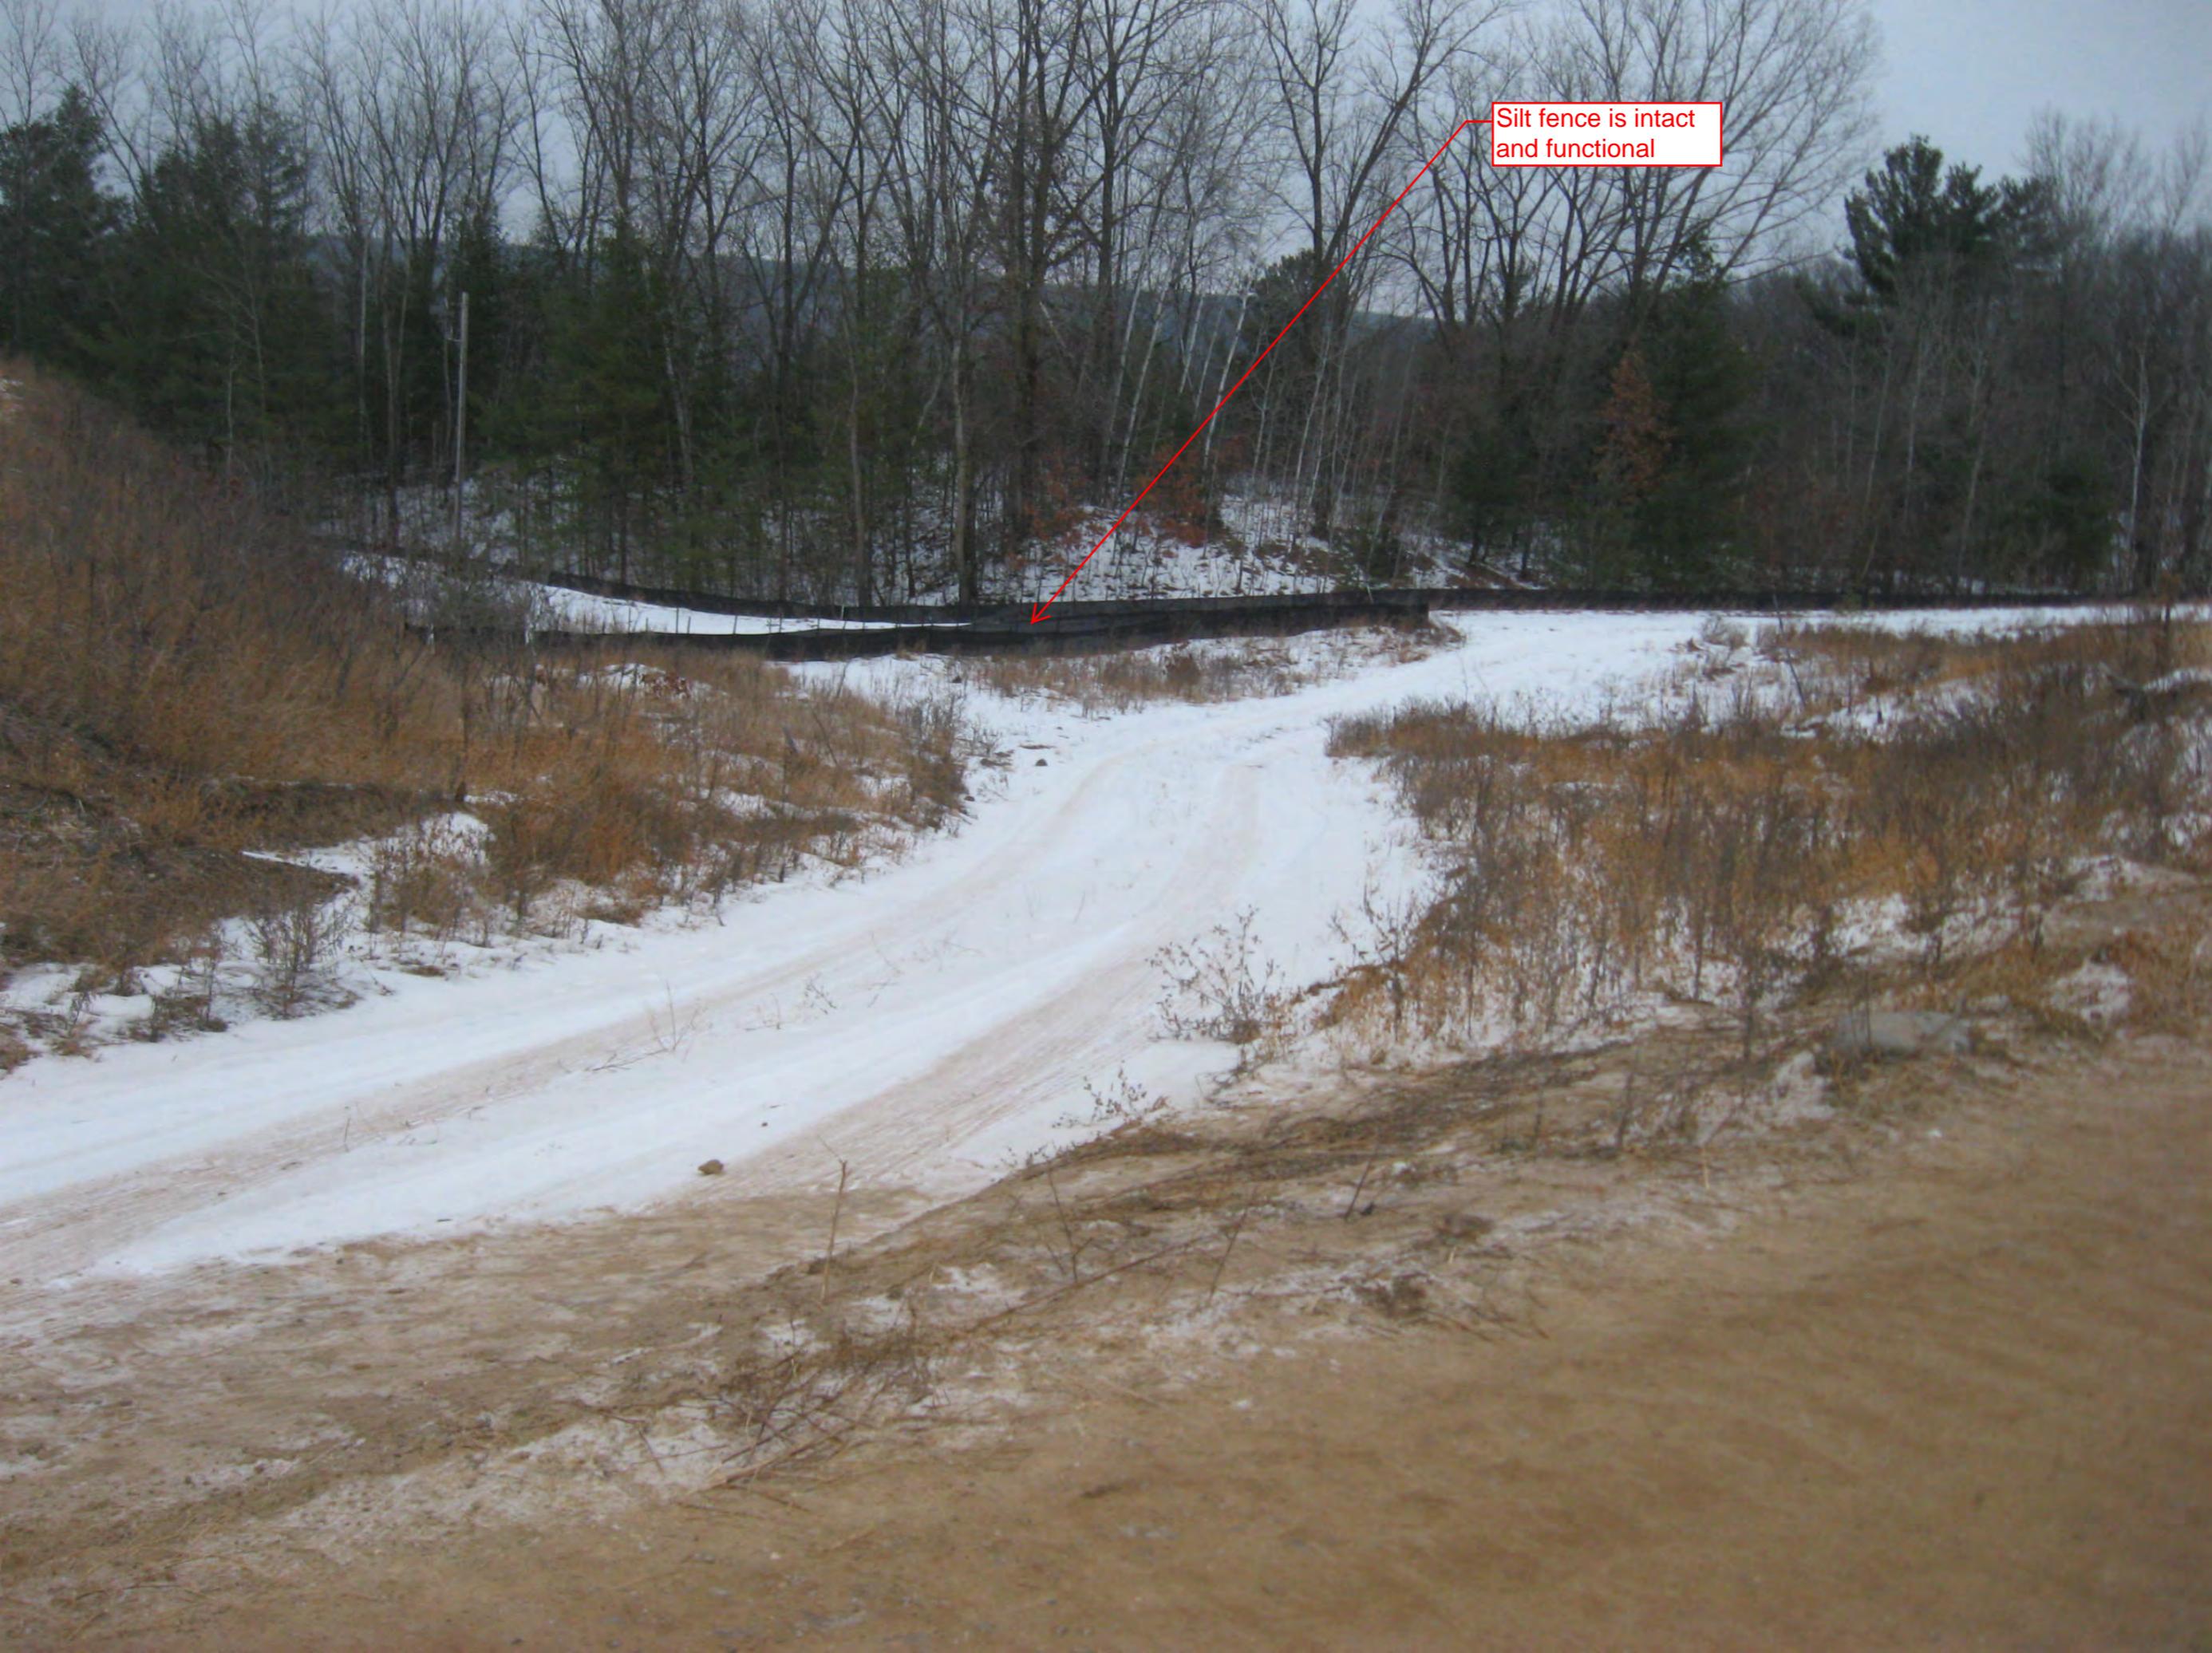
- ii. Silt fence that had been installed in 2013 as per the stormwater pollution and prevention plan (SWPPP) was in good shape. The silt fence throughout the project area was still effective for perimeter control.

Silt fence is intact and functional

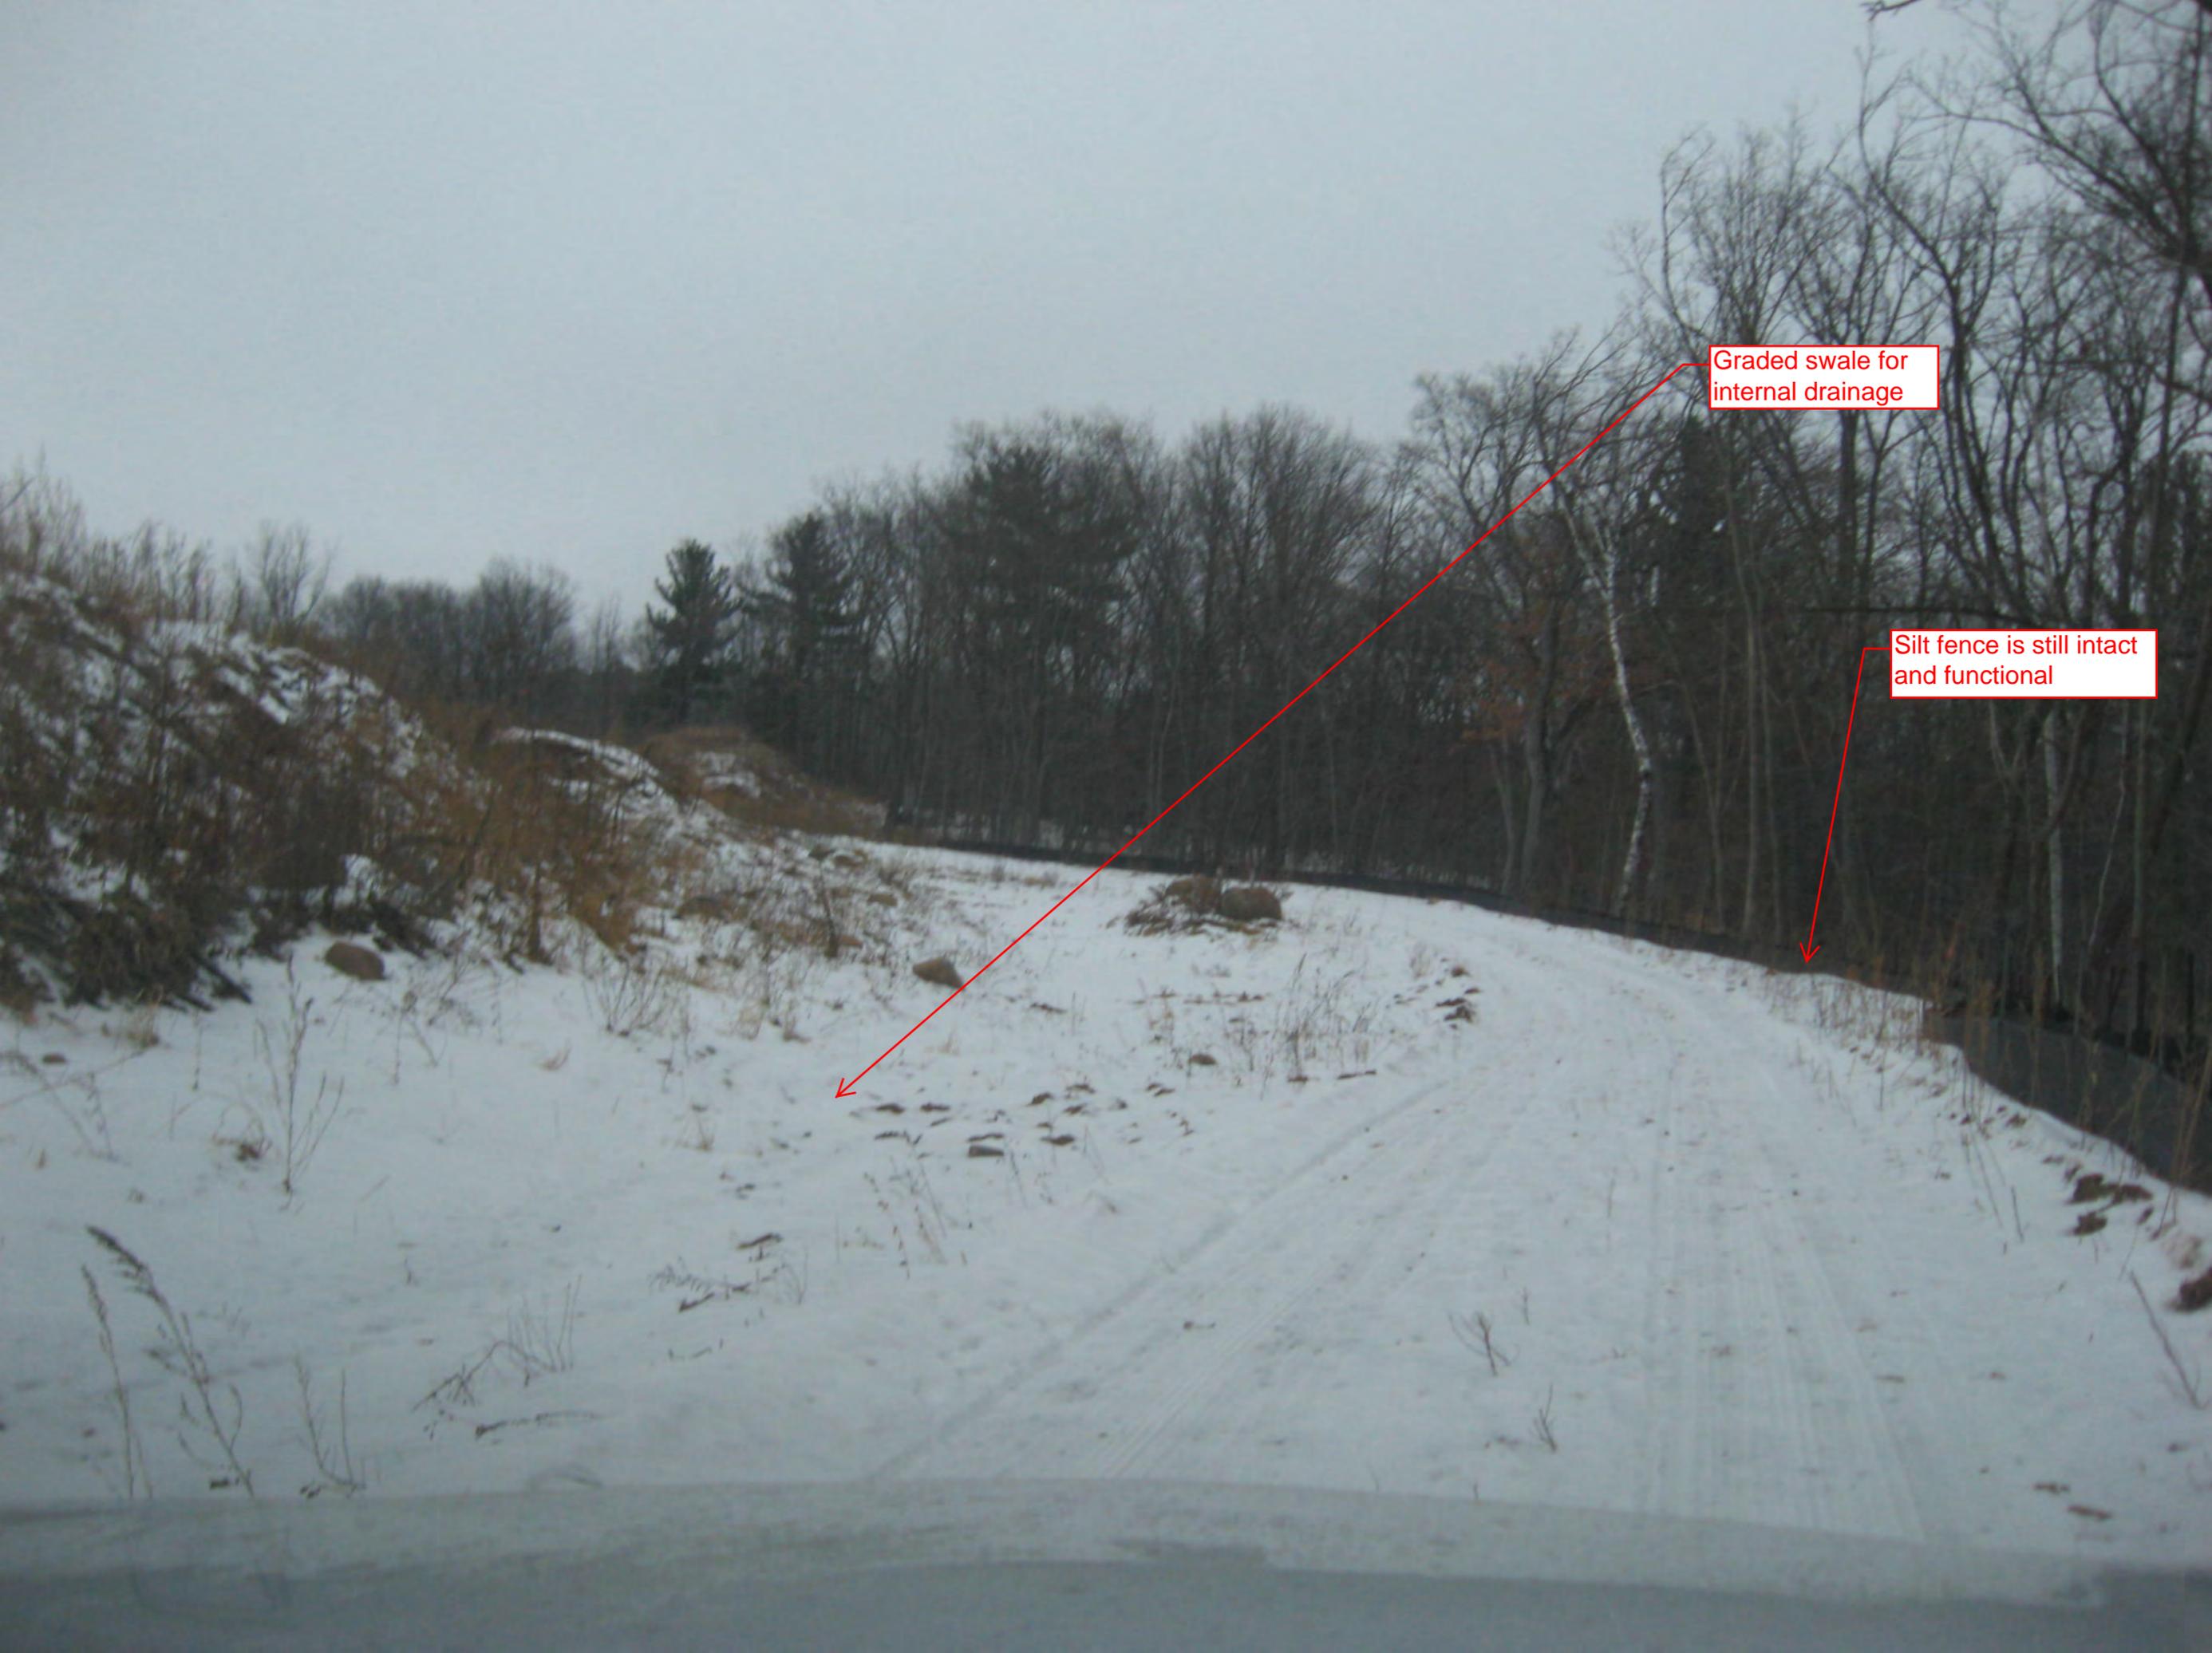
- v. In the July report, it was noted that Tiller regraded the internal driveway road that runs along the south and east project limits so that it sloped inward to the mine and therefore runoff would be directed internally. The diversion drainage ways appeared to be functioning and were directing stormwater runoff internally to a ponding area. (see attached picture). This was noted in the previous 2014 reports and is still valid.

Graded swale for internal drainage

Silt fence is still intact and functional

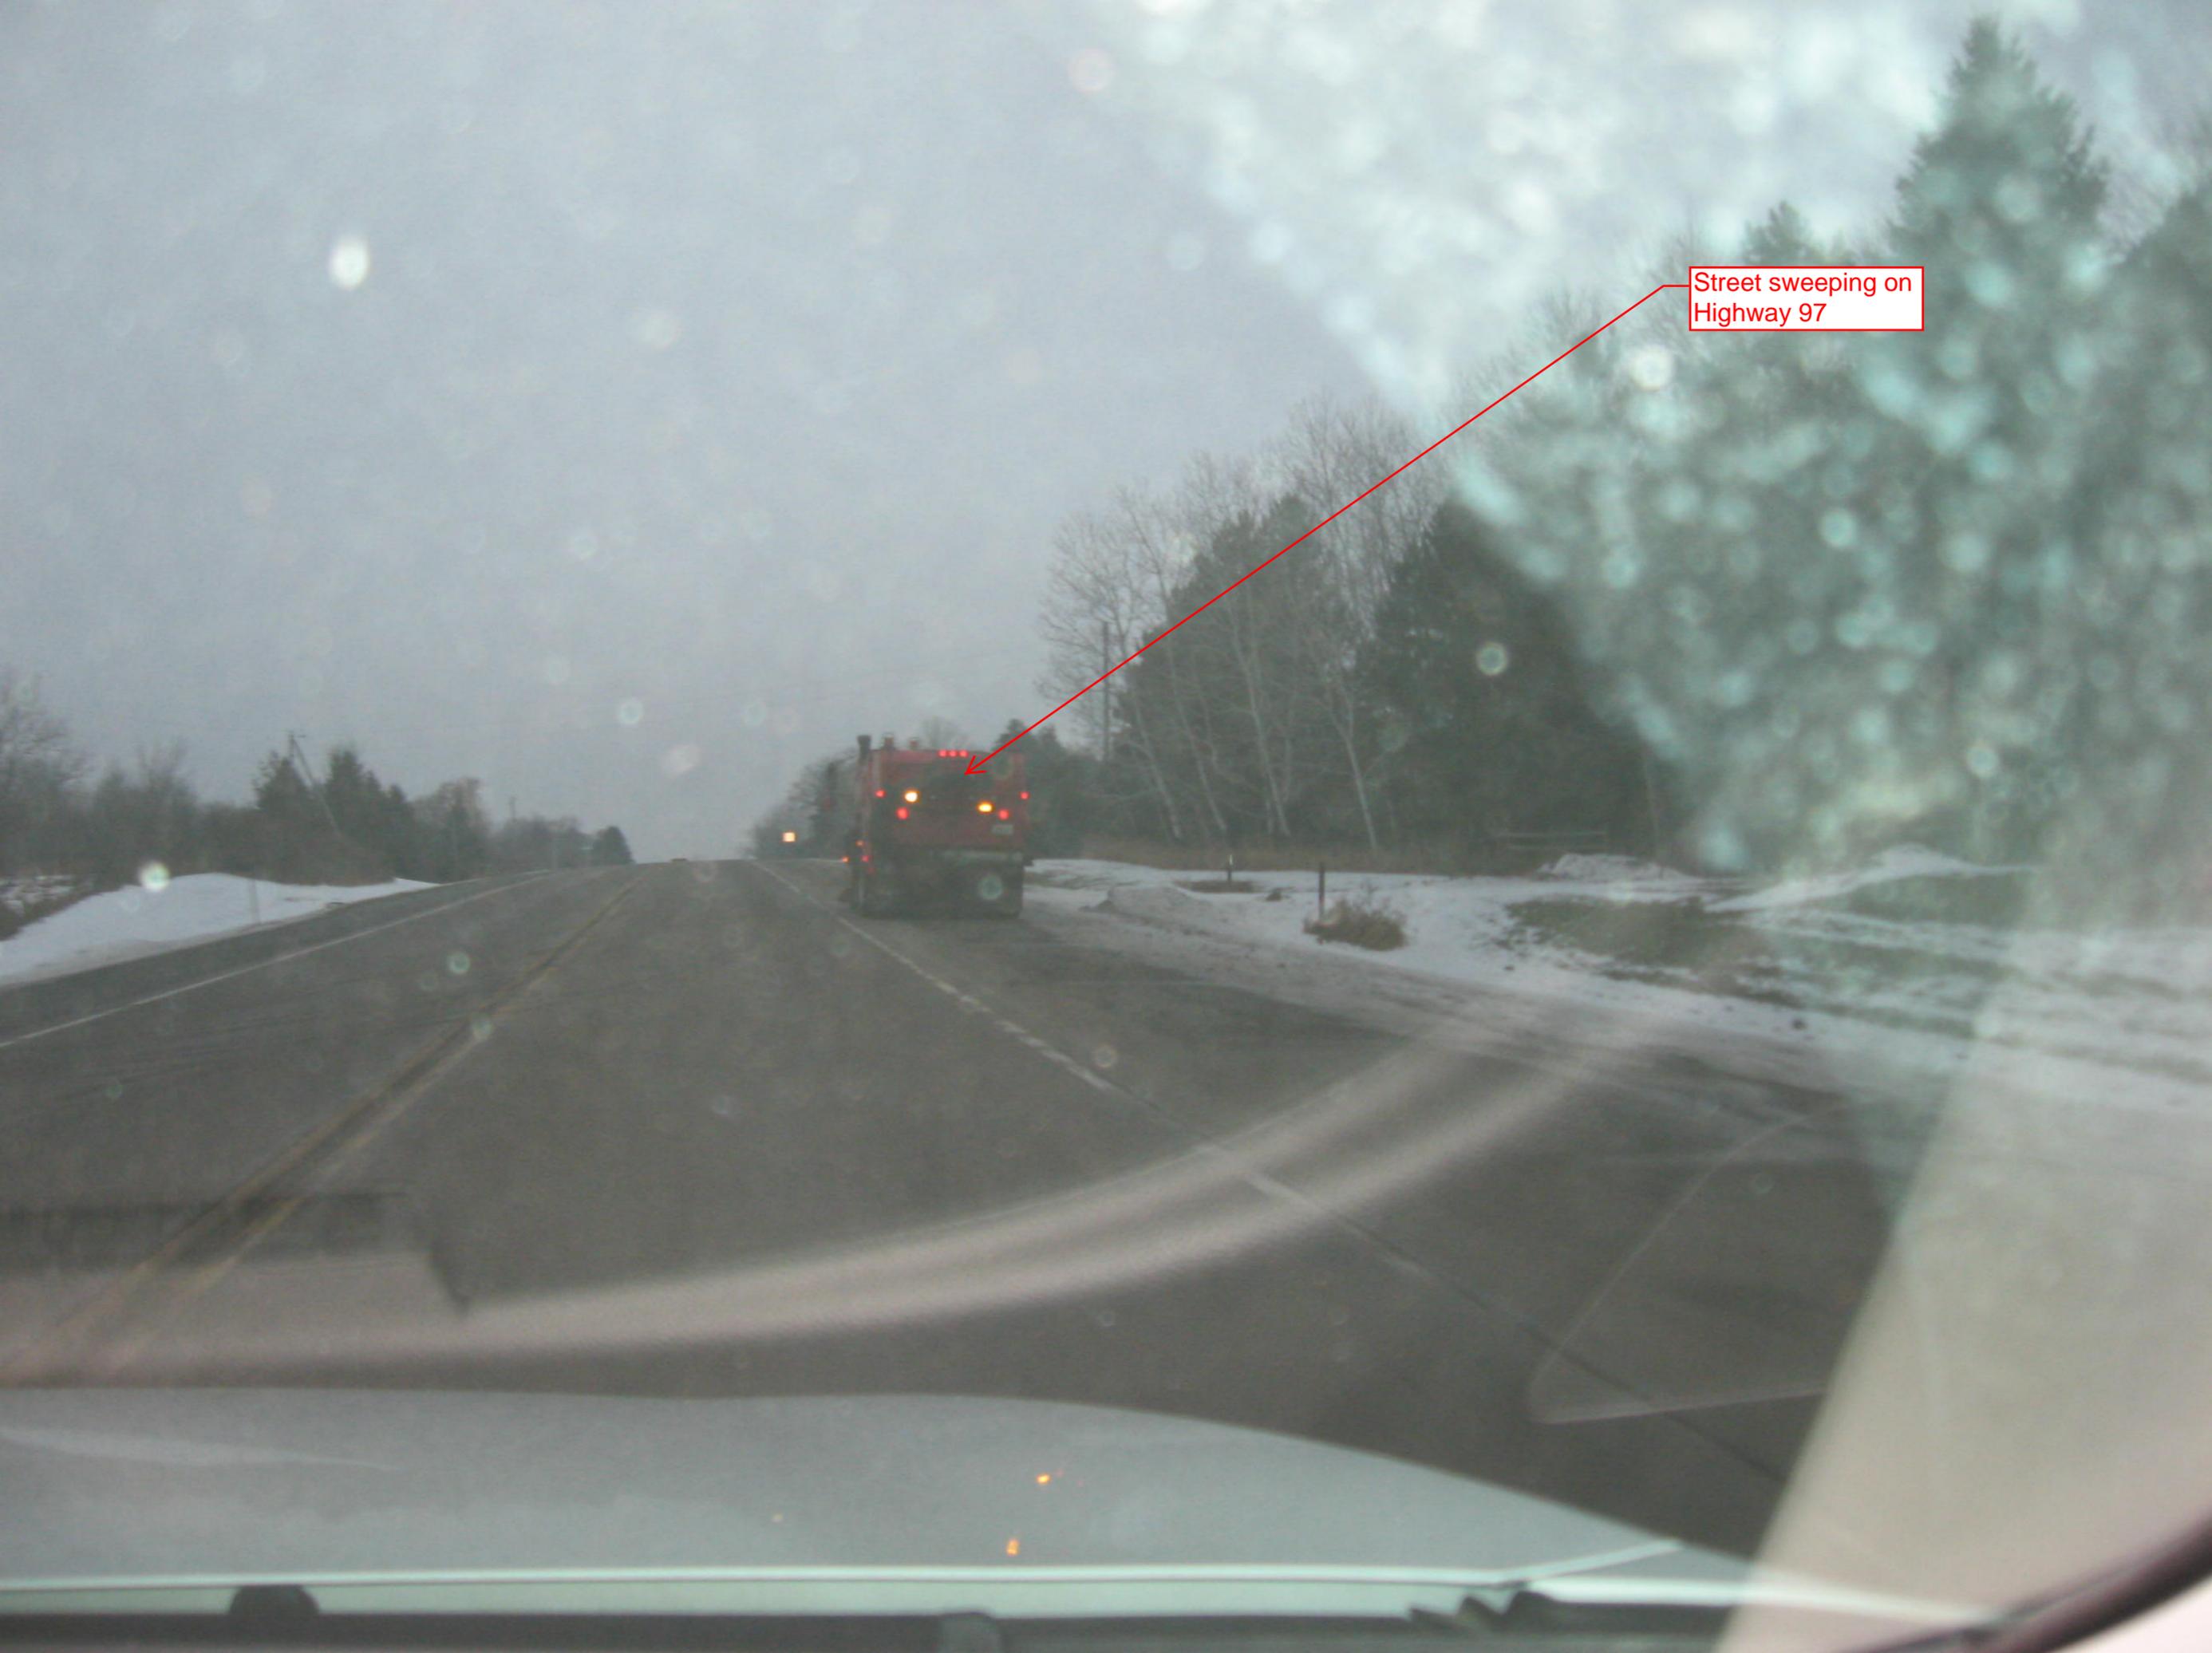
- vi. To minimize material being deposited on Highway 97, Tiller had a large street sweeper onsite that is dedicated to the haul operations between the Zavoral Mine and the Scandia Mine (see picture of active street sweeping of HWY 97).

Street sweeping on
Highway 97

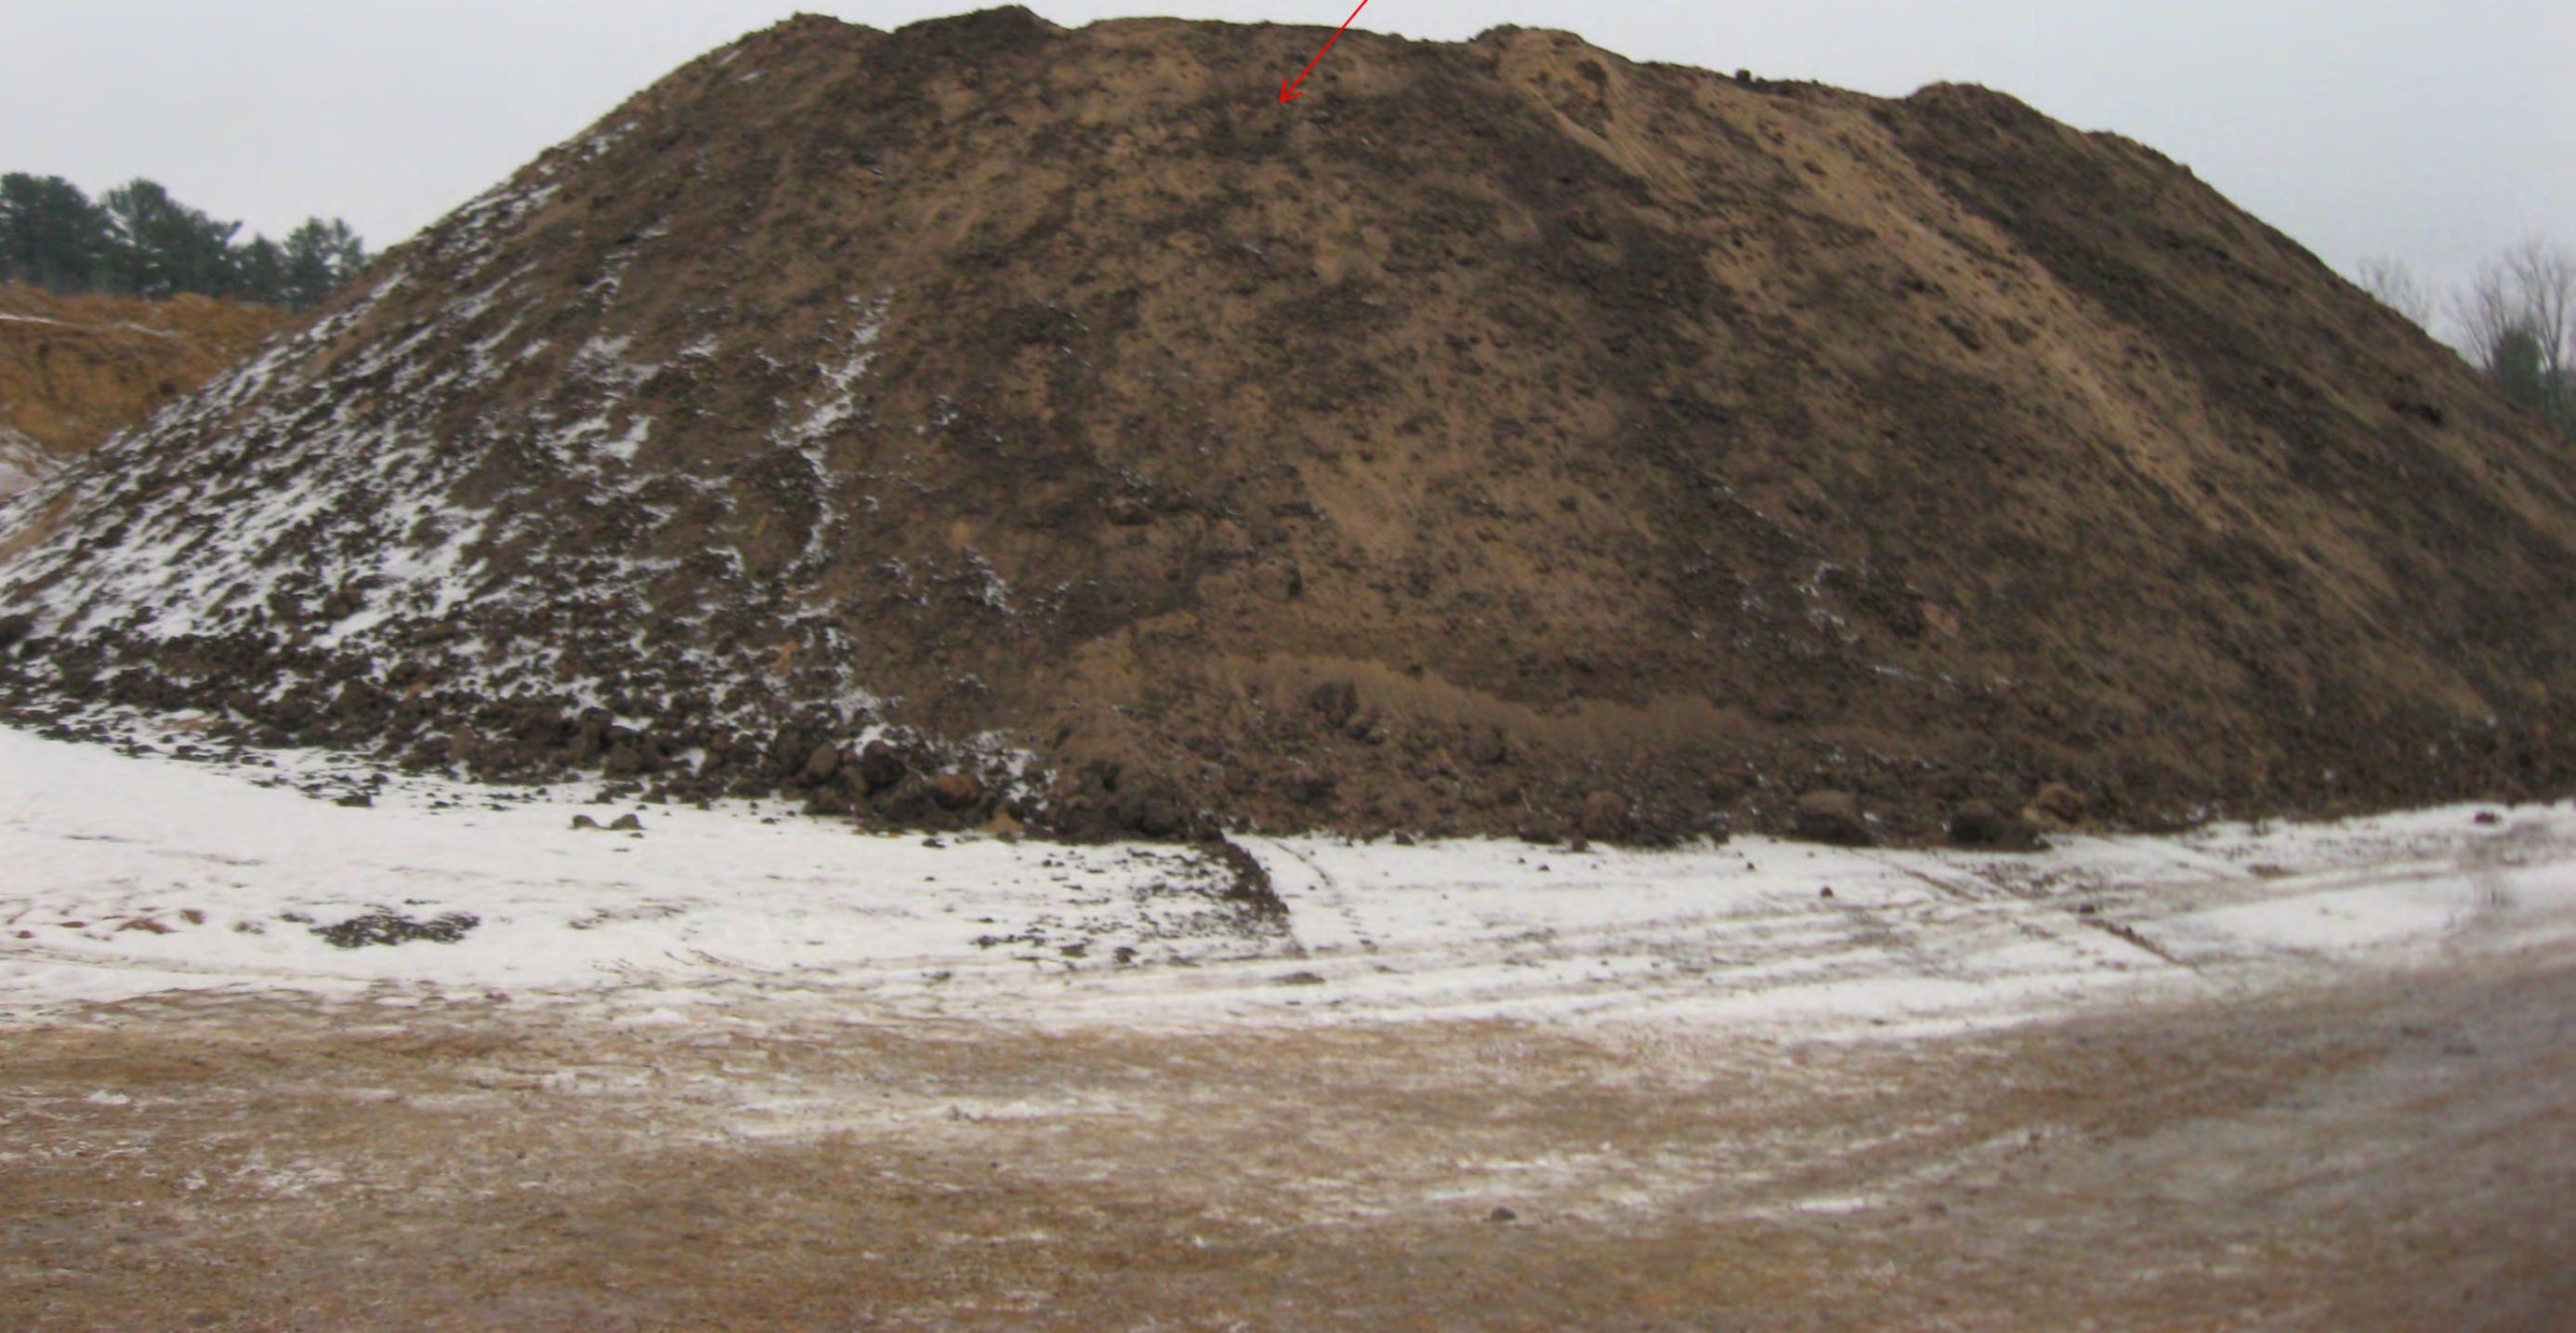
- v. A significant amount of the required organic soil had been stockpiled on site. Mixing the organic soil with the sand material was ongoing and a large amount of mixed reclamation topsoil material was onsite and ready for final placement into the reclamation areas (see attached picture).

Stockpile of mixed topsoil
(sand and organic) for
reclamation
