WASHINGTON  
CONSERVATION  
DISTRICT

**RE:** **Zavoral Mining and Reclamation Project – Monitoring and Inspection Report  
2015 Inspection #8 – November 19, 2015**

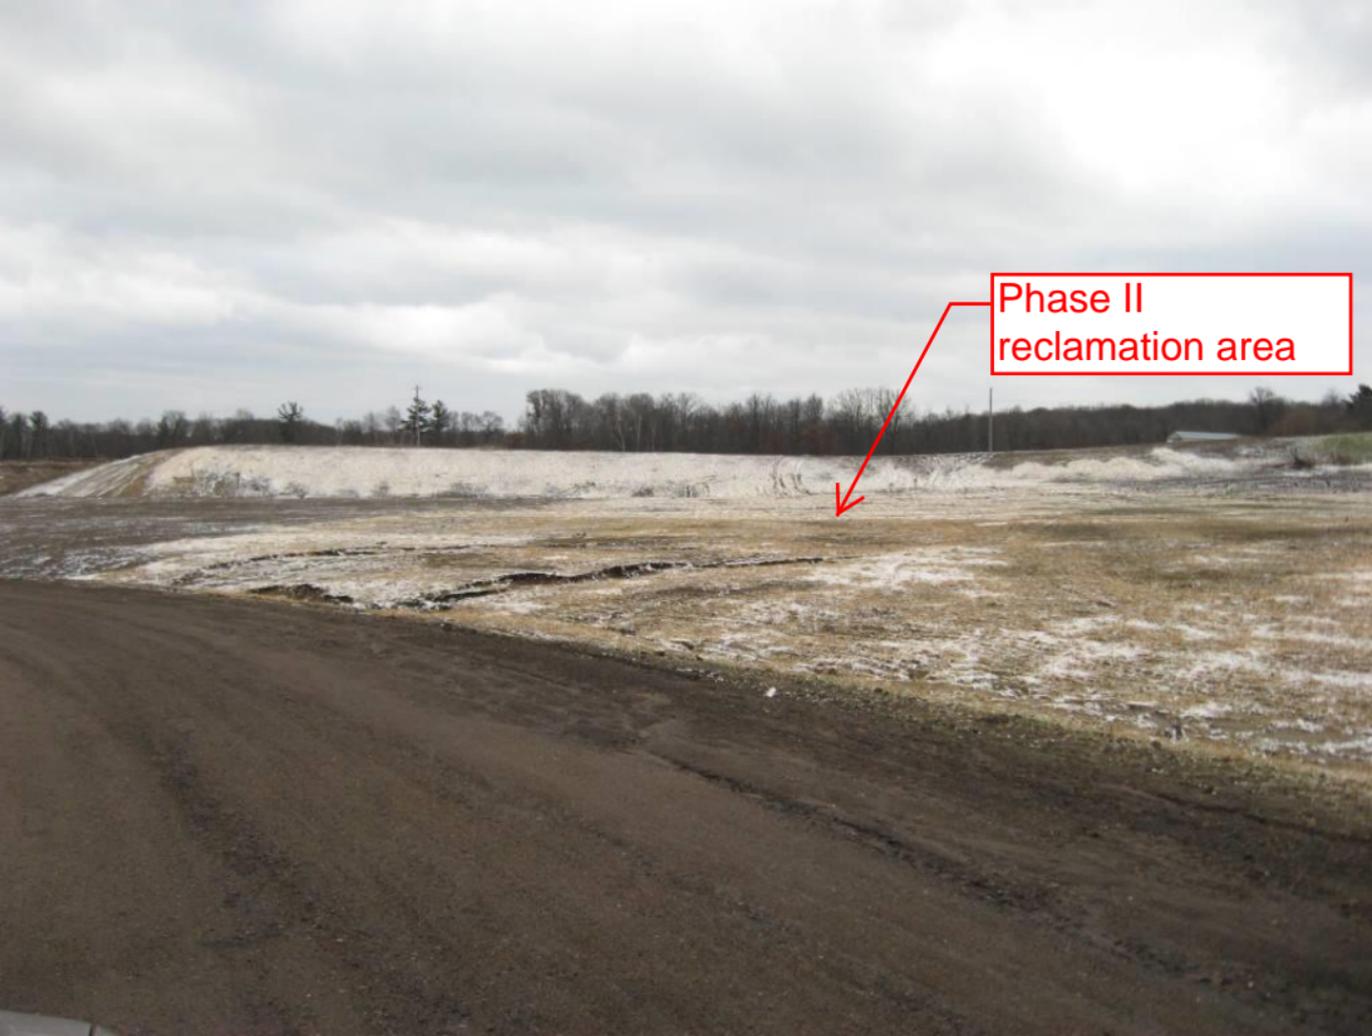
Phase II  
reclamation area

- i. Grading of Reclamation Phase II was complete.

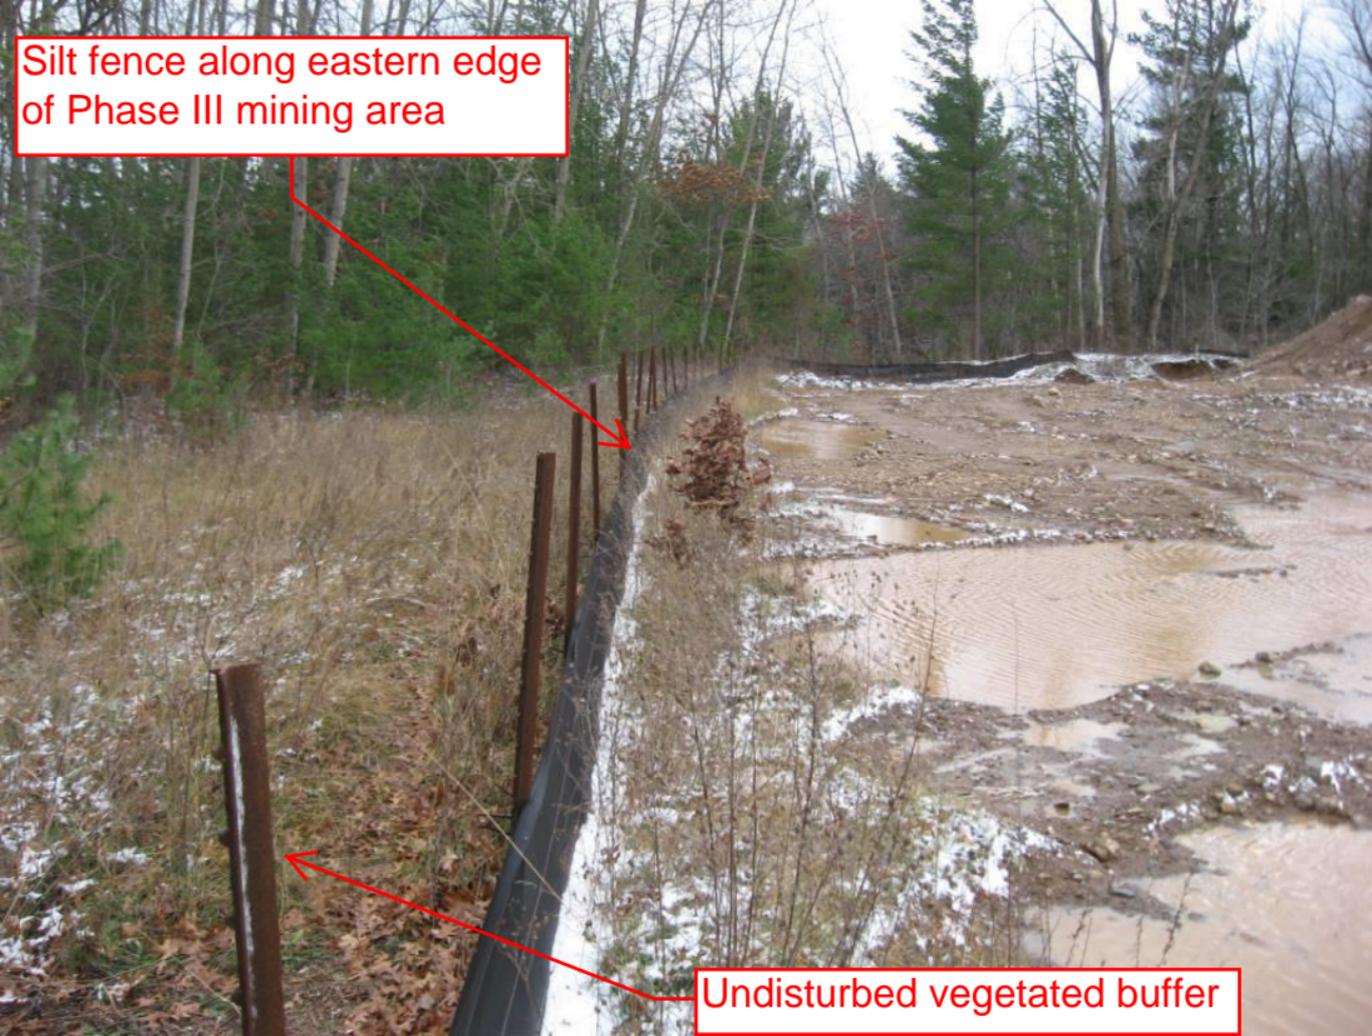
Silt fence along eastern edge of Phase III mining area

Undisturbed vegetated buffer

Road to owner's cabin

- iii. Portions of ground within the Phase III mining area had been excavated, primarily on the eastern edge, just north of the driveway to the owner's cabin. The silt fence in this area was still fully functional and there was no disturbance of the vegetated buffer outside of the fenced-in mining area (see photo).

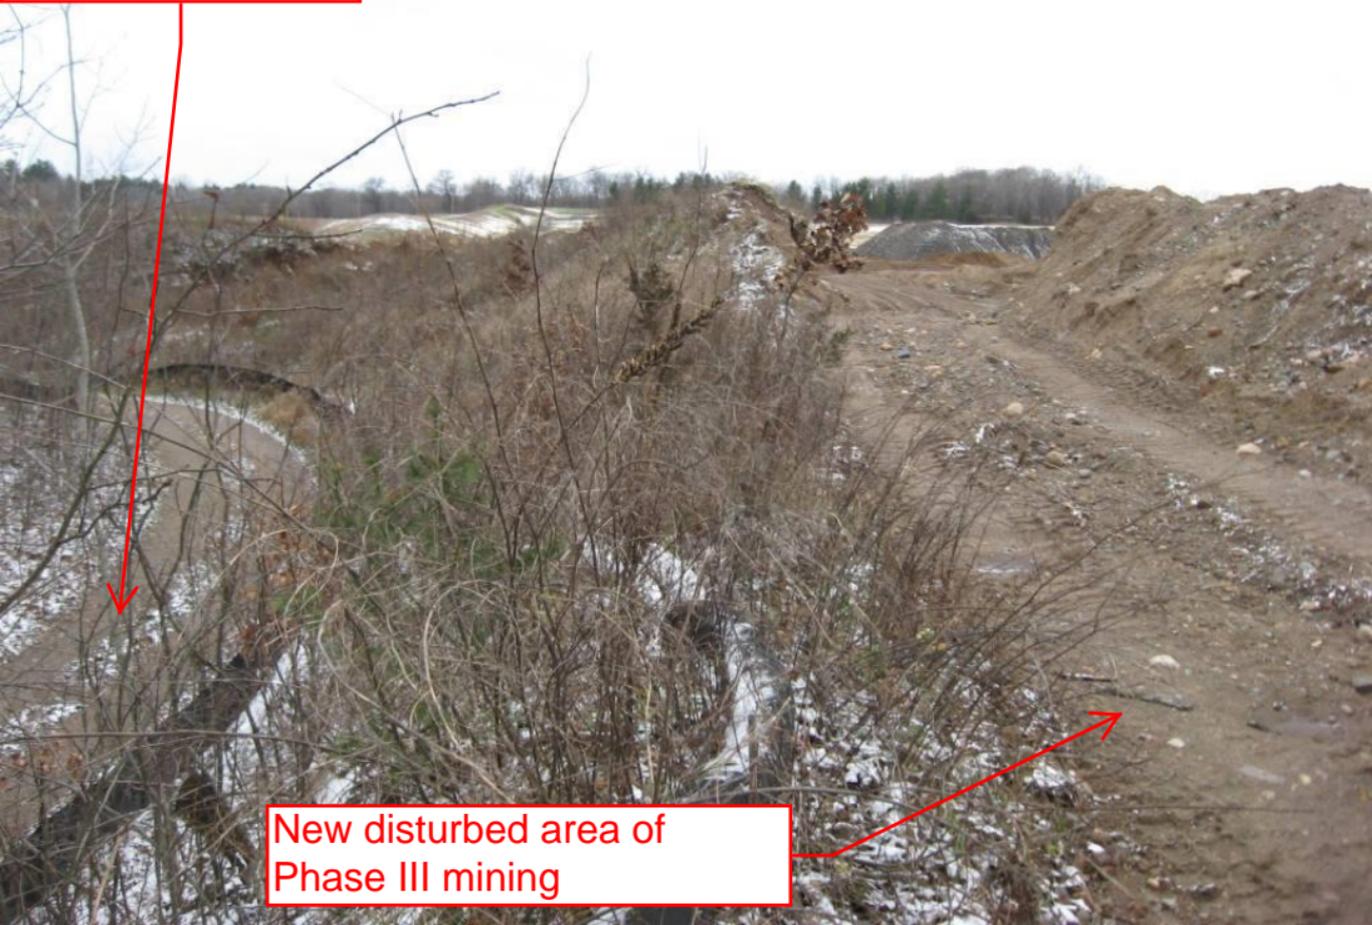
New disturbed area of Phase III mining

Road to owner's cabin

Mine drains internally

- v. The actively mined areas now all drain internally.
2. Technical Service 4 – Threatened and Endangered Species
  - a. Task 1 – Conduct Site Reviews to Document Compliance with Blanding's Turtle SOP

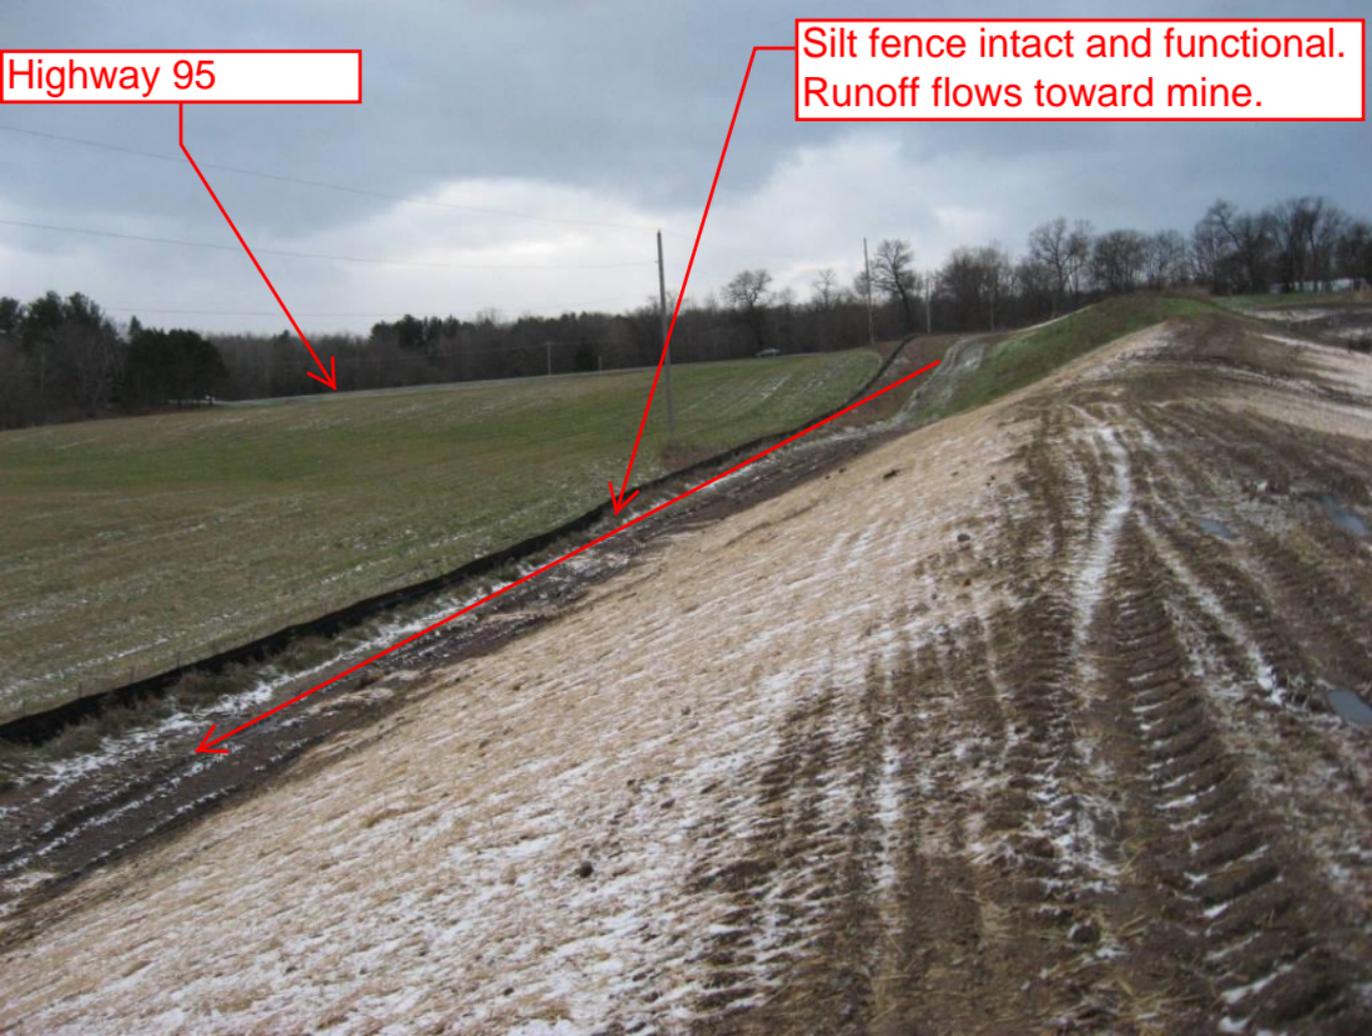
Highway 95

Silt fence intact and functional.  
Runoff flows toward mine.

- ii. Some work on the screening berms on the west side of the pit had been done resulting in soil disturbance. The perimeter control on the outside of the mine pit was still fully functional and erosion control measures had been implemented on the steep slopes (see photo).

- iv. Silt fence that had been installed in 2013 as per the stormwater pollution and prevention plan (SWPPP) was in good shape. The silt fence throughout the project area was still effective for perimeter control.

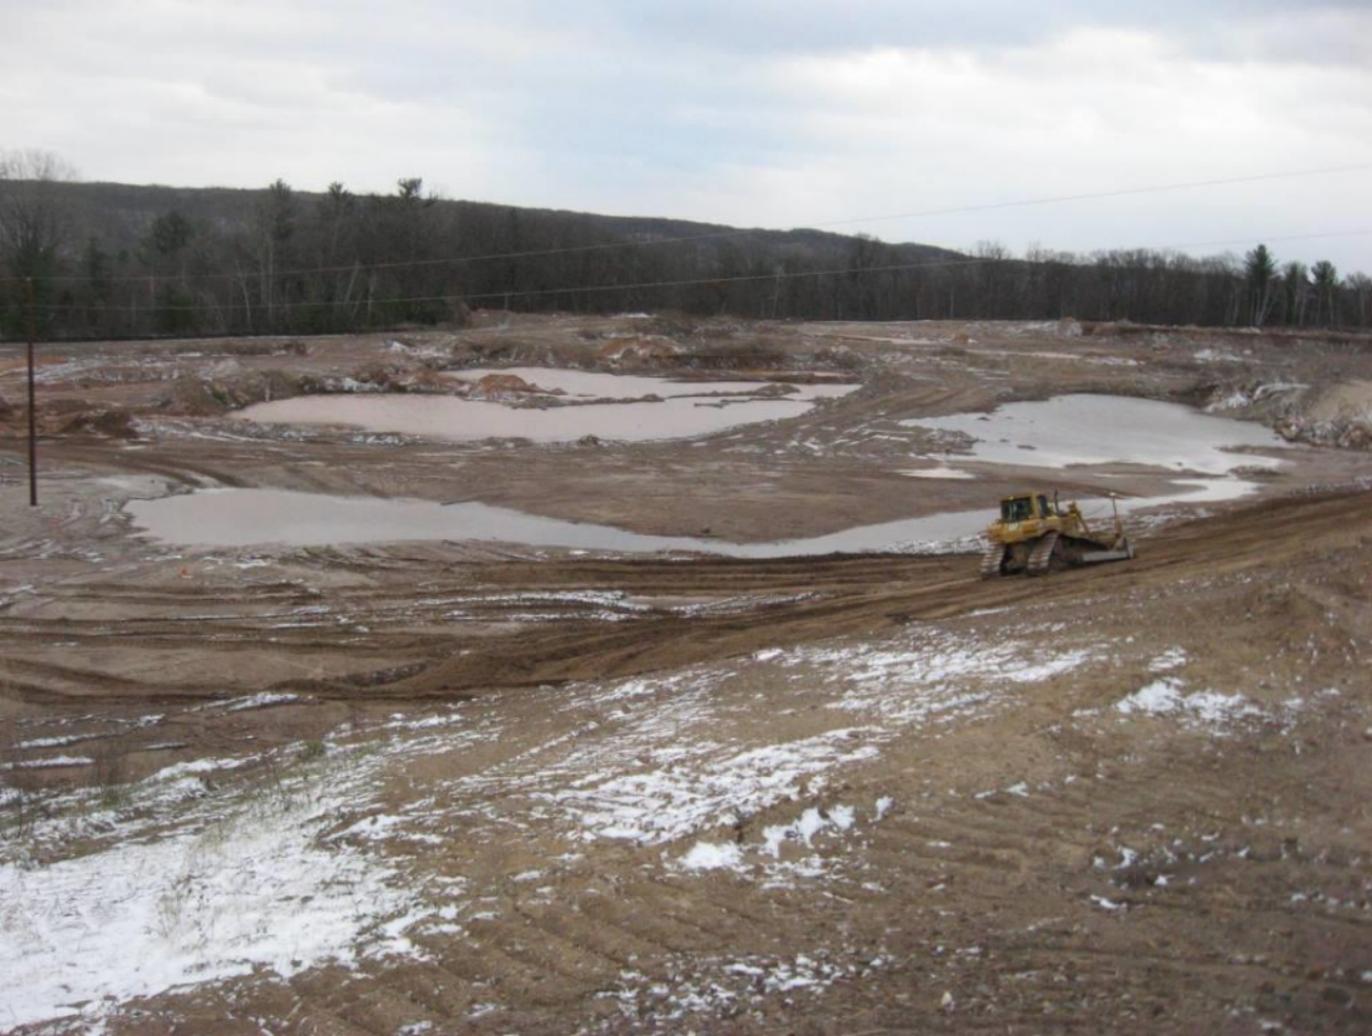
Silt fence intact

Runoff stays on site
