MEMORANDUM

FROM: Jed Chesnut, Wetland/Natural Resource Specialist

DATE: March 17, 2015

RE: **Zavoral Mining and Reclamation Project – Monitoring and Inspection Report
2015 Inspection #1 – March 12, 2015**

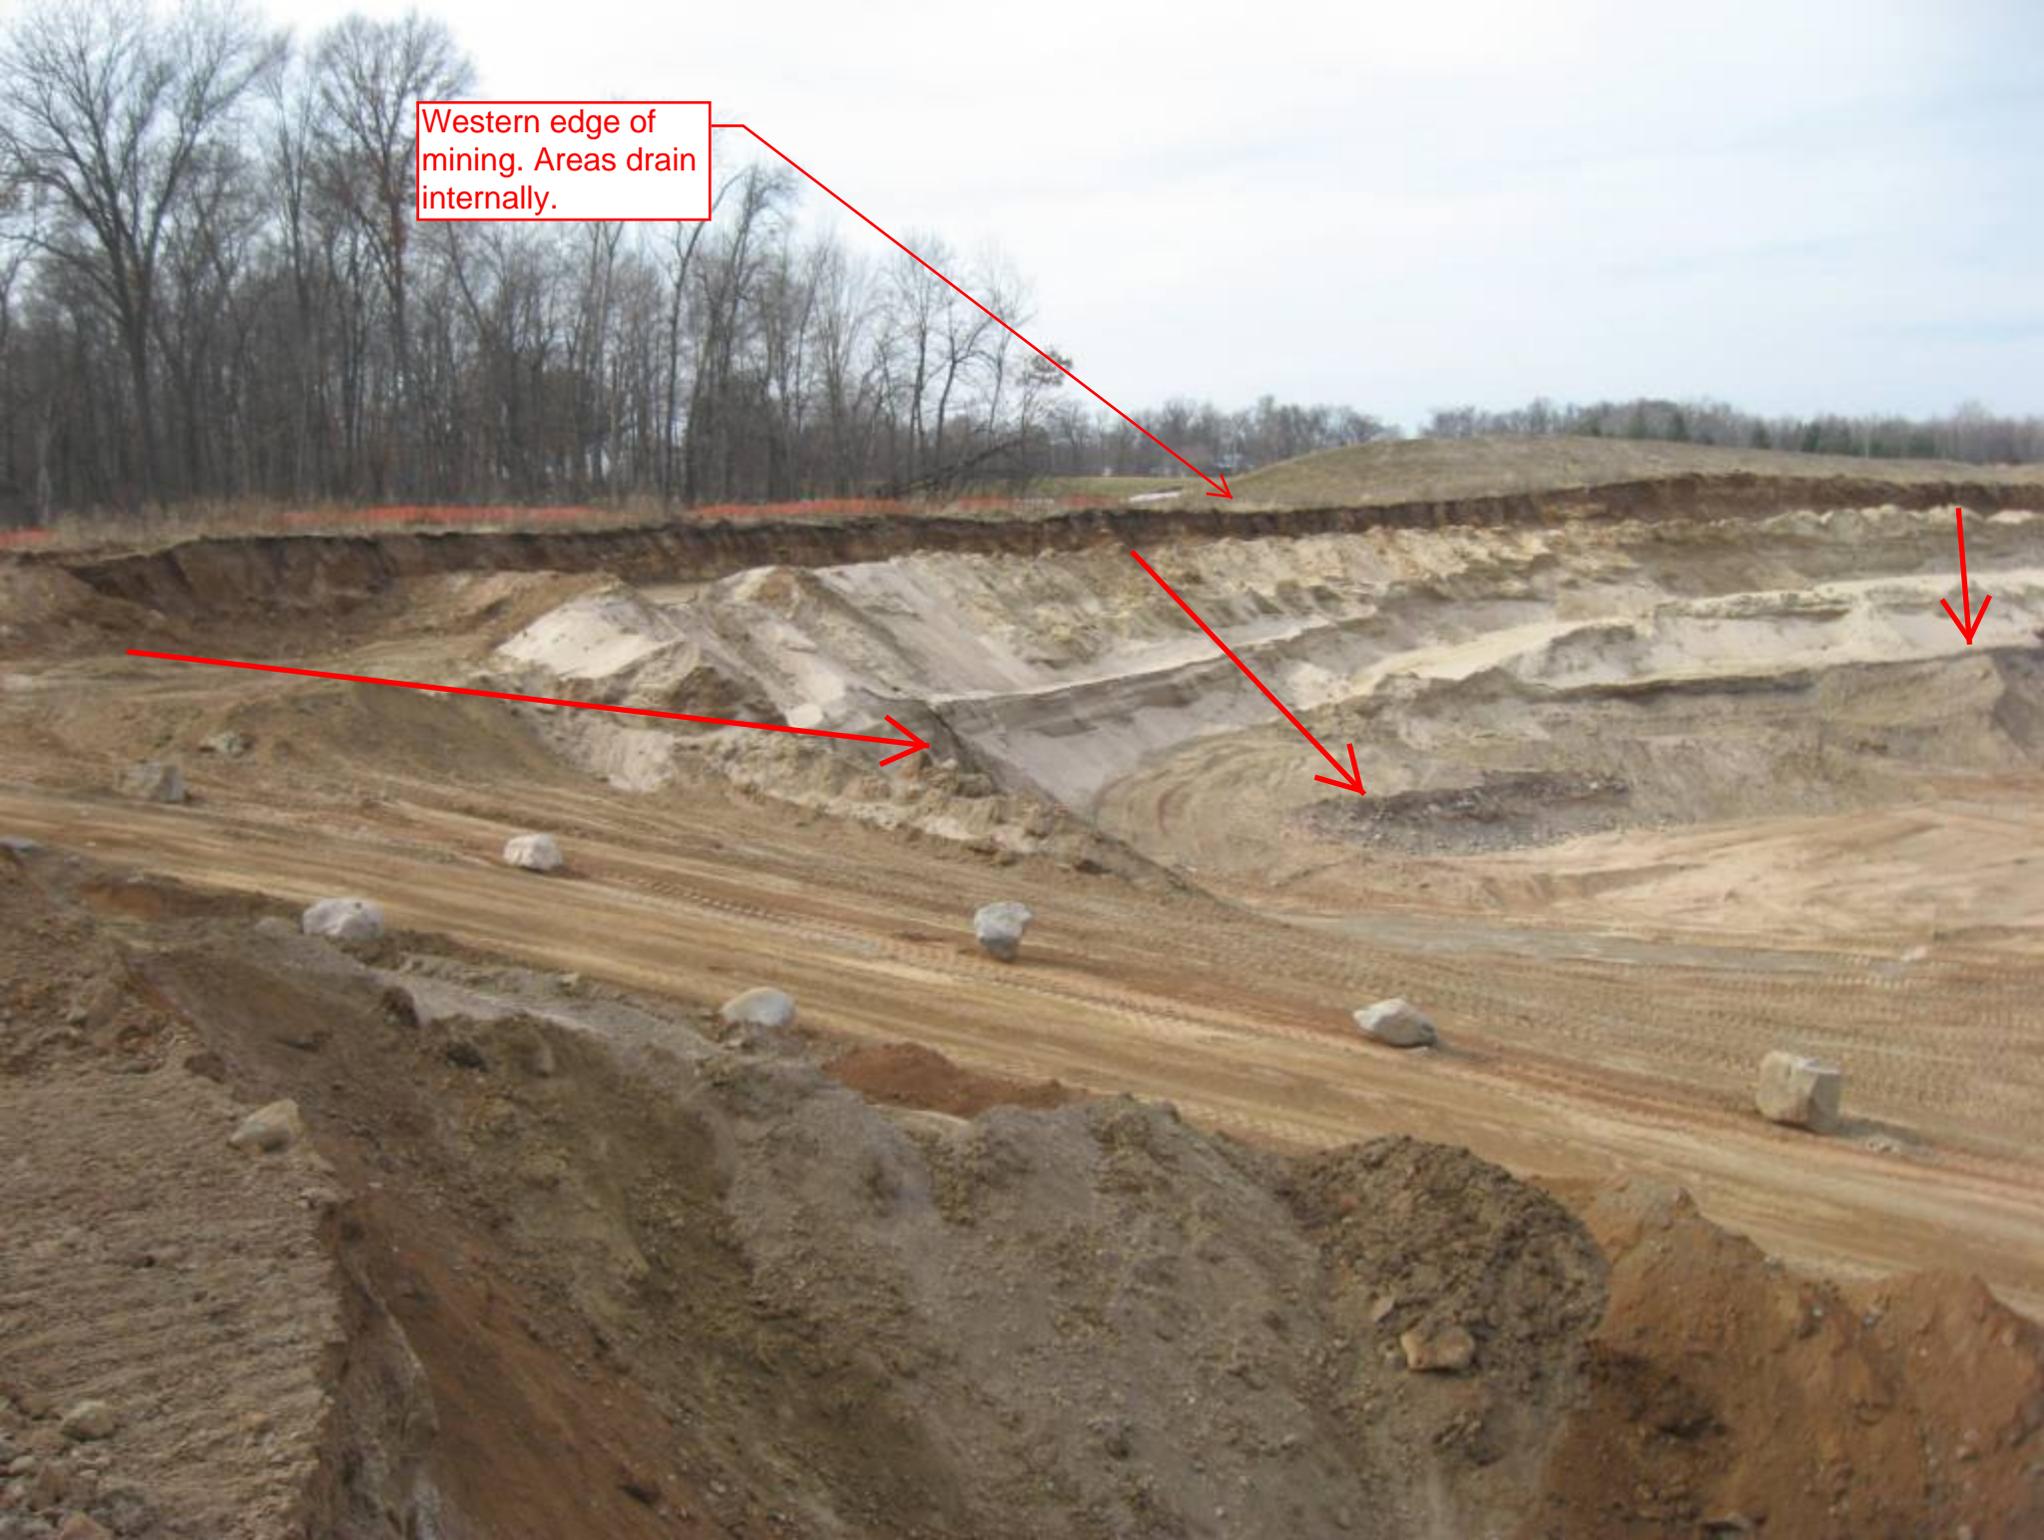
Western edge of mining. Areas drain internally.

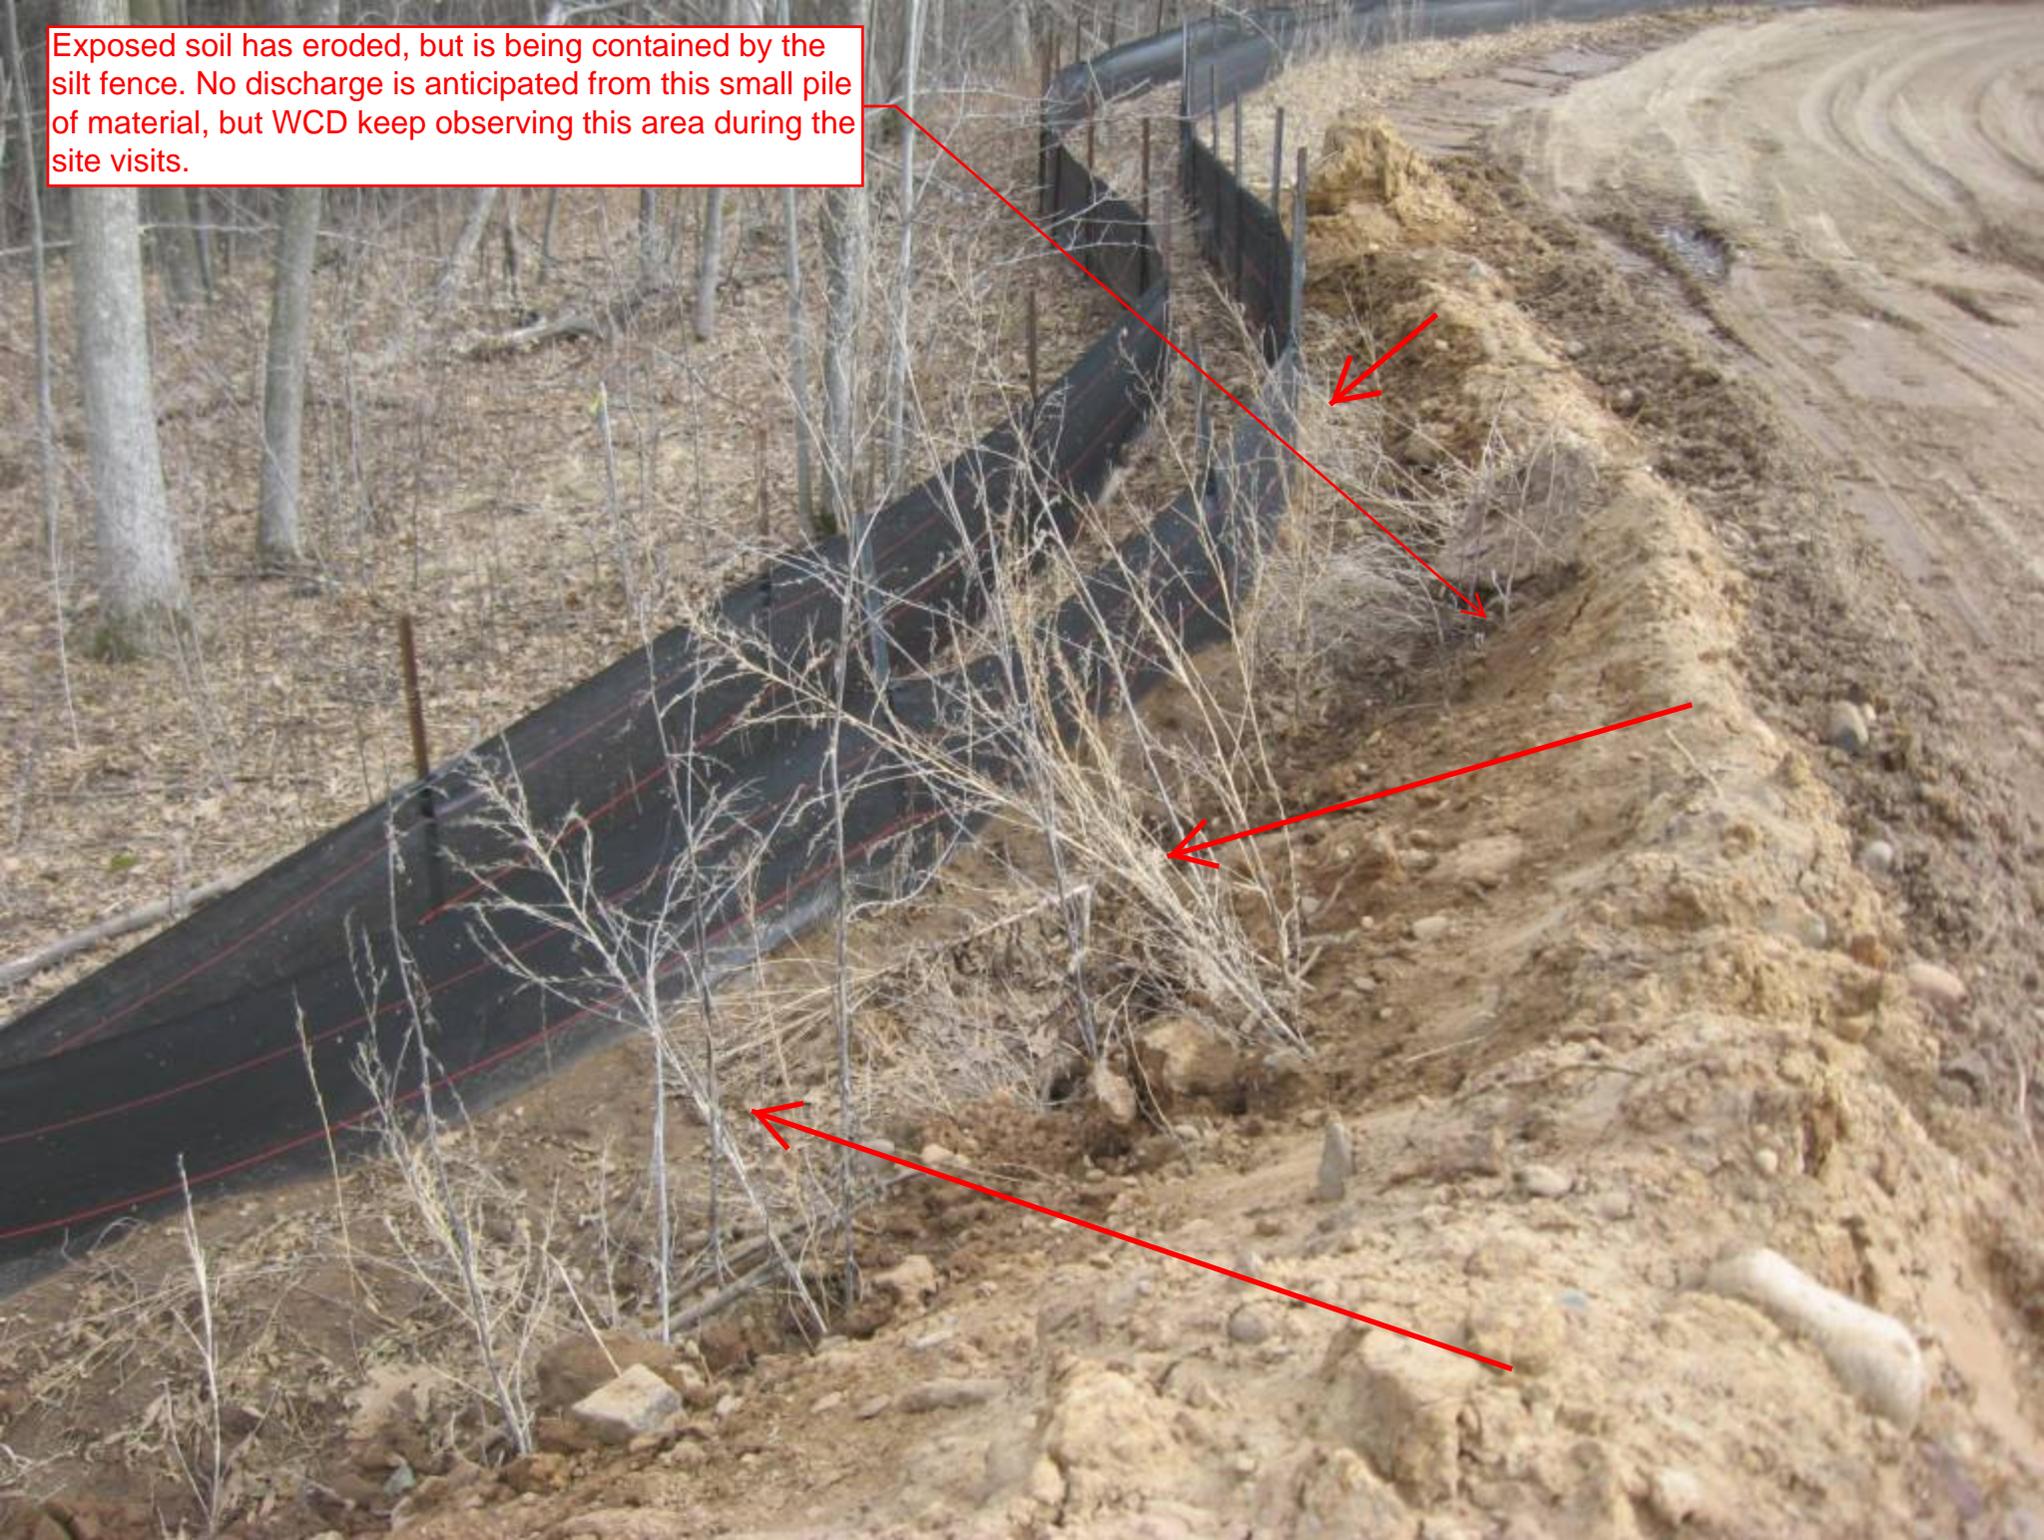
- viii. A small area of exposed soils was observed along the east project limit. The soils had experience some erosion, however the silt fence was functioning properly to

contain the sediment. This area will be checked during each inspection to ensure that sediment does not discharge out of the mine area.

Exposed soil has eroded, but is being contained by the silt fence. No discharge is anticipated from this small pile of material, but WCD keep observing this area during the site visits.

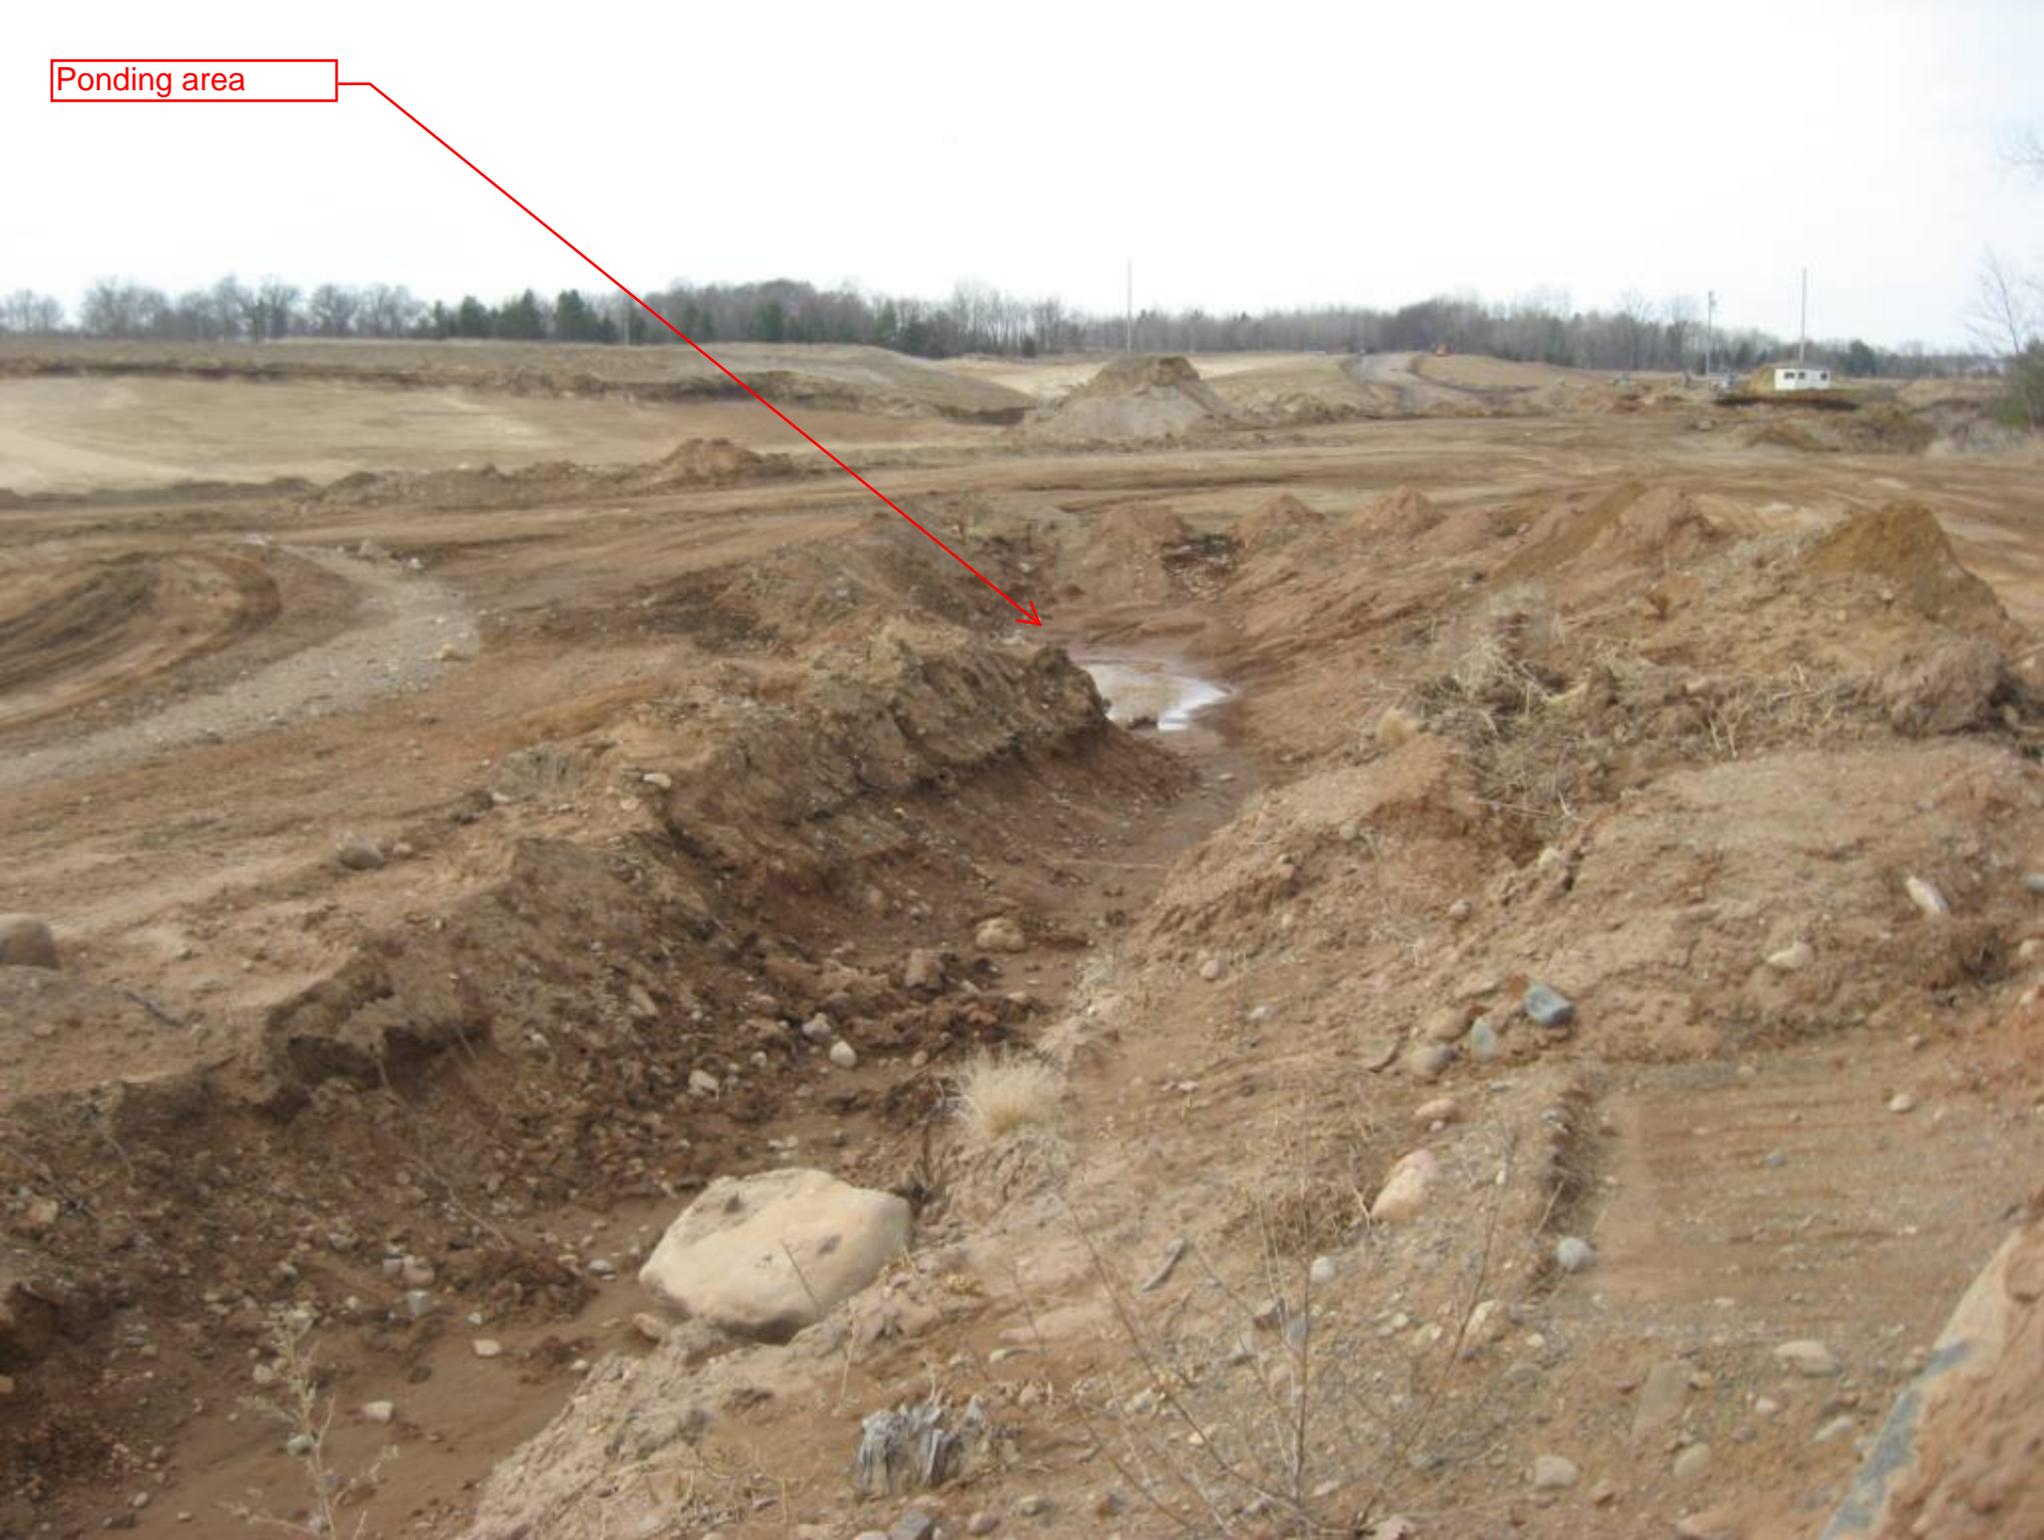
Ponding area

- vii. In 2014, Tiller regraded the internal driveway road that runs along the south and east project limits so that it sloped inward to the mine and therefore runoff would be directed internally. Most of the driveway along the south was no longer present since the area was mined. The driveway is now within the mined area. The diversion drainageways along the east project limit were still present and appeared to be functioning by directing stormwater runoff internally to a ponding area (see attached picture).

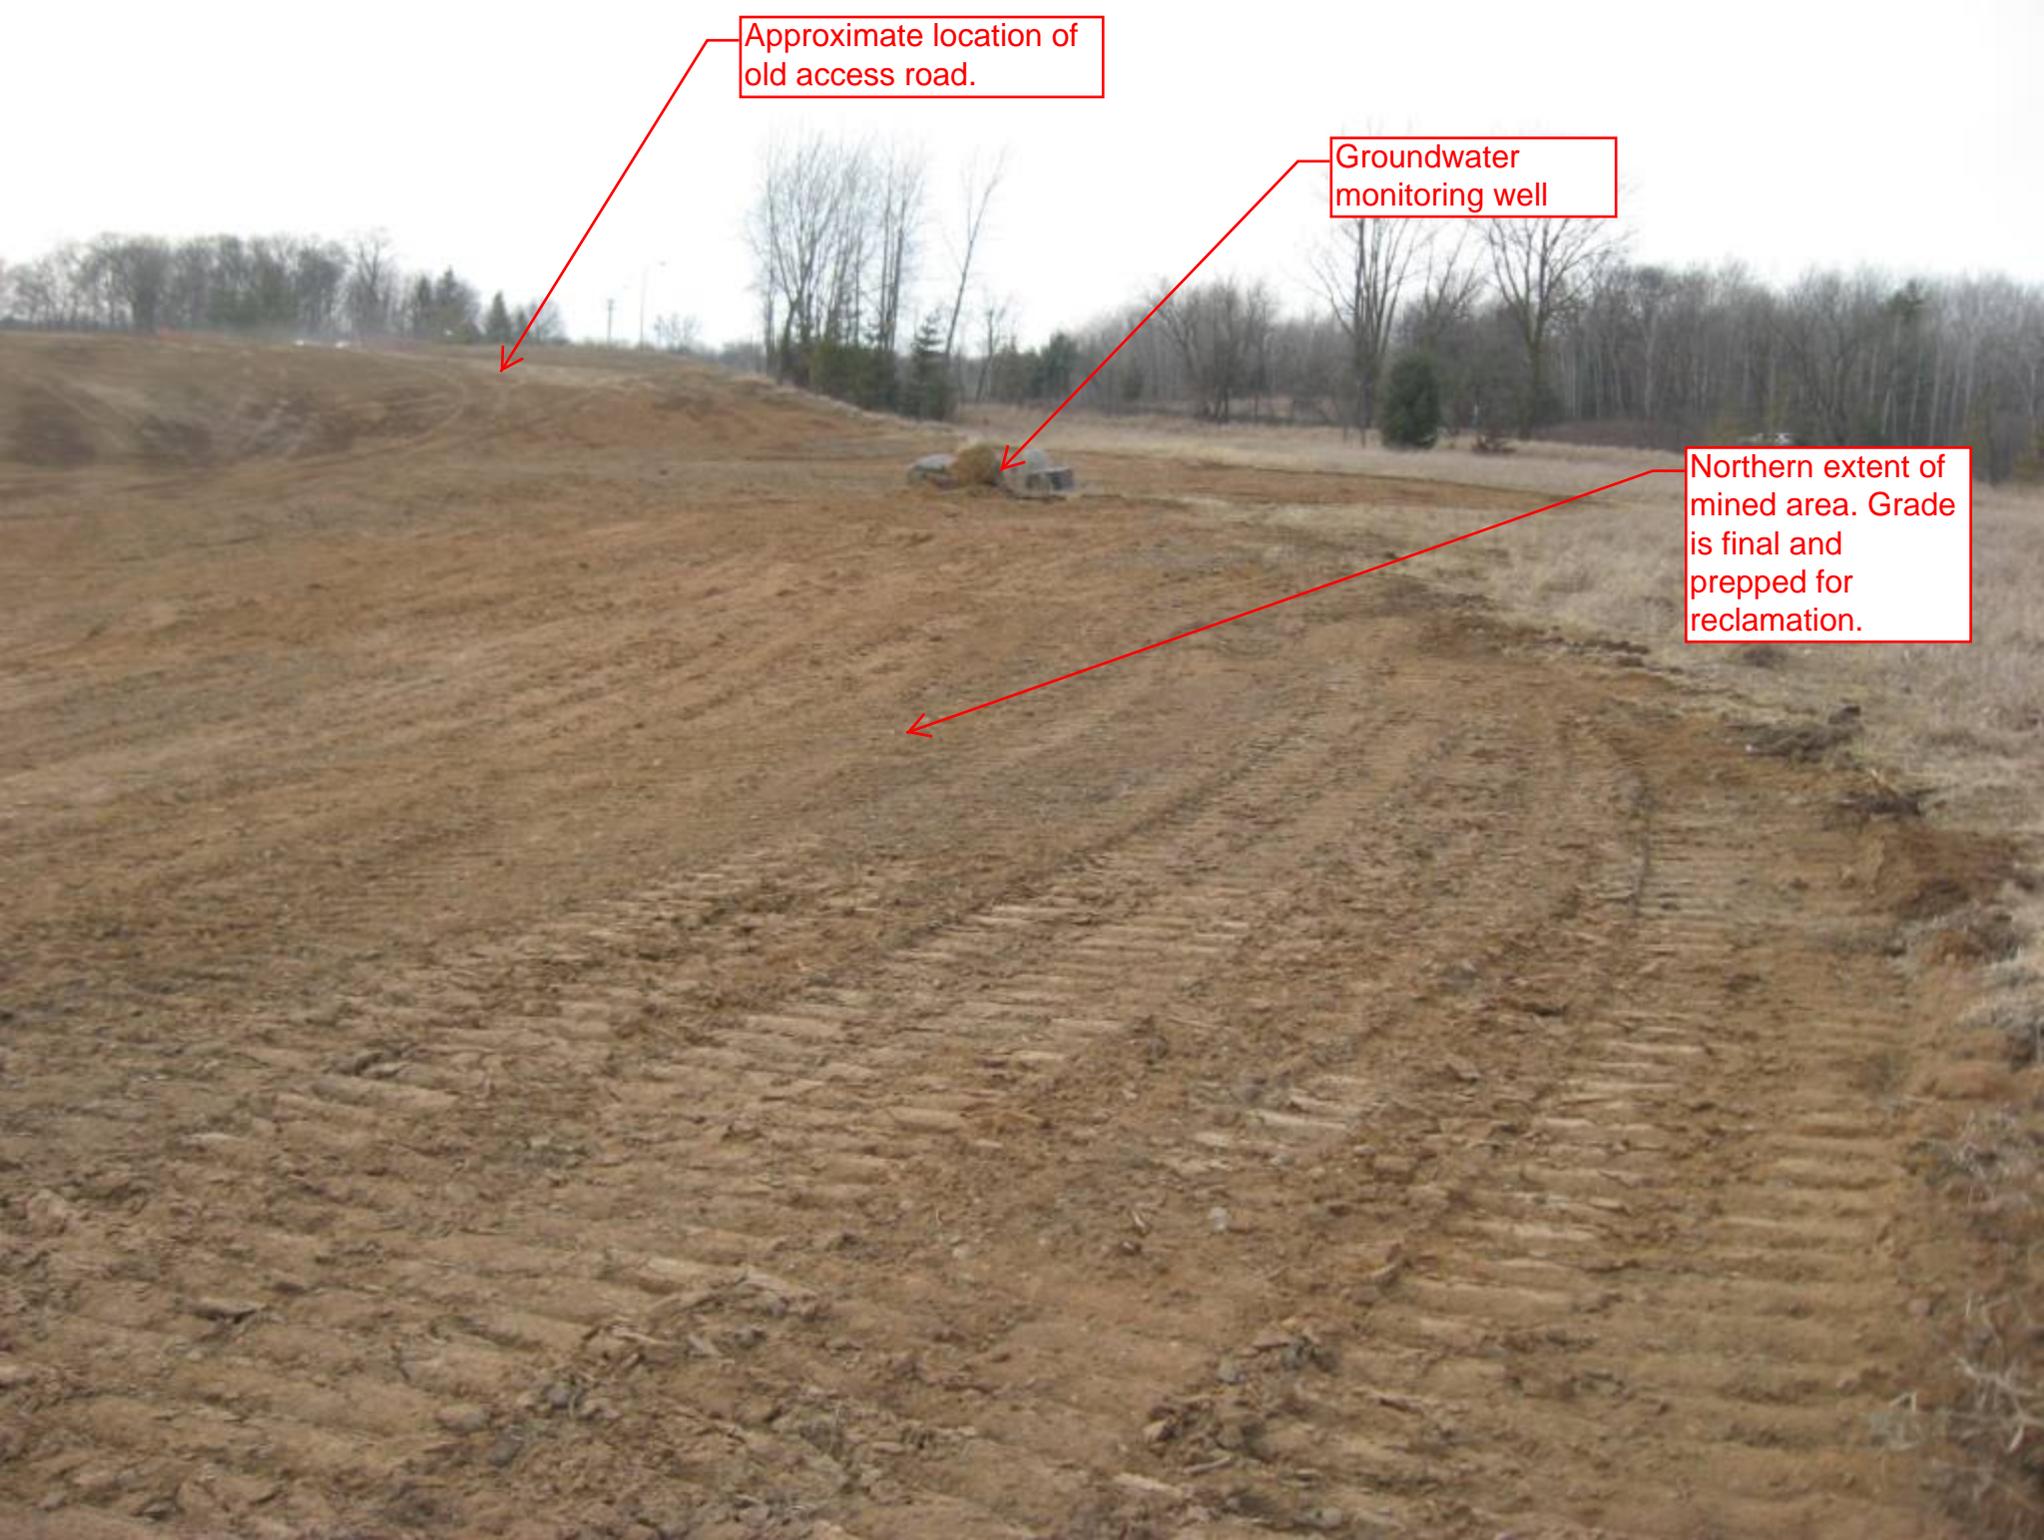
- vi. The old access road has been completely removed and the northern area of the mine had been "finished-graded" in preparation for Reclamation Phase II. The entire northern boundary of the active mine area slopes and drains internally (see attached pictures).

Northern extent of mined area. Grade is final and prepped for reclamation.
