## MEMORANDUM

**FROM:** Jed Chesnut, Wetland/Natural Resource Specialist

**RE:** **Zavoral Mining and Reclamation Project – Monitoring and Inspection Report  
2014 Inspection #3 – July 28, 2014**

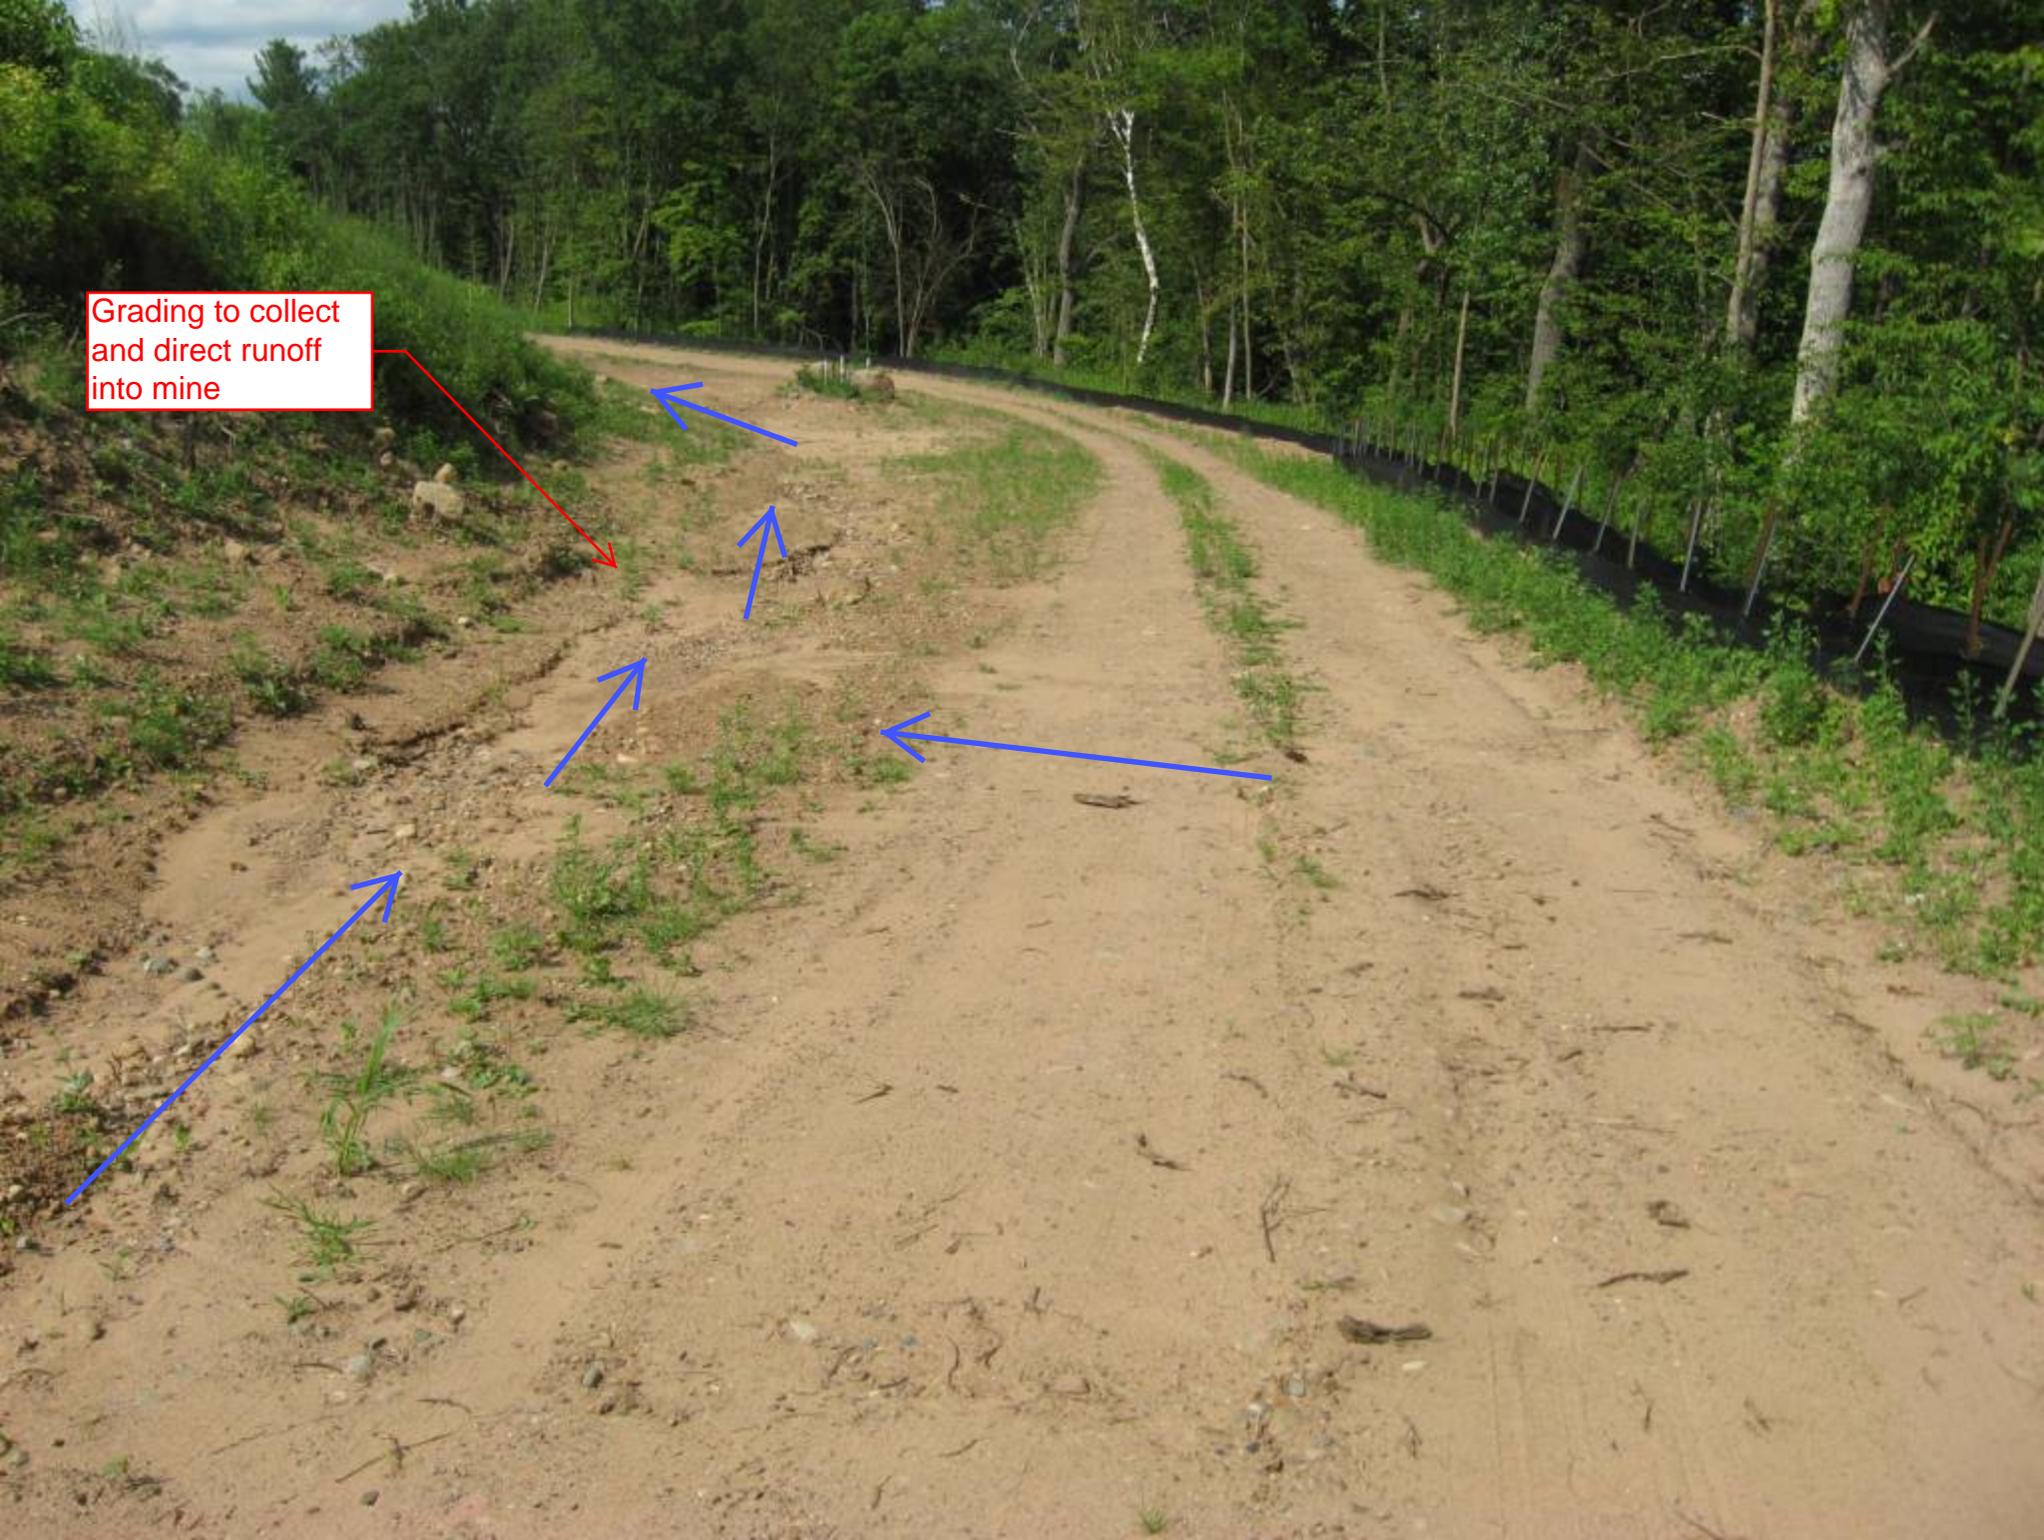
- viii. In the June report, it was noted that Tiller planned to regrade the internal driveway road that runs along the south and east project limits so that it slopes inward to the mine and therefore runoff will be directed internally. This work had been completed prior to the July site inspection. Along the length of the road, Tiller graded on the mine side to create drainageways that direct and collect runoff into the mining area. This significantly reduces the potential for stormwater discharge off the mine site along the south and southeast edge of the mine (along the owner's driveway). Tiller

is leaving the silt fence in place as perimeter control for the very small area of road and edge that drains away from the mining area (see attached pictures).

Grading to collect and direct runoff into mine
